BUILDING INSPECTION REPORT

April, 2009

Civic Stadium Code Issues

Building Inspection Report

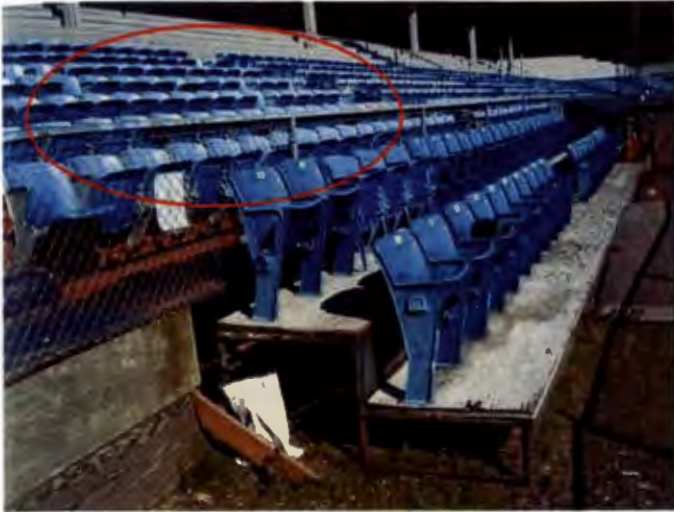
- 21. The metal bleachers have the most extensive deterioration. Due to a lack of water drainage from the walking surfaces, and the grade below at the footings, the decking and support systems are compromised. (OSSC 1009.5.2, 2203.2)

Structural support of metal bleacher seats corroded.

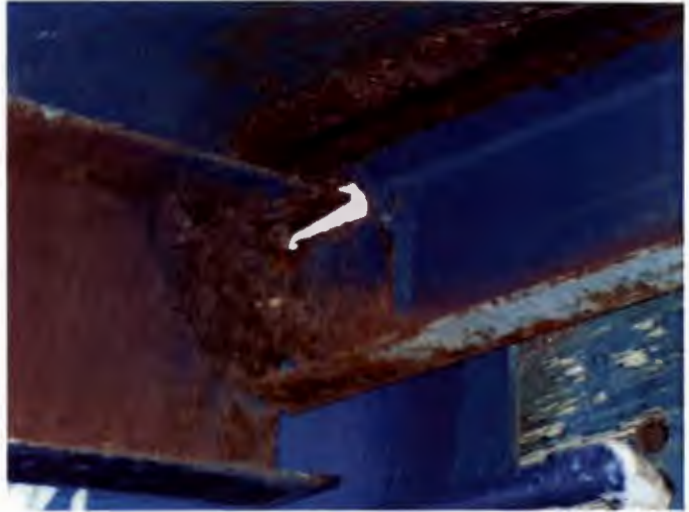
Structural support below metal bleacher section.

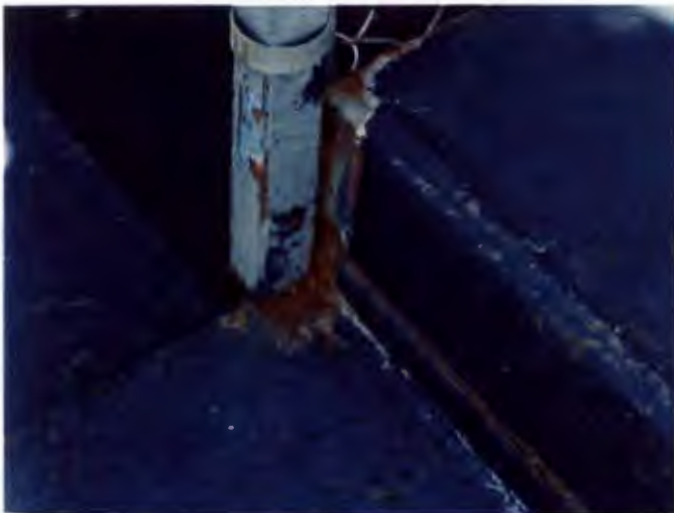
Metal stairs and hand rails.

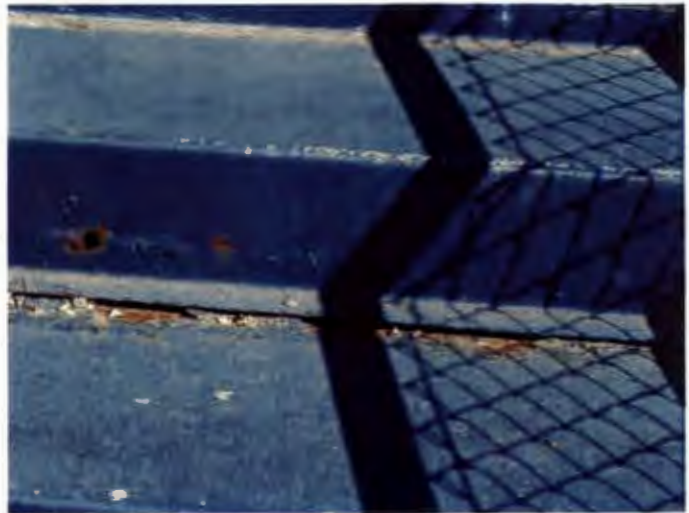
Metal stairs to raised bleacher seats.

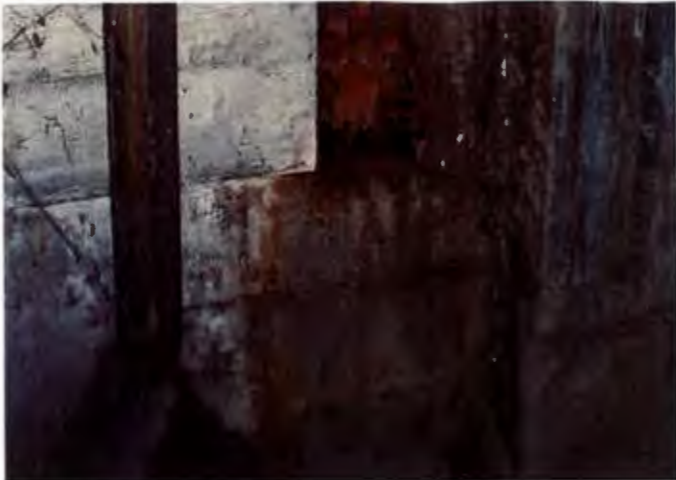
Roof downspout drains to grade along foundation.
Visible signs of dry rot.

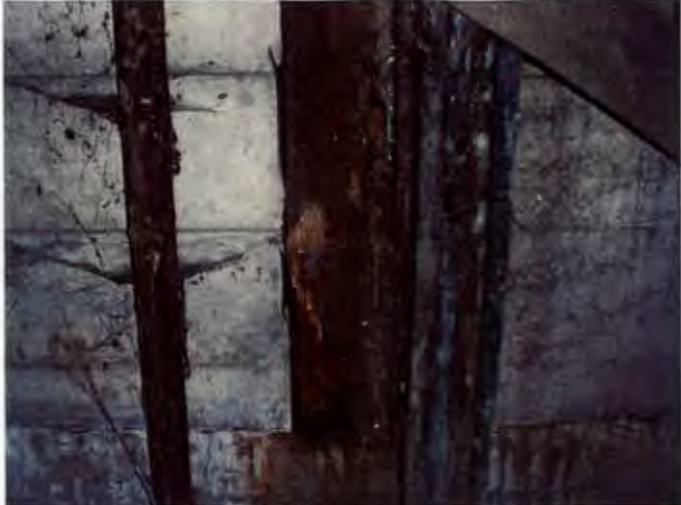
Roof downspout drains to grade along foundation.
Visible signs of dry rot.

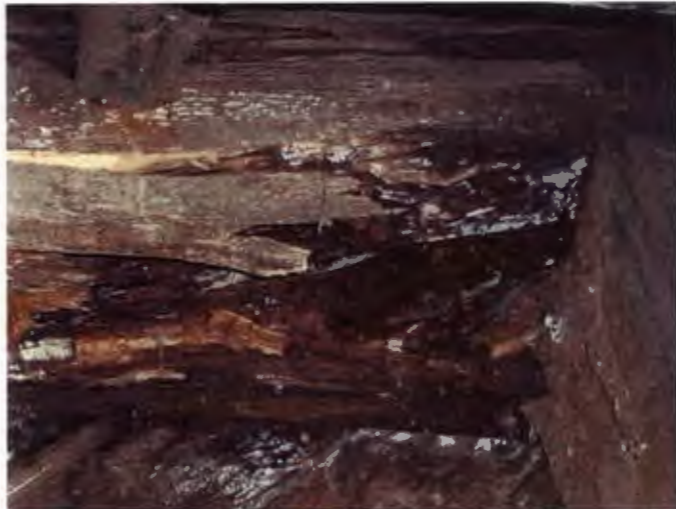
Visible signs of dry rot.

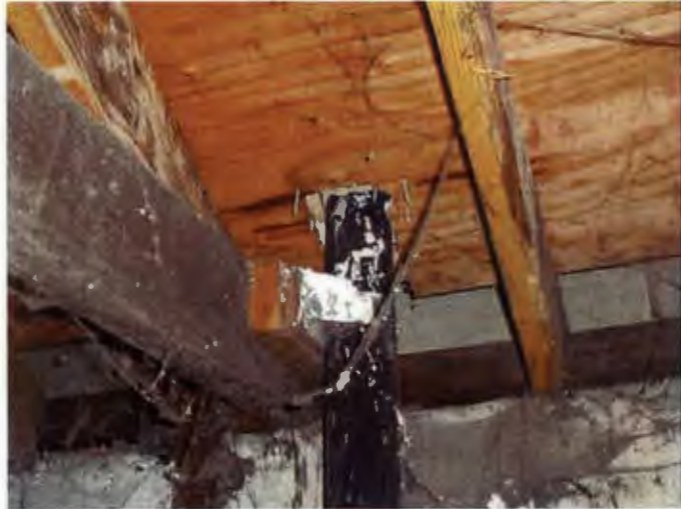
Visible signs of dry rot.

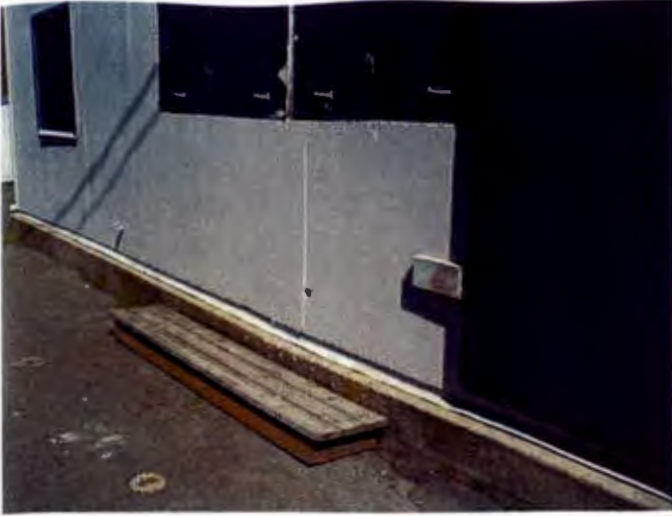
Temporary, non-secured steps to concession stand.

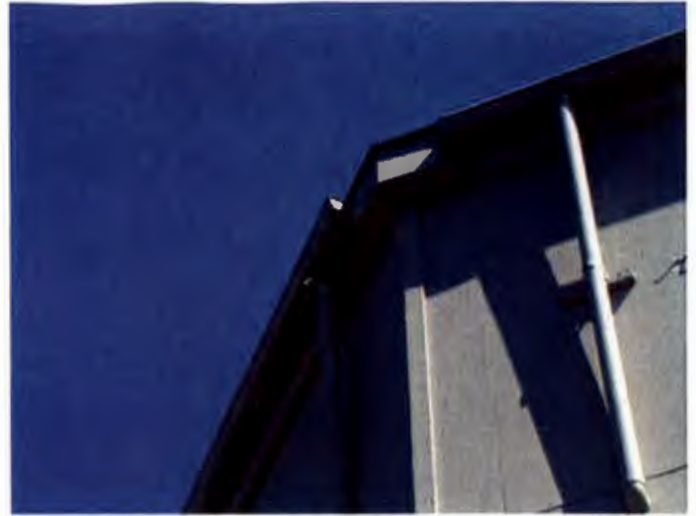
Downspout(s) disconnected from gutter. Gutters are not supported along roof edge.

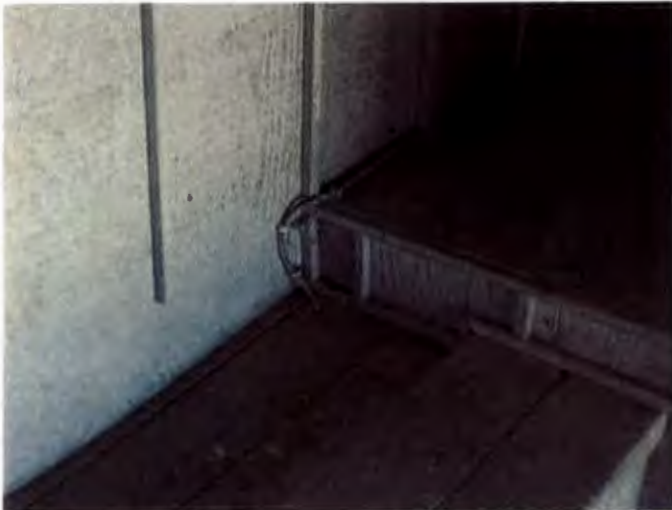
Unprotected wiring in wooden bleacher section.

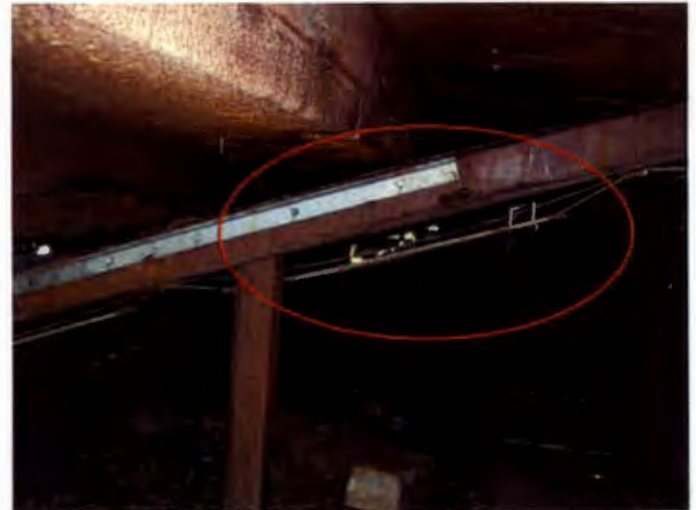
Electrical conduit corroded and broken, suspended with electrical wiring.

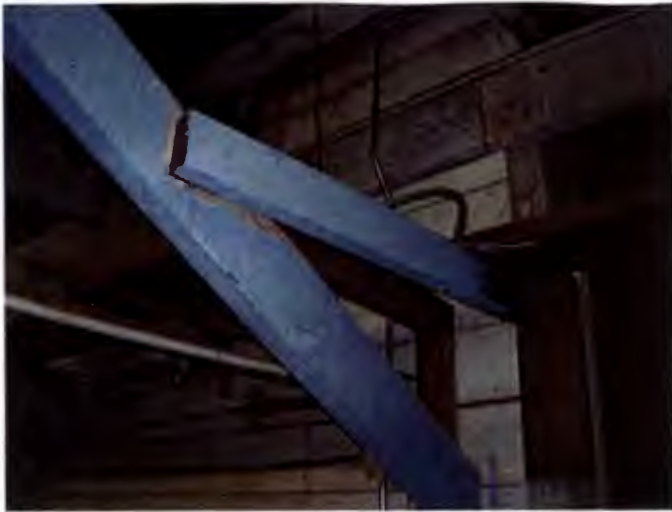
Alteration to structural framing.

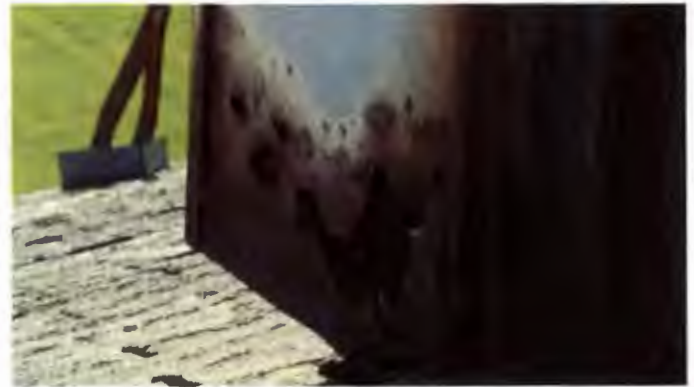
26. The light towers are in need of painting to prevent any further corrosion of the bare metal. (OSSC 2203.2)

Stadium lighting located on roof.

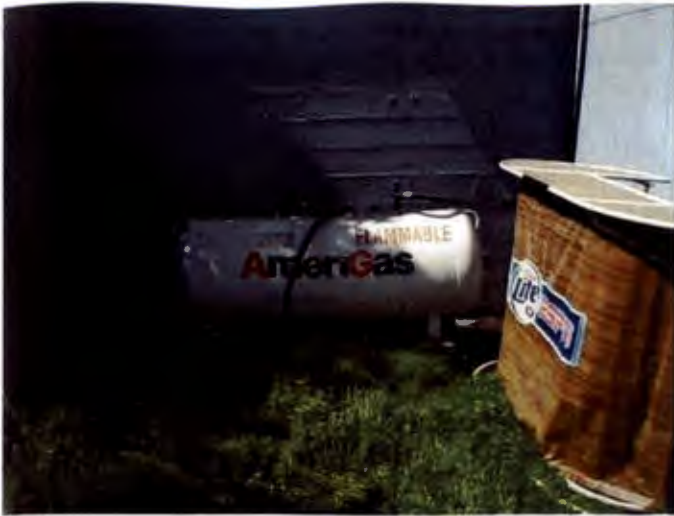
Propane accessible and open to the public.

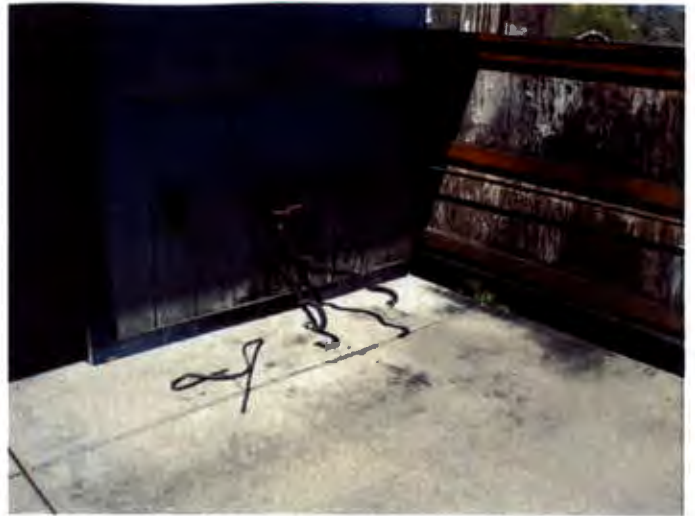
Flexible connectors require quick-connect fittings.

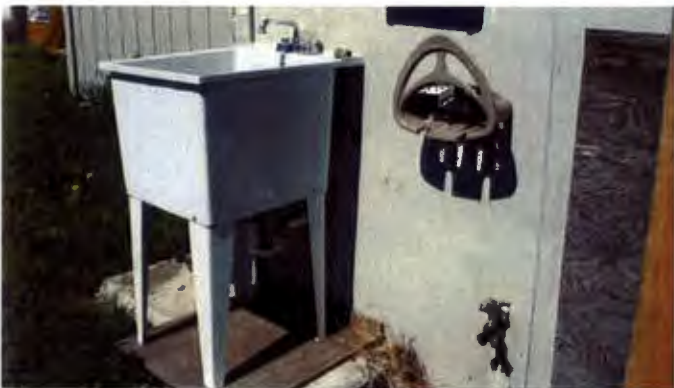
44.	The outside sink is not secured to a structure and not protected from freezing or mechanical damage; the drain is piped under the structure and dumps onto the ground. (OPSC 310.1, 303, 313.5, 313.6)

Concession area outside sink not secured to structure, or protected from freezing or mechanical damage. Drain is piped to ground under structure.

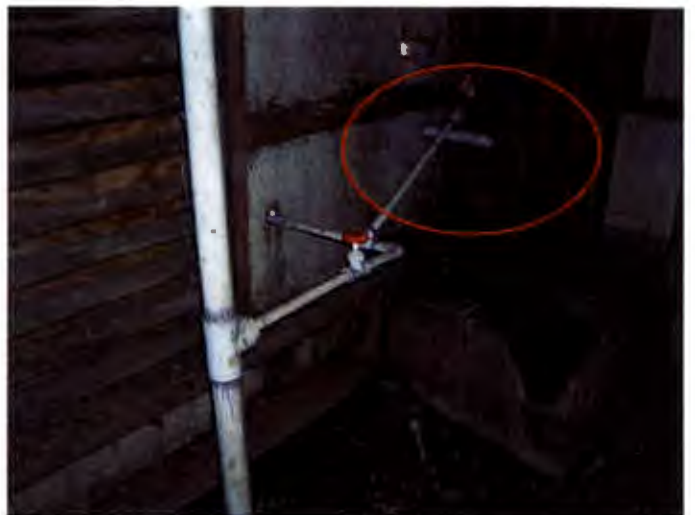
Drain of utility sink, drains to ground.

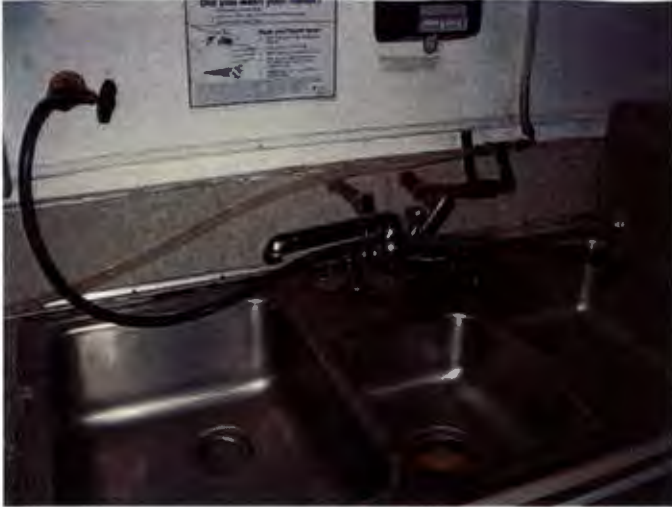
Non-compliant plumbing and garden hose in food prep area.

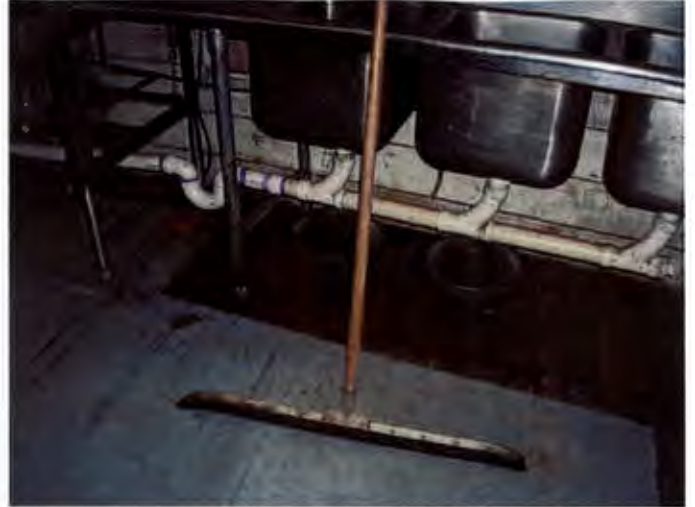
Leaky plumbing under sink drains.

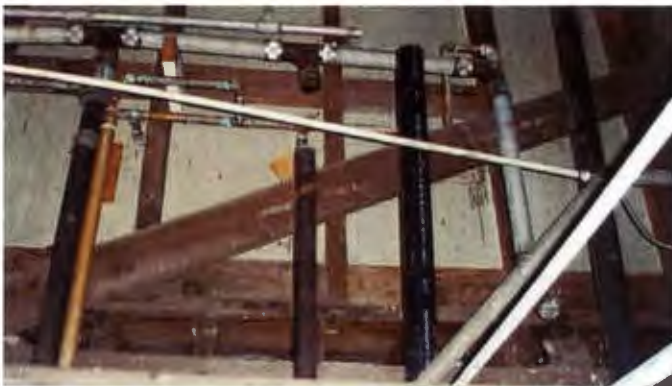
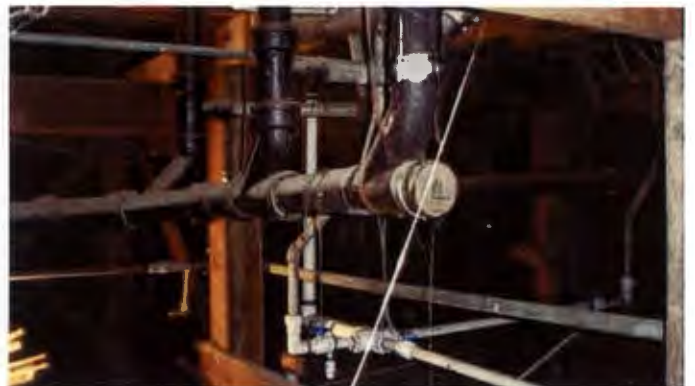
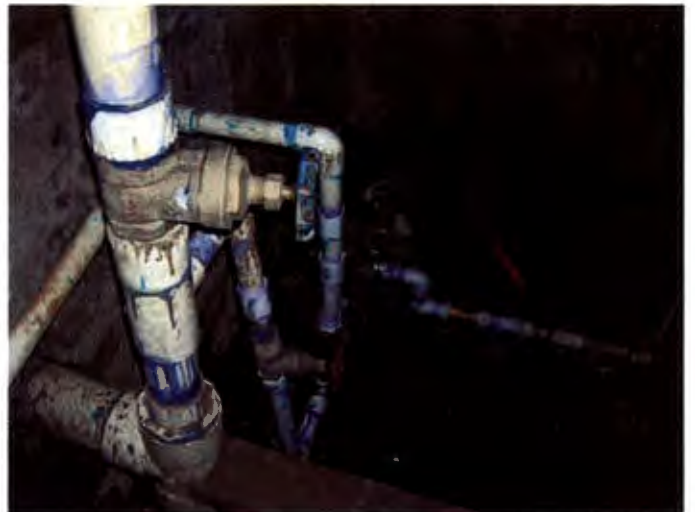
Plumbing cross connections and improper pipe material.

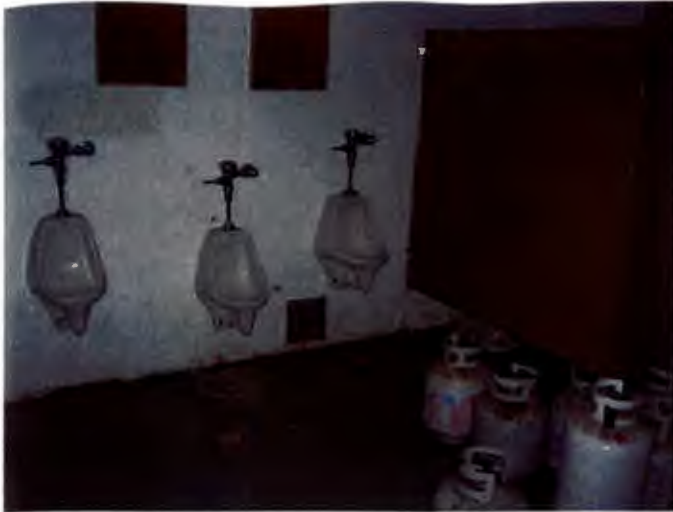
Urinals installed without venting; old toilet fixtures not properly sealed.

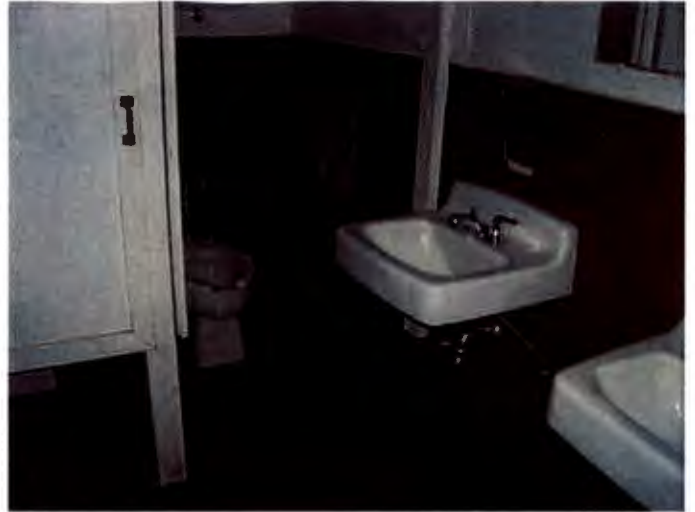
82.	The lavatory is blocking access to two toilet stalls. (OPSC 309)
Plumbing	
83.	The drinking fountain located outside is broken and is not secured to the wall. The drain is tied into the sanitary waste system with no trap and no vent. Traps and vents are required. (OPSC 310.1, 310.4, 901, 1001.1)

Lavatory sink projects into toilet stall.

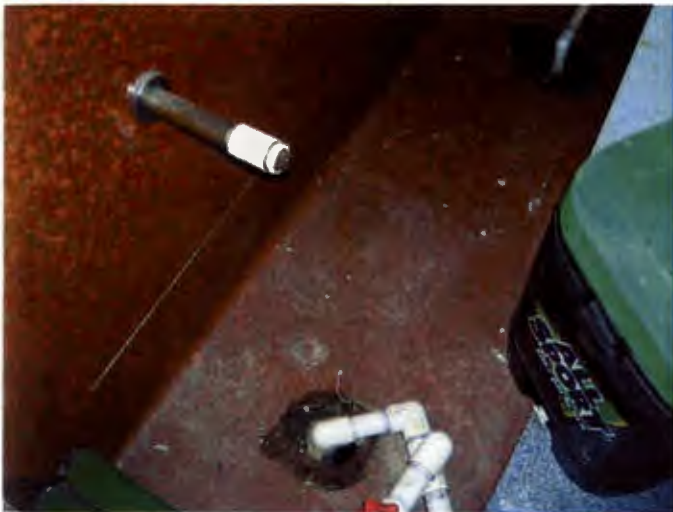
Open unvented drains to sanitary sewer system; source of sewer and sewer gas and access point for rats and vermin.

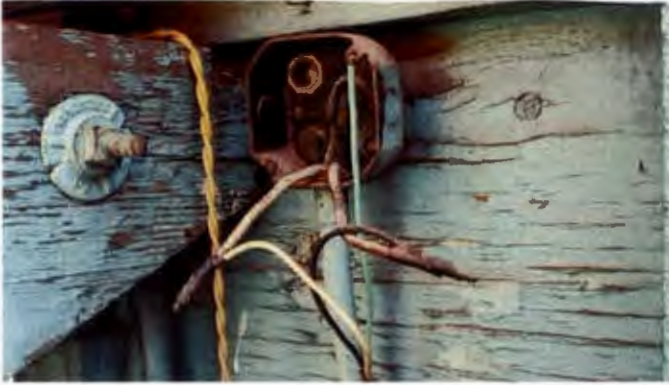
Electrical box cover missing; improper wire termination.

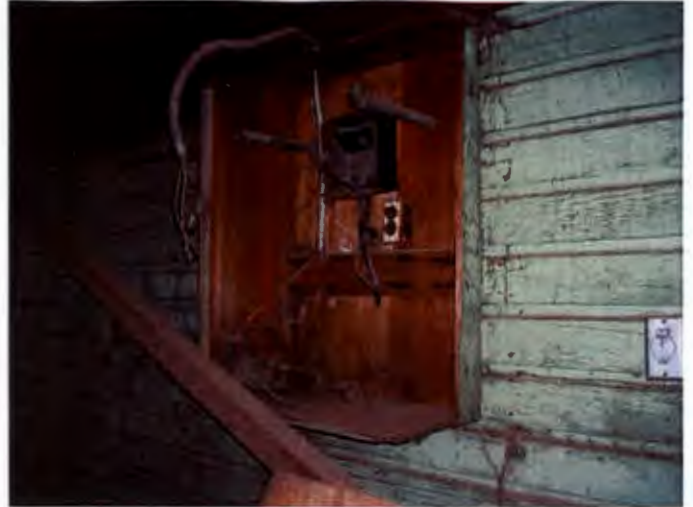
Exposed wiring.

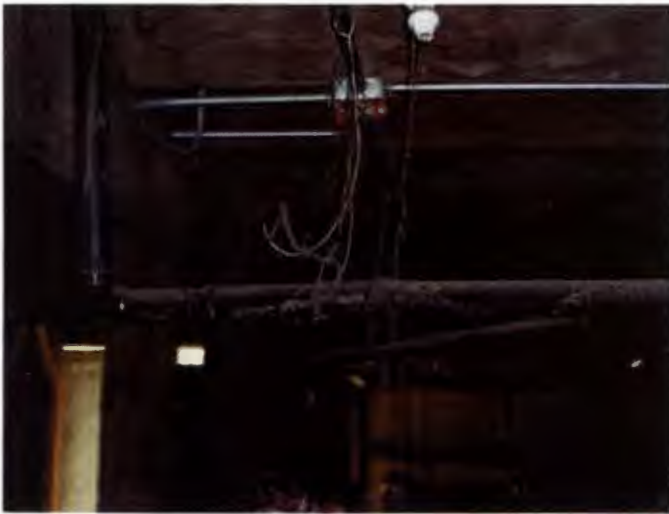
Electrical box cover missing.

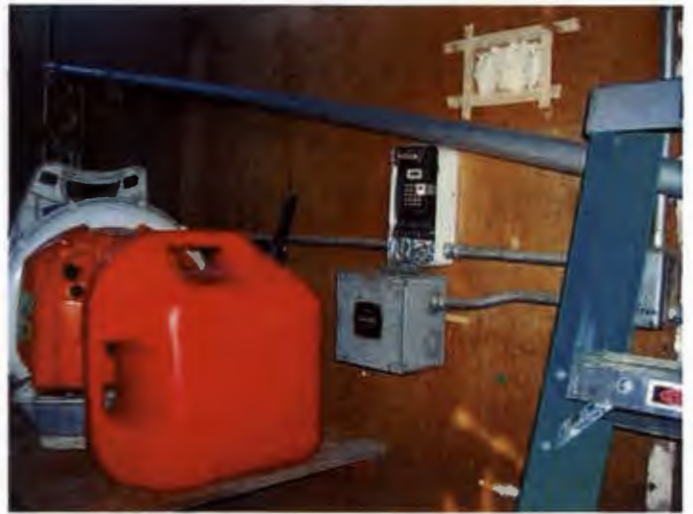
Irrigation control box missing cover, fumes from gas can be source of possible ignition.

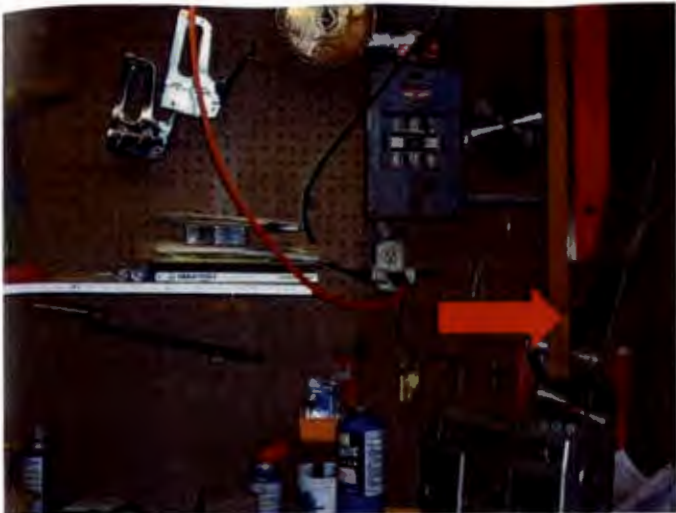
Unsecured 220 volt outlet; outlet wired from sub panel. Overuse of extension cords.

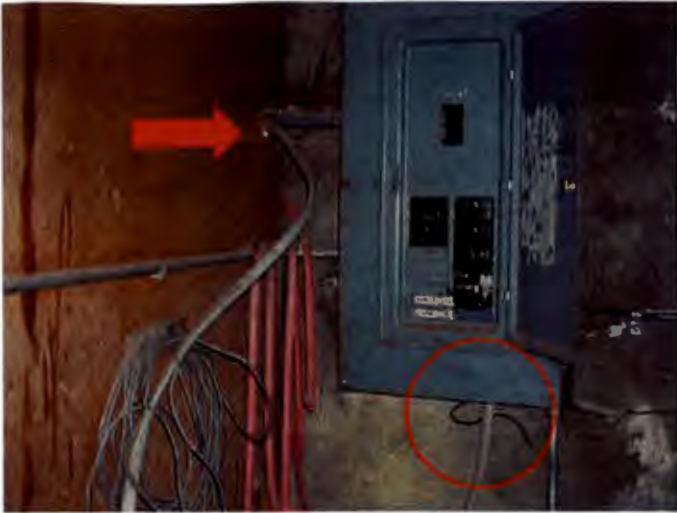
Wiring from electrical panel feeds 220 outlet

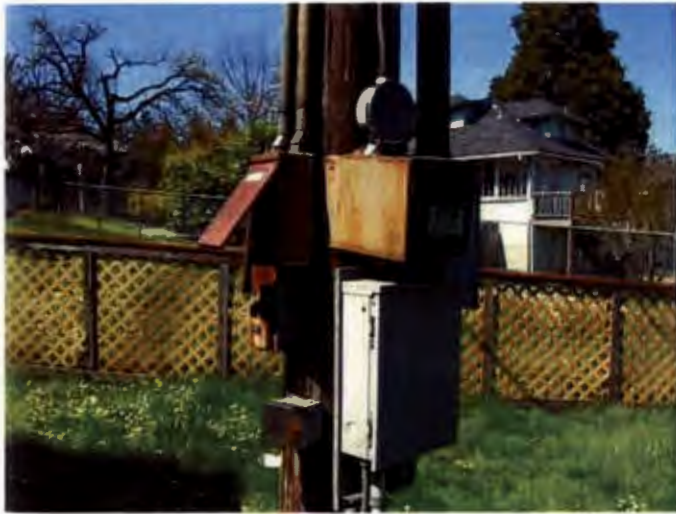
Open and insecure electrical boxes in concessions area.

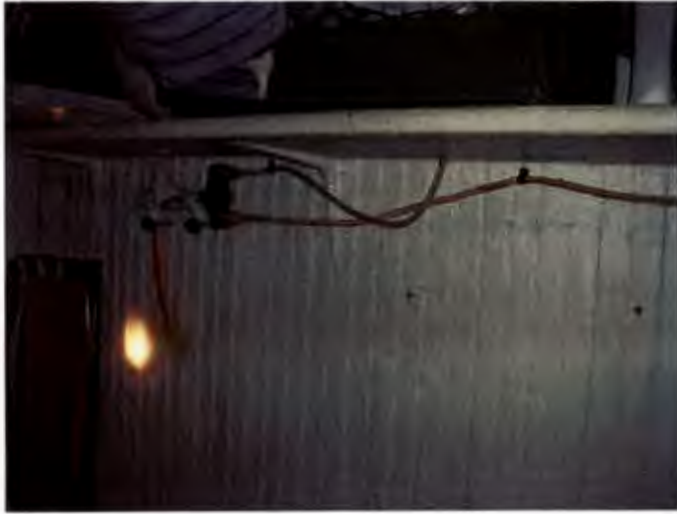
Over use of extension cords.

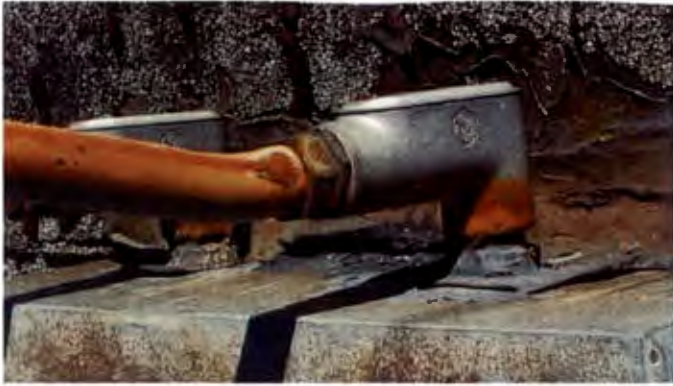
Deteriorated weather-proofing.

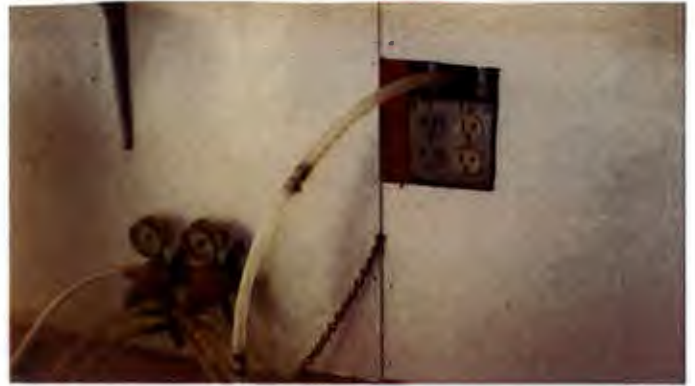
Carbonation tubing in outlet wiring chase.

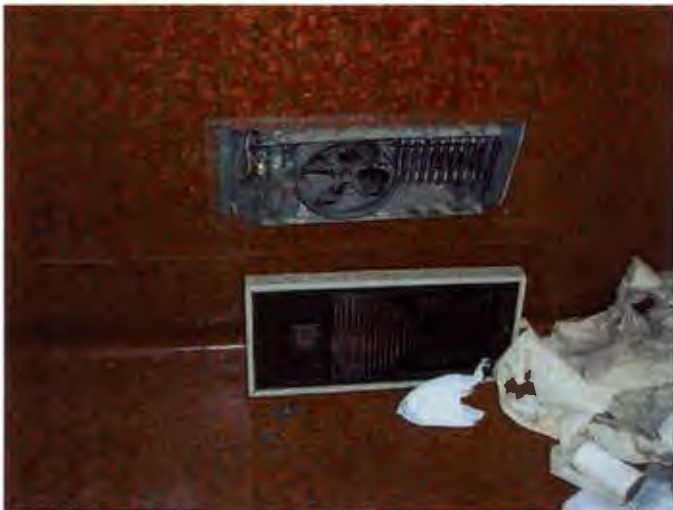
Unattached heater cover.

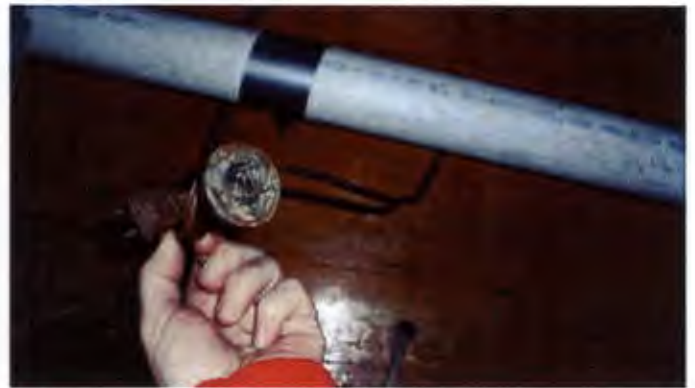
Corroded plugs.

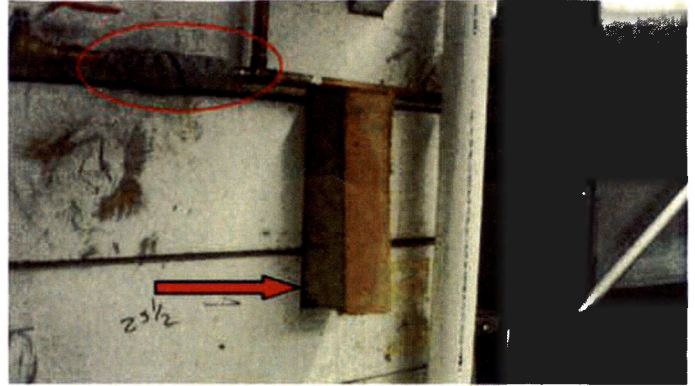
- 16. Several repair patches are on freeze-damaged galvanized and copper pipe and fittings. The patches are of unknown material and may be harmful to people and/or piping. (OPSC 310.1, 604.1)
- 17. The irrigation piping and the domestic water piping are interconnected without separation. A backflow preventer is required (*unable to confirm at the time of site visit*). (OPSC 603.4.6)
- 18. Several hose-bibs have been added with no vacuum breakers. (OPSC 603.4.7)
- 19. PVC pipe has been used to repair and re-pipe failing galvanized and copper piping. PVC pipe is not approved for use inside a structure. PVC pipe is required to be supported at 4' maximum spacing to prevent sagging and failing piping. (OPSC 604.1, 310.1 and PC pipe installation standards)

Plumbing patch with unknown material; structural element removed.
