**Summary of Council Discussions/Actions
on Downtown Improvements**

Map to Accompany Downtown Urban Renewal Slums and Blight Report 2016

Downtown Urban Renewal District – Determination of Slums and Blight - Detailed Property Survey

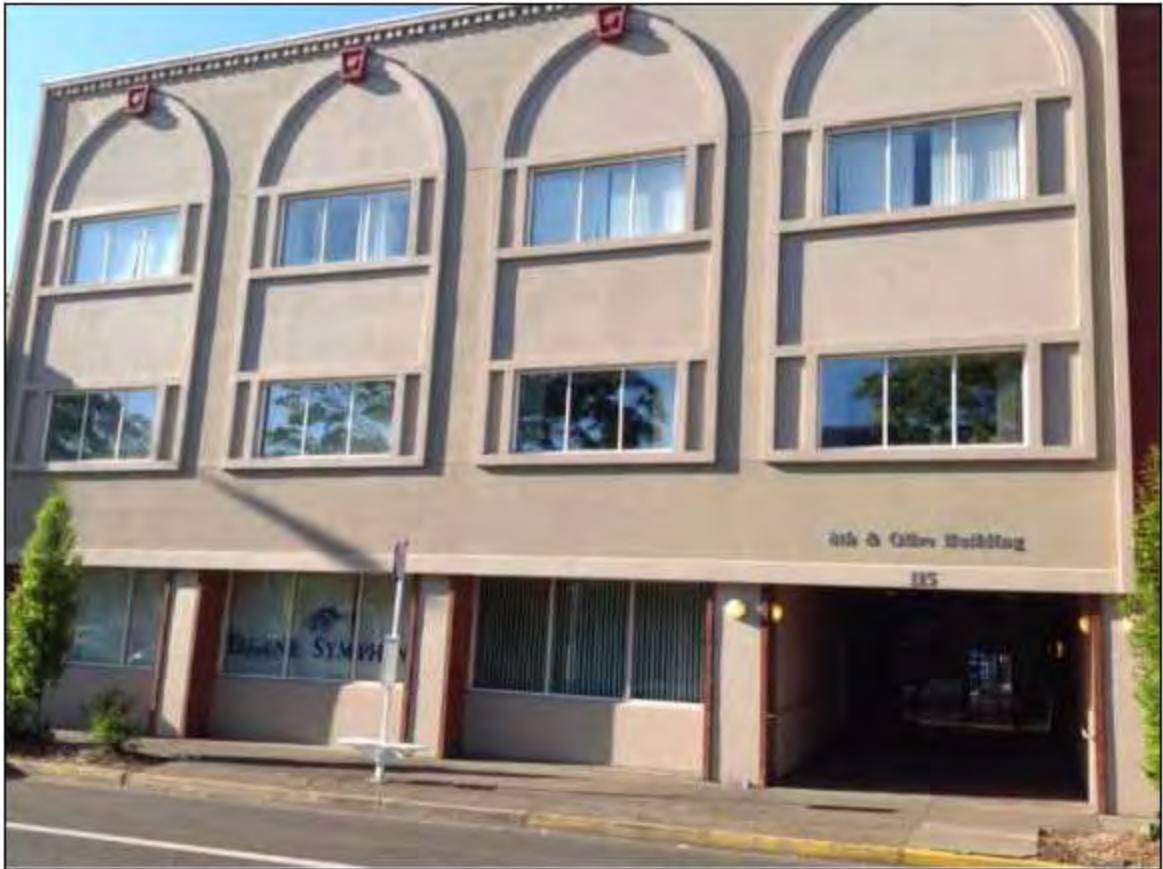
Property: 1	Name: 8 th and Olive Building	Determination of Blight: Yes
Taxlot(s): 1703311215300	1703311215500	Depreciation Ratio: 2.45
Property Notes: Building appears in good condition. Determination of blight ORS 457.010 (1)(g).

Photos show multiple sides of building.

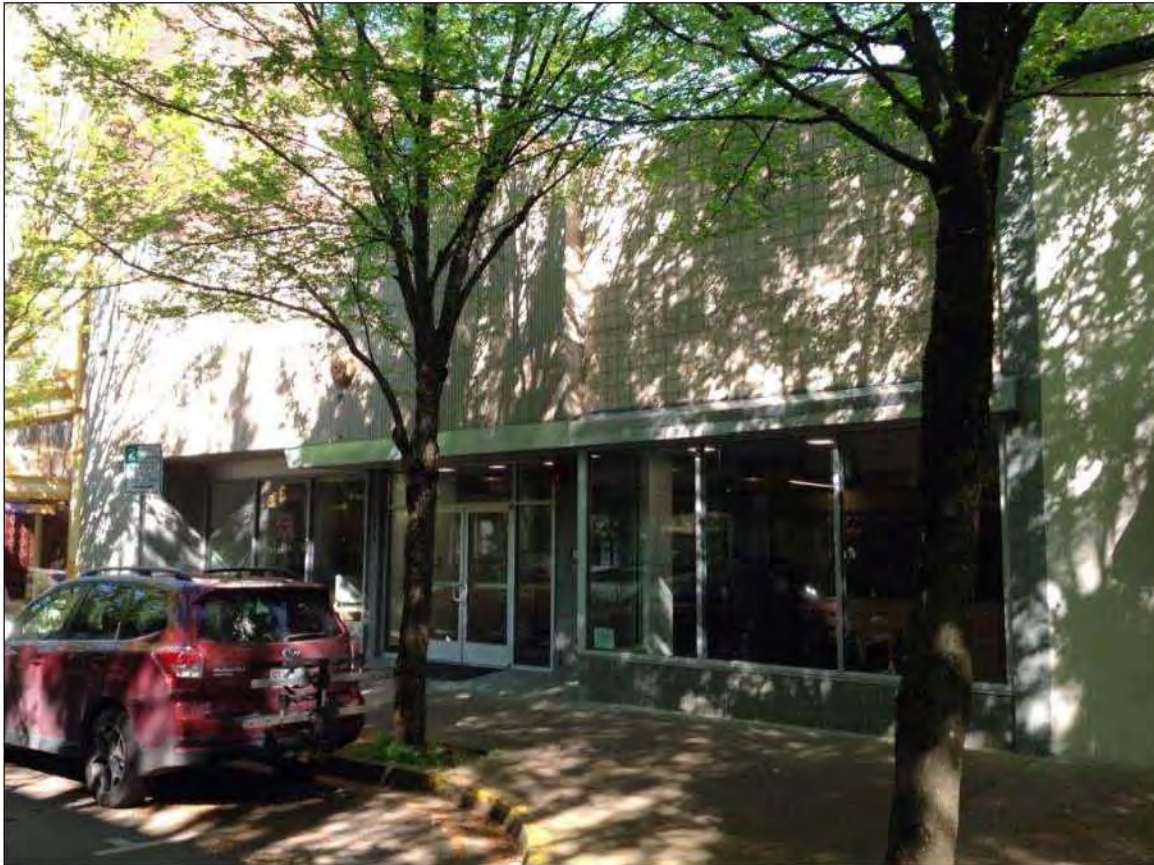
Property:	2	Name:	AHM Brands	Determination of Blight:	Yes
Taxlot(s):	1703311109300			Depreciation Ratio:	1.93
Property Notes:	Building appears in fair condition. One location has what appears to be tape holding tiles in place on west side. Determination of blight ORS 457.010 (1)(a)(A) and (g).

Photos: Top: Building facing Willamette Street; bottom left: sections with what appears to be taped tiles; bottom right: back side of building facing West Park Street.

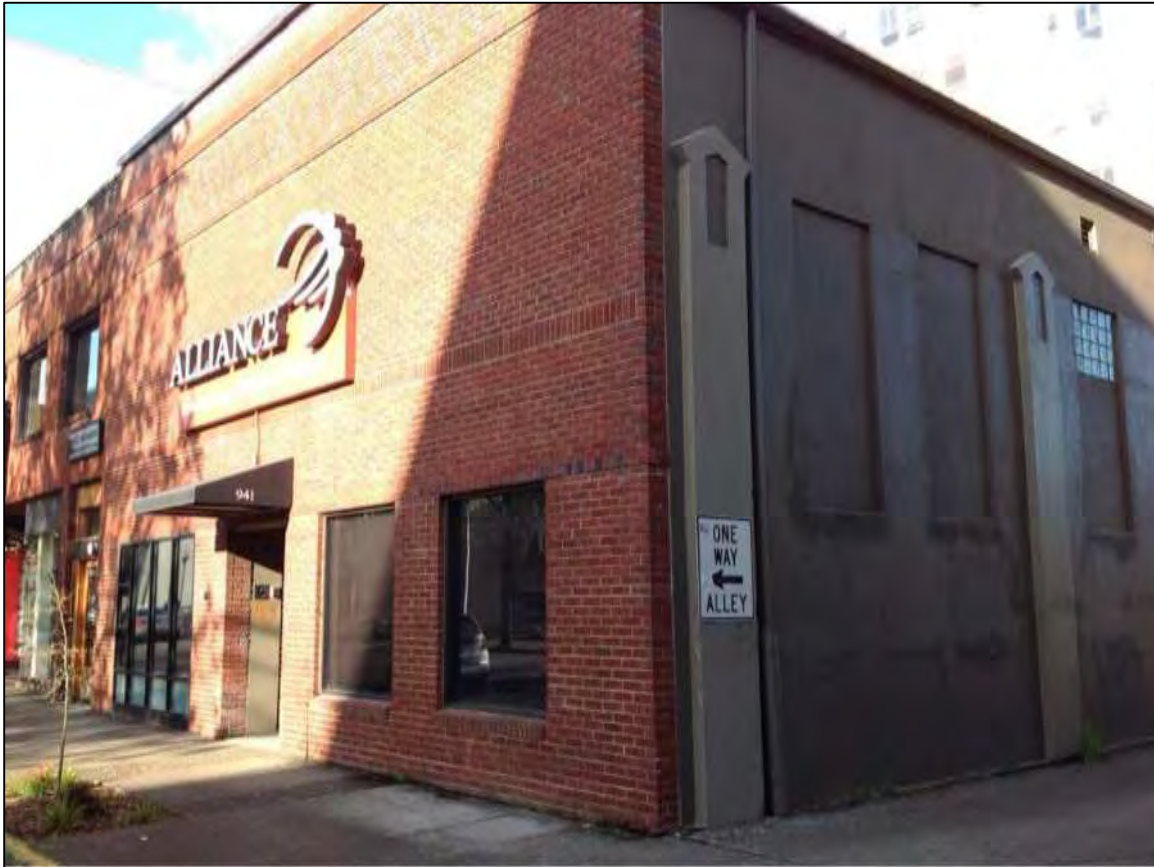
Property:	3	Name:	Alliance insurance	Determination of Blight:	No
Taxlot(s):	1703311406800			Depreciation Ratio:	6.75
Property Notes:	Building is in good condition.

Photos: Building front facing Oak Street.

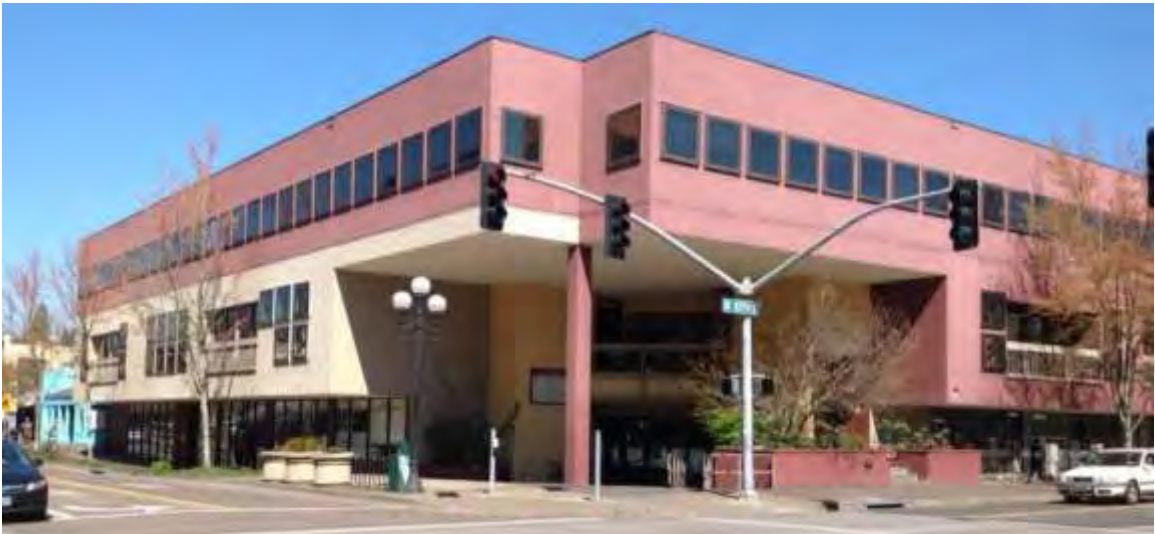
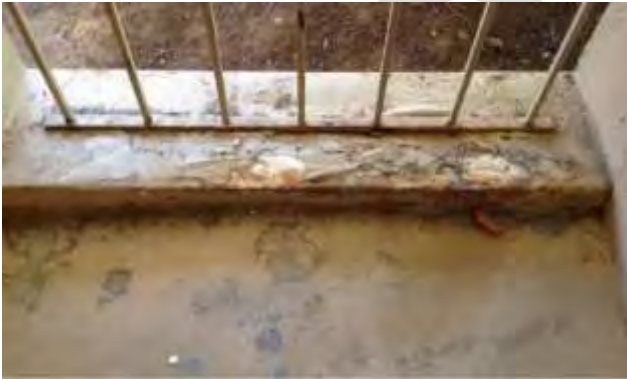
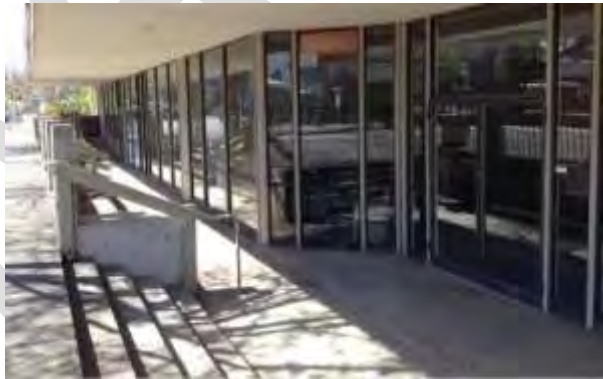
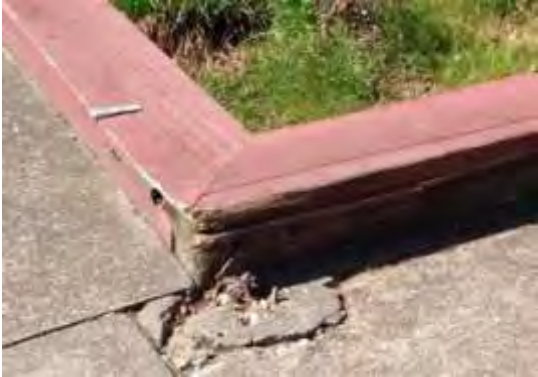
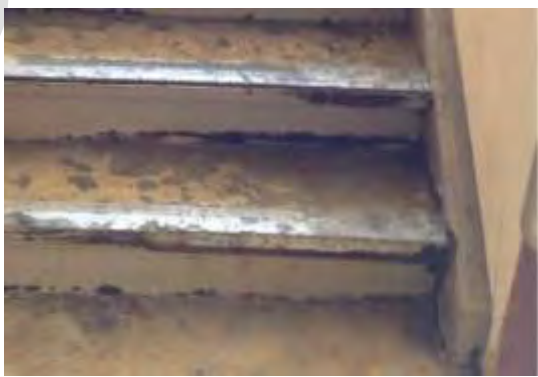
Property:	4	Name:	Atrium Building	Determination of Blight:	Yes
Taxlot(s):	1703311302600			Depreciation Ratio:	4.00
Property Notes:	Property is in fair conditions and has mostly city offices. There are signs of damage visible on the exterior, with damaged exterior stairs and older windows. The windows on the upper levels do not open regularly affecting ventilation. The property has underutilized outdoor open space and closed street side windows on south side. Blight determination based on ORS 457.010 (1)(a)(A), and (h) and includes seismic stability concerns.

Photos: Top: Building view from 10th Avenue and Olive Street; middle left: image of damage on interior stairwell window edge; middle right: underutilized open space facing 10th Avenue; bottom left: wood damage example; bottom right: exterior stairs damage.

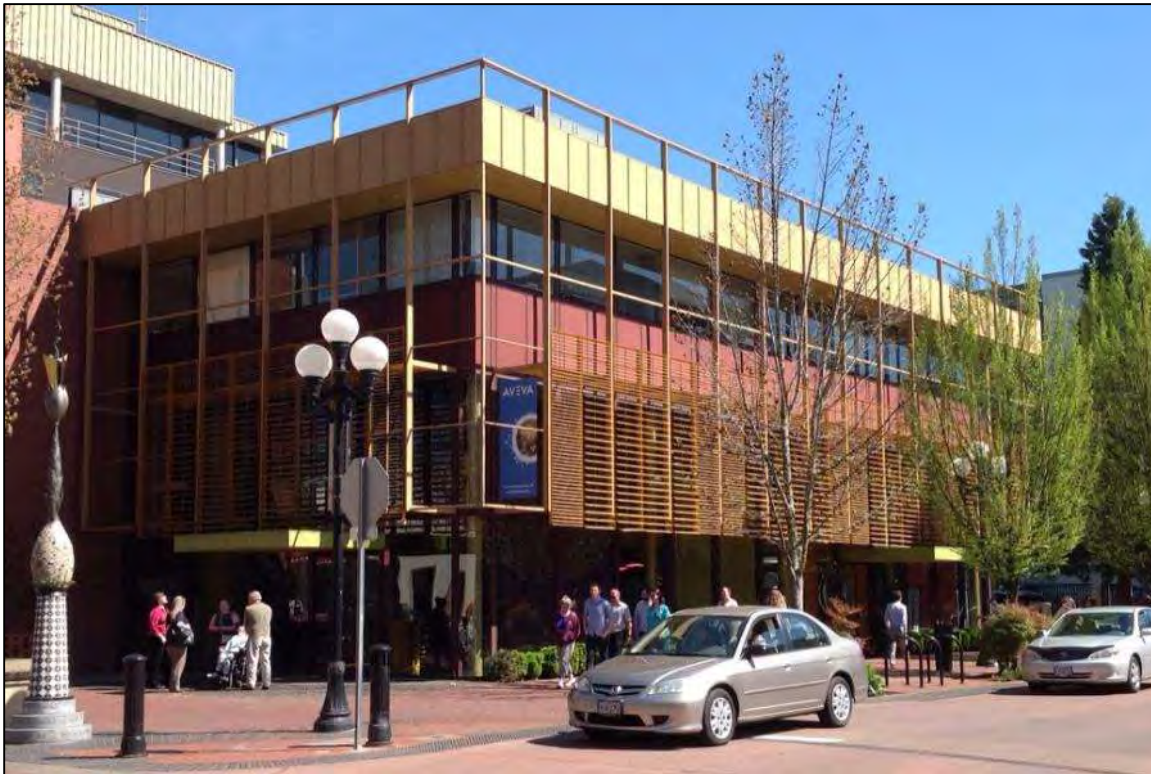
Property:	5	Name:	Aveva	Determination of Blight:	Yes
Taxlot(s):	1703311403900			Depreciation Ratio:	2.15
Property Notes:	The property appears in good shape. The building has some exterior damage along the building-ground line, including an area with piping exposed, one section appears boarded up on 2nd floor and the adjacent parking lot has damage. The adjacent parking is also underutilized space. Determination of blight ORS 457.010 (1)(g).

Photos: Top: front of building facing Broadway and Willamette Street; middle left: damage on building ground line; middle right: exposed pipes on building ground line; bottom: damage on parking lot.

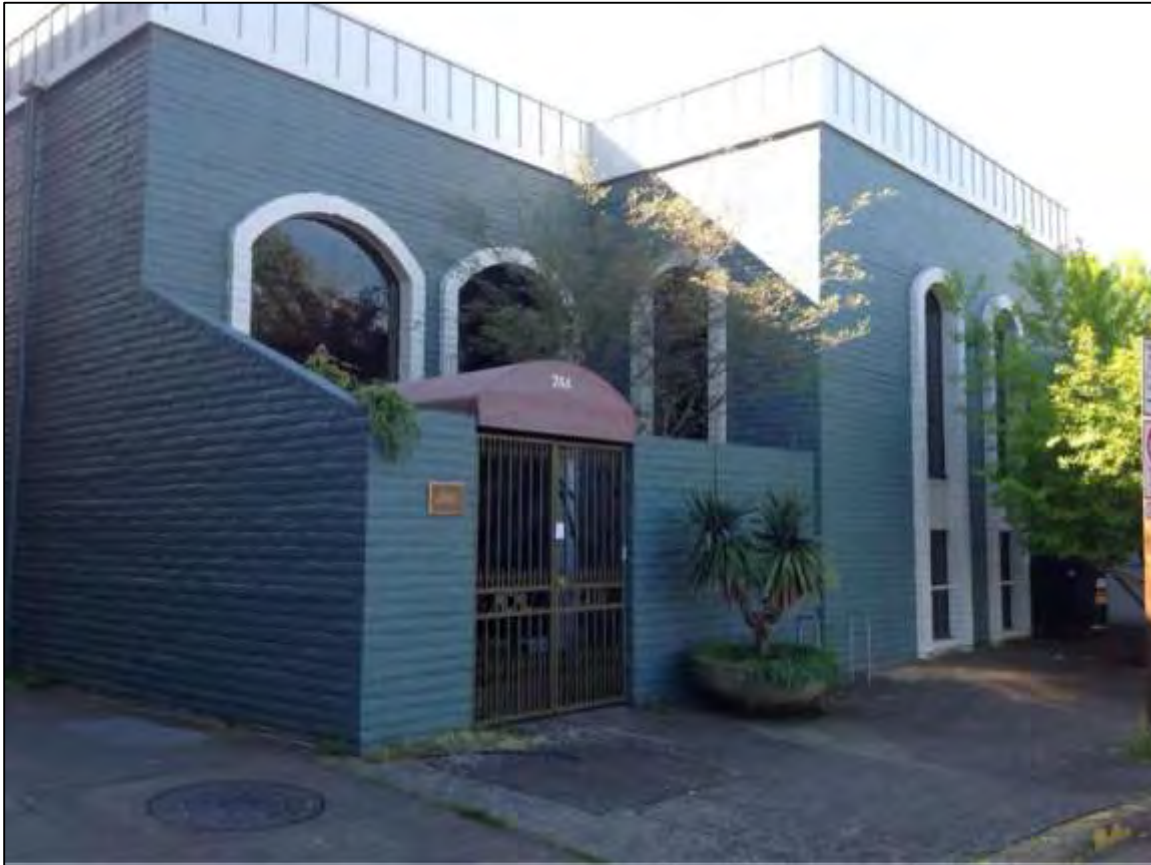
Property: 6	Name: Baden & Company	Determination of Blight: No
Taxlot(s): 1703311109001		Depreciation Ratio: 5.09
Property Notes: Building appears in good shape.

Photos: Building front facing West Park Street.

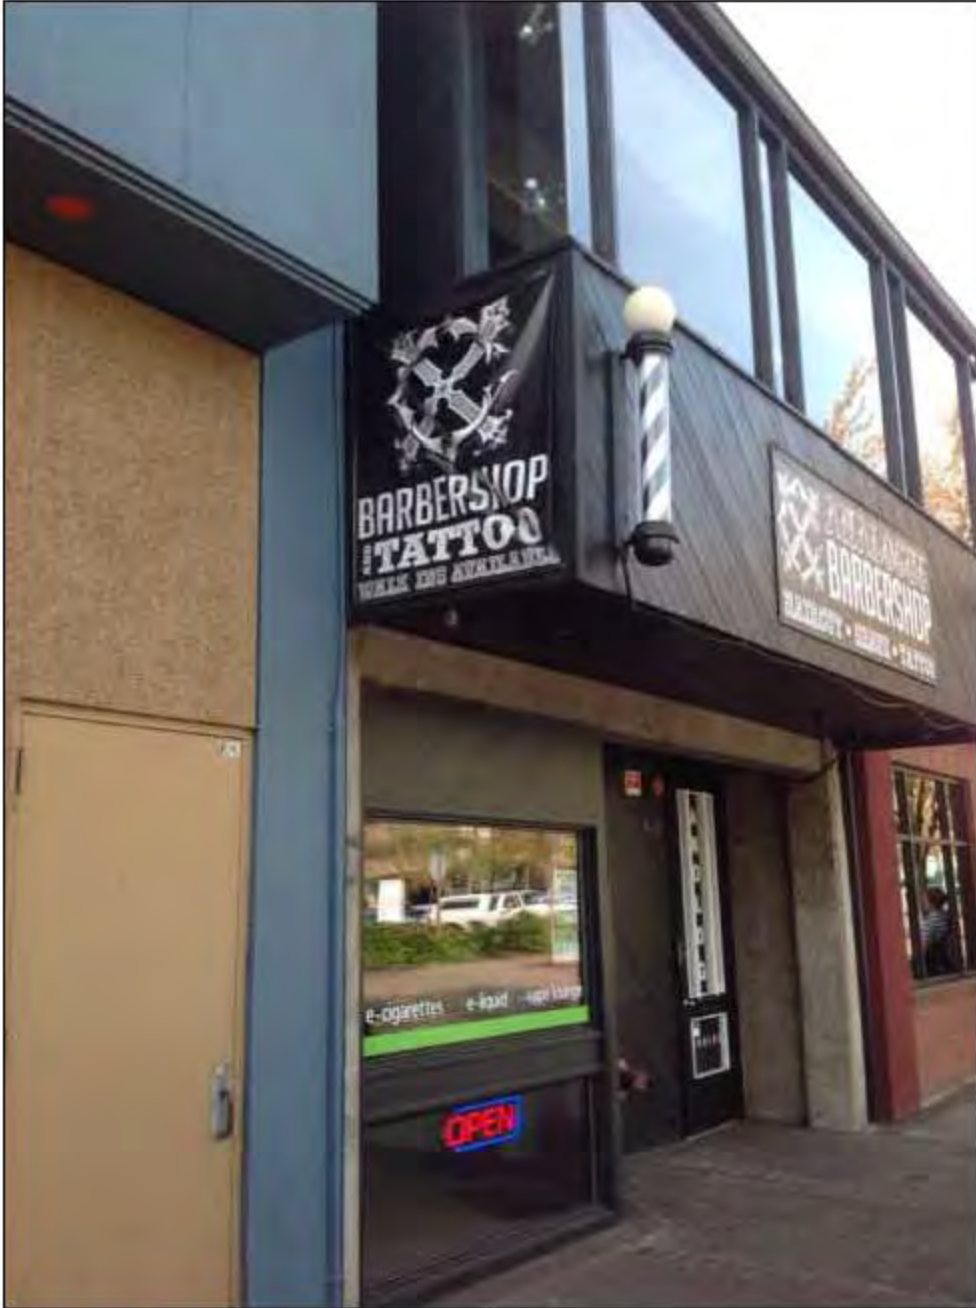
Property: 7	Name: Barbershop and Tattoo, Emerald Vapors	Determination of Blight: No
Taxlot(s): 1703311304700		Depreciation Ratio: 6.62
Property Notes:	Building appears in good shape

Photos: Front of building facing Olive Street.

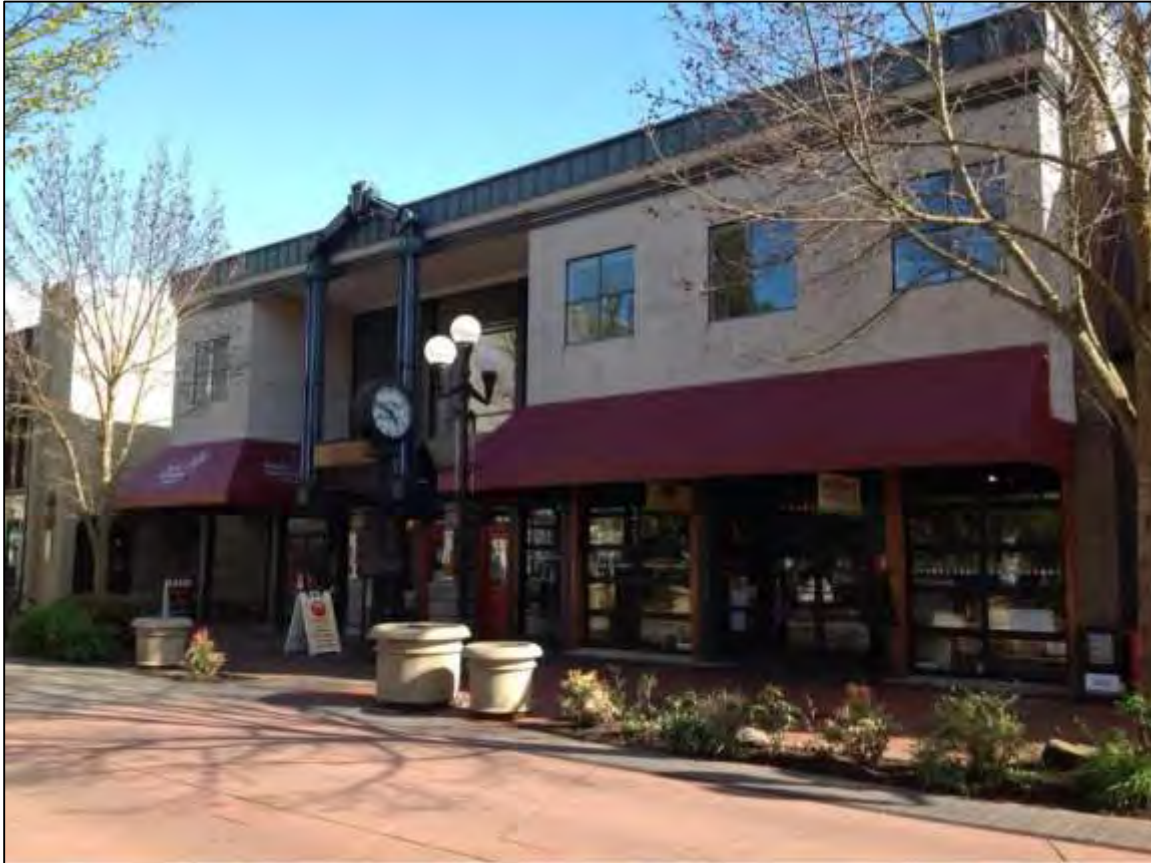
Property: 8	Name: Belly	Determination of Blight: No
Taxlot(s): 1703311405200		Depreciation Ratio: 4.38
Property Notes:	Building in good condition. Building has offices on second floor, bottom floor commercial.

Photos: Building front facing East Broadway.

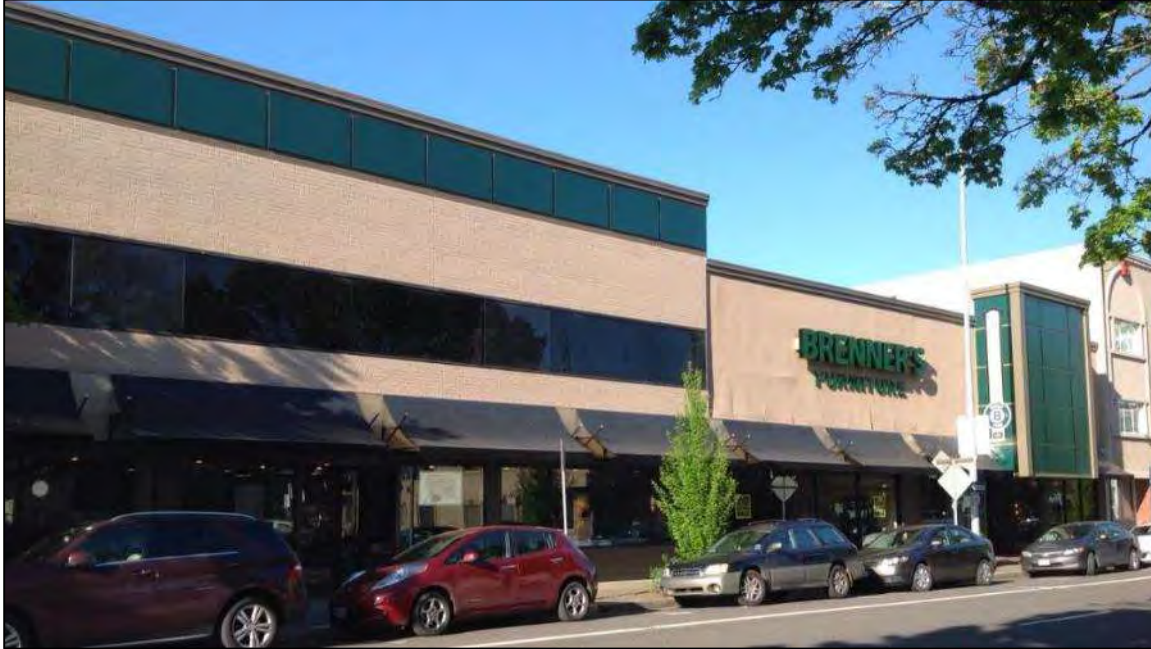
Property: 9	Name: Brenners Furniture	Determination of Blight: Yes
Taxlot(s): 1703311214900	1703311215400	Depreciation Ratio: 1.92
Property Notes:	Building is large, appears in fair condition. The facade section with tiles appear to be wearing. Determination of blight ORS 457.010 (1)(a)(A) and (g).

Photos: Top: front of building facing West 8th Avenue; bottom: close-up view of wear on façade tiles.

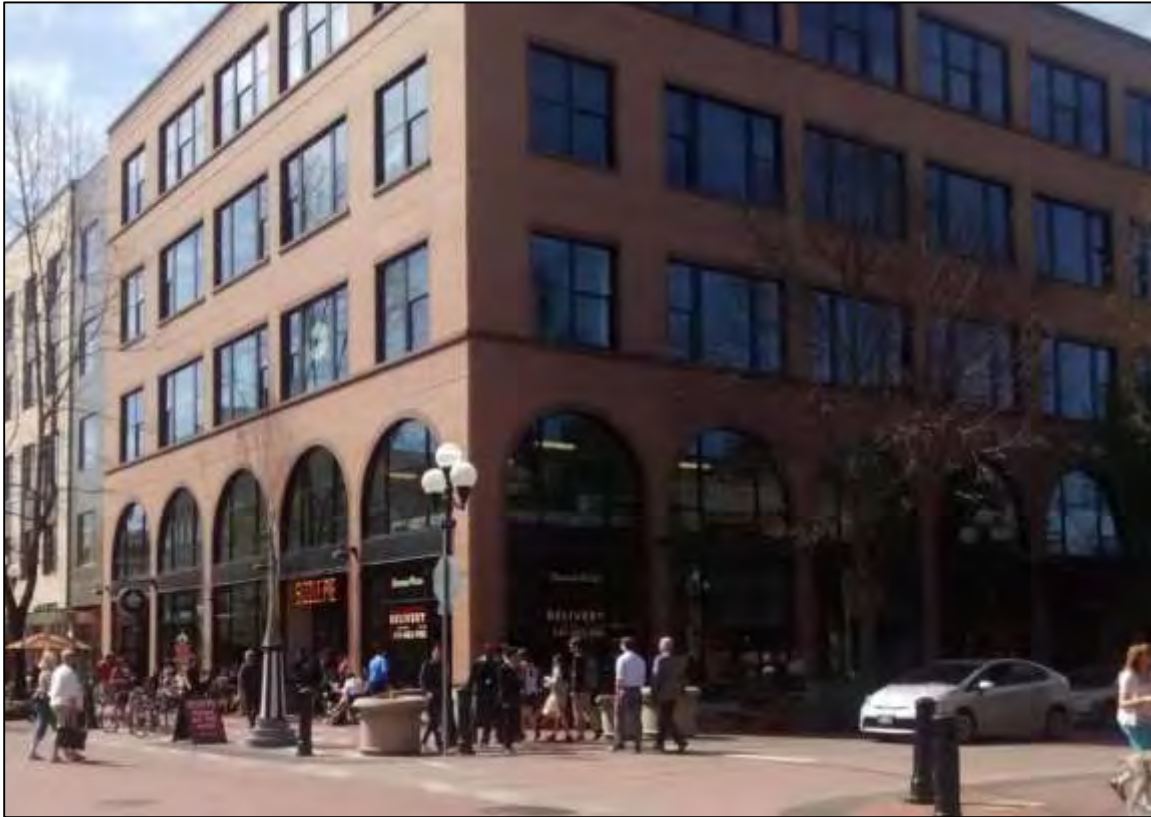
Property:	10	Name:	Broadway Commerce Center	Determination of Blight:	No
Taxlot(s):	1703311301300			Depreciation Ratio:	13.97
Property Notes:	Recently renovated (last five years). Building in good condition. Office on top 4 floors and commercial on bottom.

Photos: View of building on Broadway and Willamette Street.

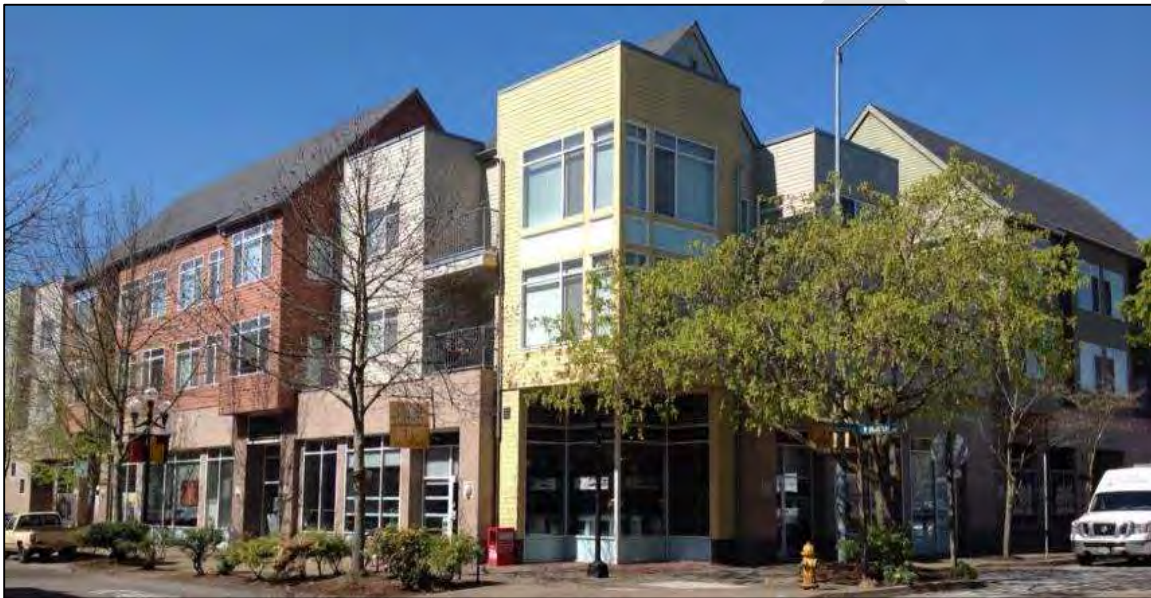
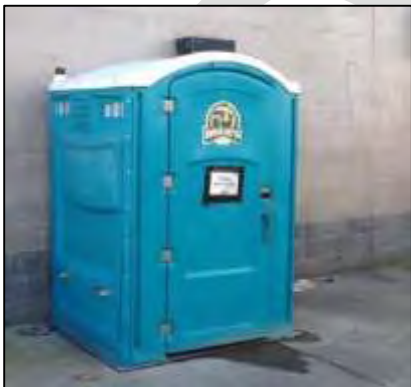
Property:	11	Name:	Broadway Place North	Determination of Blight:	Yes
Taxlot(s):	1703311316100		1703311316300	Depreciation Ratio:	N/A
	1703311316500		1703311316800		1703311316900
Property Notes:	Building in good condition. Property has upper level apartments, street level commercial, and lower level public parking. The building has closed public restrooms with a portable restroom as replacement, these closed restrooms are underutilized space. Building is also adjacent to a poor condition building to the north not in district. The property land value is zero so blight cannot be calculated based on depreciation values. The presence of vacant restrooms with portable toilet is creates added expense to taxpayers, safety, and perceptions of blighted areas. Blight Determination based on ORS 457.010 (h) and (i).

Photos: Top: building on NW corner of Broadway and Charnelton Street; bottom: portable restroom in alley north of building.

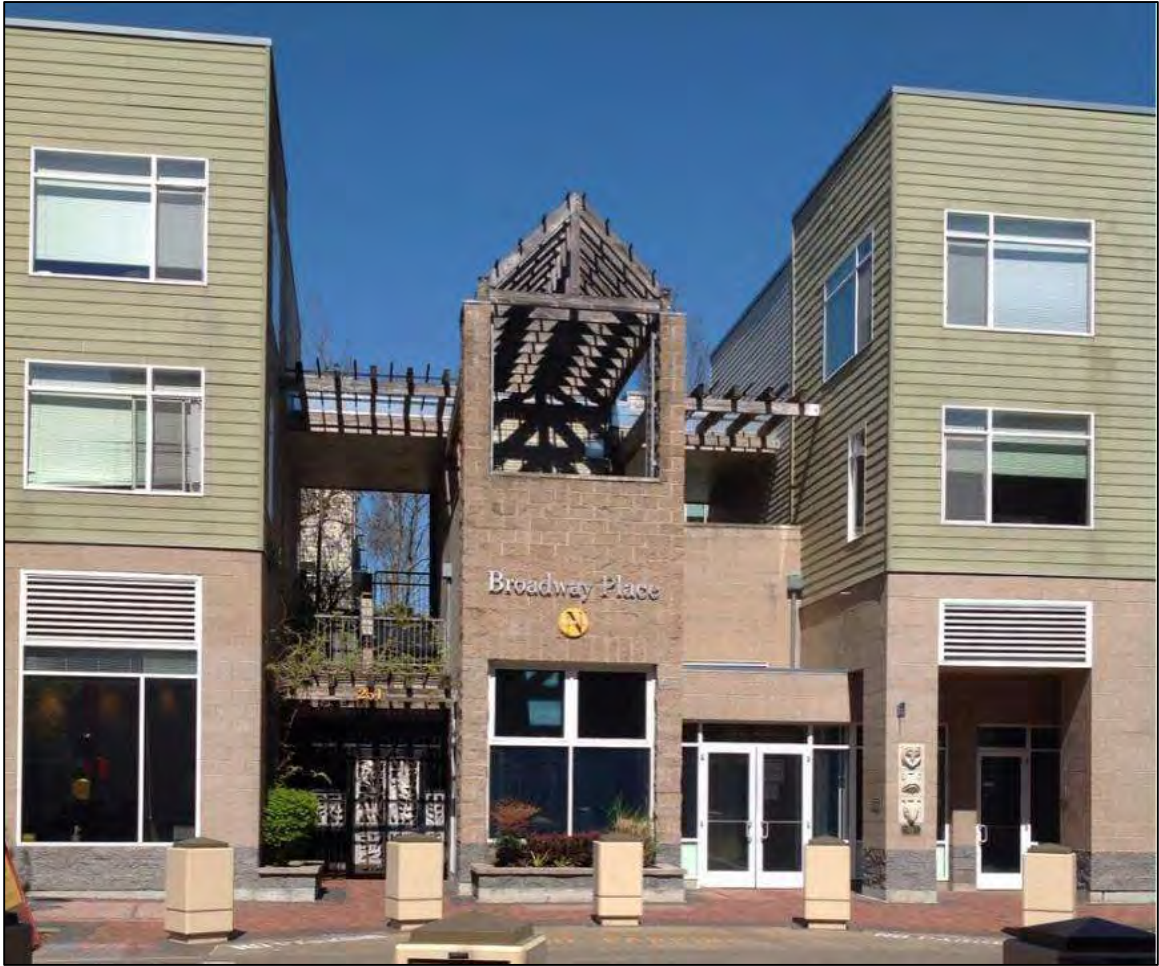
Property: 14	Name: Broadway Place South	Determination of Blight: No
Taxlot(s): 1703311316200	1703311316400	Depreciation Ratio: NA
	1703311316600	
Property Notes:	Property in good shape.

Photos: View of property mid-block on Broadway.

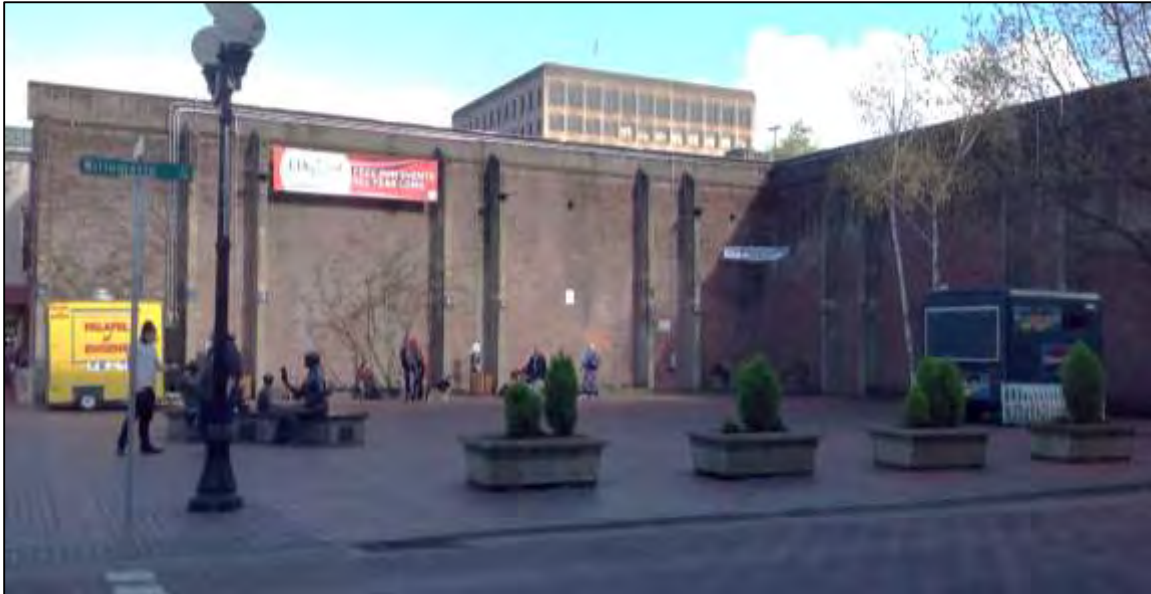
Property: 15	Name: Broadway Plaza	Determination of Blight: Yes
Taxlot(s): 1703311404801		Depreciation Ratio: 0.10
Property Notes:	This property is a public open space plaza. The property is underutilized, does not have utilities such as running water, or amenities such as a drinking fountain, a bathroom, or shade. The area also has concerns for safety based on past vandalism. Blight determination by ORS 457.010 (1)(g), (h), and (i).

Photos: View of property from Broadway and Willamette Street.

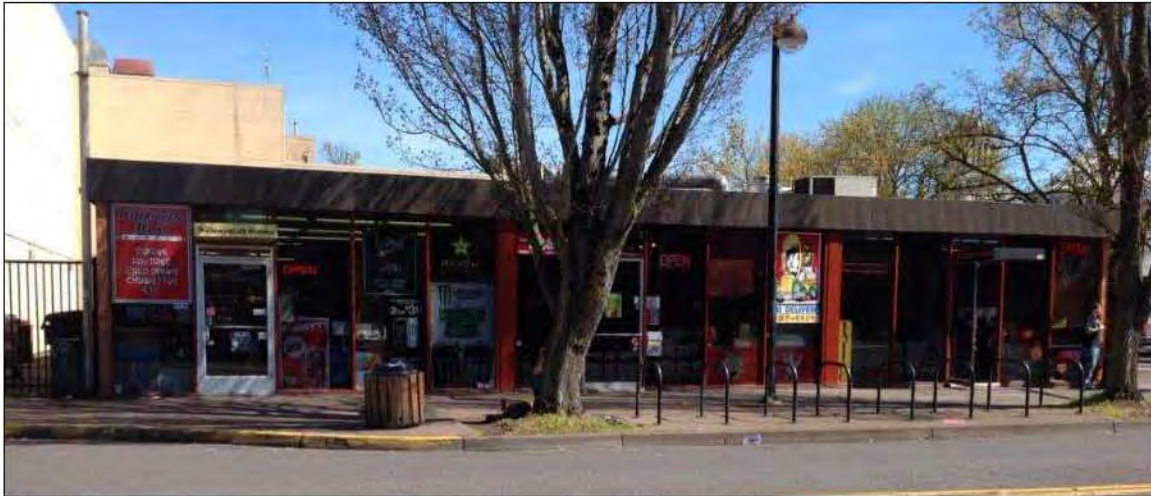
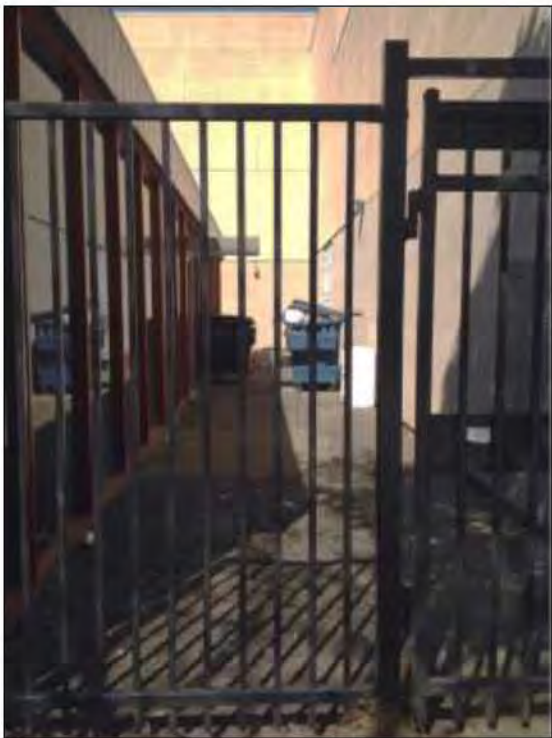
Property: 16	Name: Business	Determination of Blight: Yes
Taxlot(s): 1703311412900		Depreciation Ratio: 0.92
Property Notes:	Buildings appear in good condition. Property is a series of storefront businesses in single story building, including a smoke shop, salon, tattoo parlor and mini-mart. There is a fenced off alleyway behind the building that is underutilized space and is used for garbage. Blight determination by ORS 457.010 (1)(g) and (h).

Photos: Top: view of business from Willamette Street; bottom, view of alley around businesses.

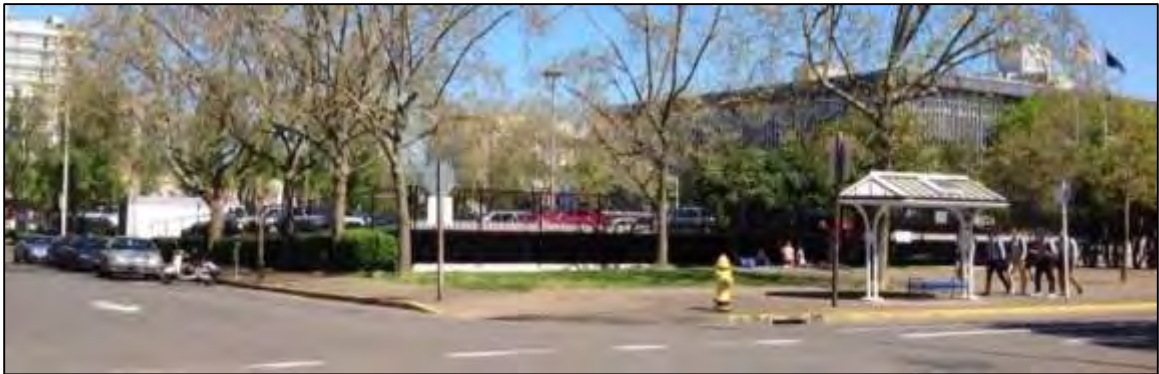
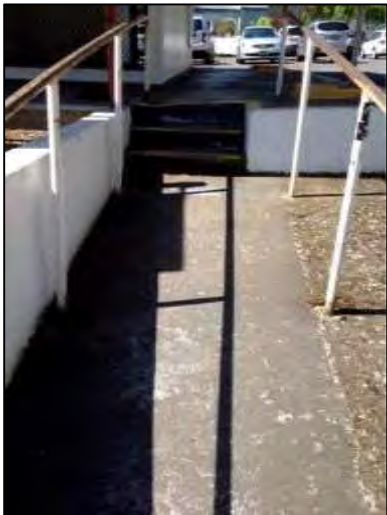
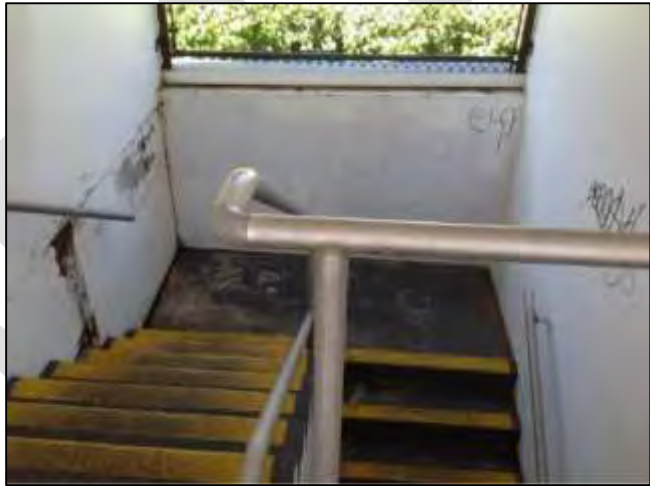
Property:	17	Name:	Butterfly Lot	Determination of Blight:	Yes
Taxlot(s):	1703311109500			Depreciation Ratio:	0.06
Property Notes:	This property is a two level parking structure with second level below ground. The property is deteriorated with large pot holes, rusty access stairwells, graffiti, and deteriorated building. Surrounding the property there are uneven sidewalks and numerous utility boxes in green spaces. The angle of the pedestrian access ramps is questionable. Determination of blight with ORS 457.010 (1)(a)(B), (g), and (h).

Photos: Top: view of property from 8th Avenue at West Park Street; bottom left: pedestrian walkway; bottom right: stairwell on property to lower level.

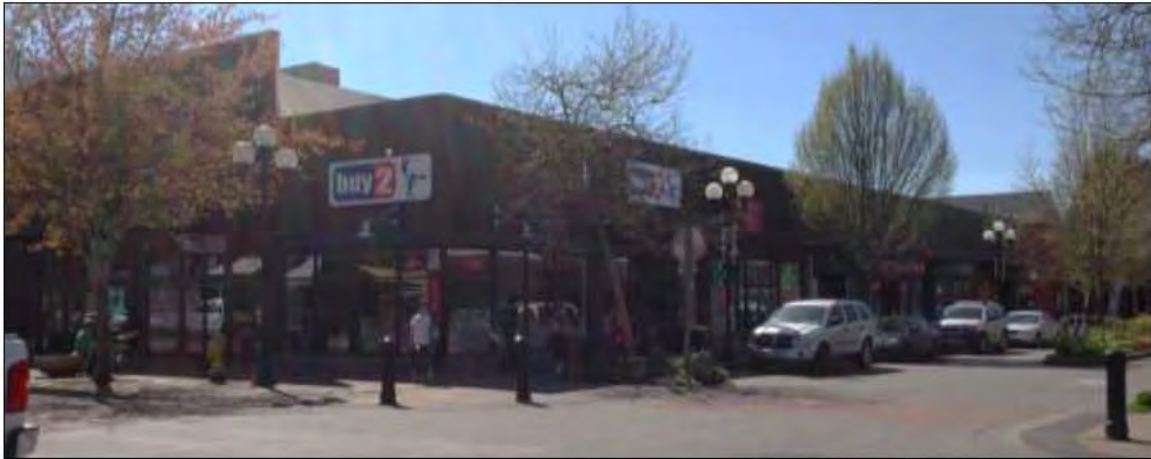
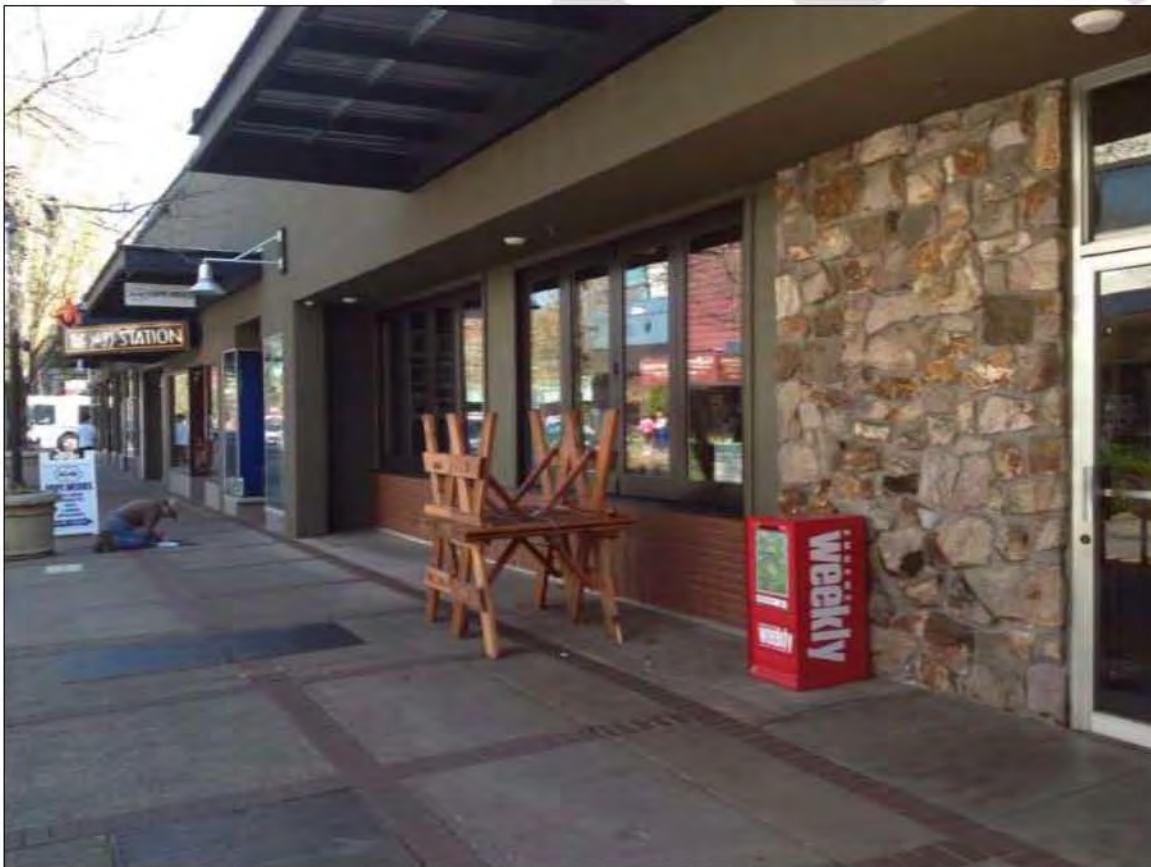
Property: 18	Name: Buy 2 block	Determination of Blight:	Yes
Taxlot(s): 1703311304900		Depreciation Ratio:	3.90
Property Notes:	The building appears in good condition. Several stores occupy this single story block including Subway, Buy 2, and the Jazz Station. Determination of blight ORS 457.010 (1)(g), and (h).

Photos: Top: view of property from Broadway and Olive Street; bottom: view of property looking east on Broadway.

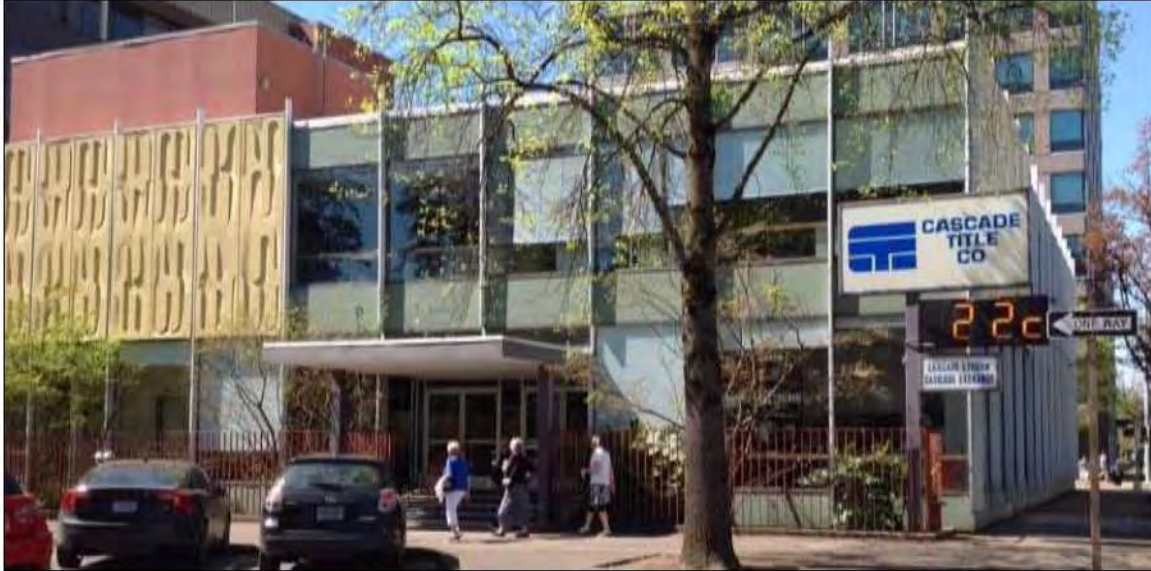
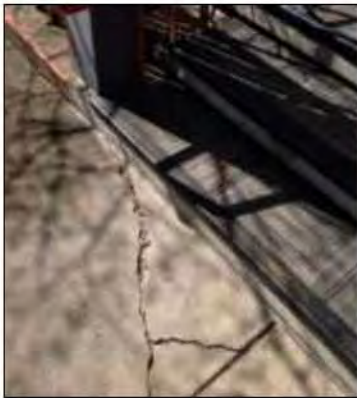
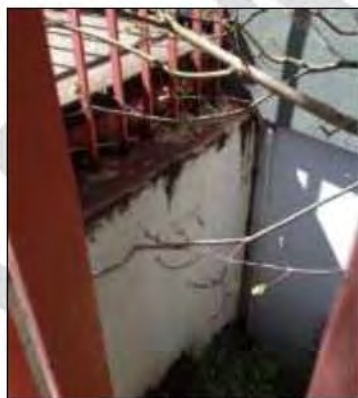
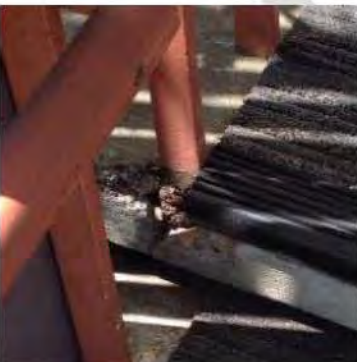
Property: 19	Name: Cascade Title	Determination of Blight: Yes
Taxlot(s): 1703311404600		Depreciation Ratio: 3.52
Property Notes:	Building appears in relatively good condition. It is an older building, but has some wear such as cracks in pavement. Determination of blight ORS 457.010 (1)(g).

Photos: Top: View of property from West 8th Avenue and West Park Street; middle left: image shows example of cracks in pavement on sidewalk outside building; middle right: image shows wear; bottom: image shows damage in cement at base of stair railing.

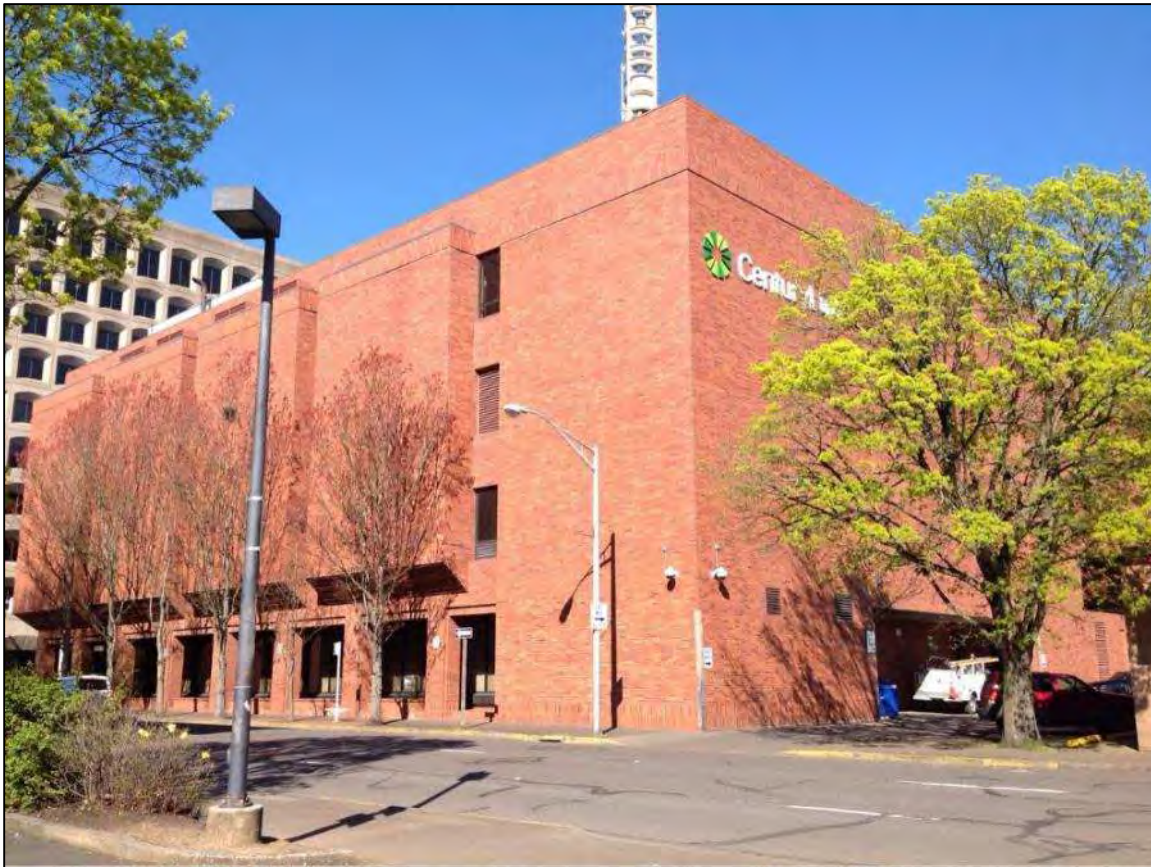
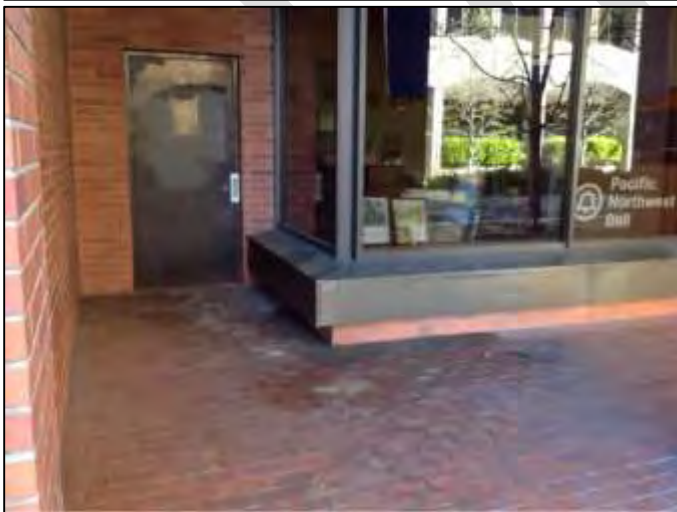
Property: 20	Name: Century Link	Determination of Blight: Yes
Taxlot(s): 1703311411500	1703311411600	Depreciation Ratio: NA
Property Notes:	Property appears in good shape. The building is a telecommunications building with a brick exterior, street level windows on two sides for store, museum and offices. The property also has empty space on north and west side. The building design does not allow easy building re-use. Determination of blight ORS 475.010 (h).

Photos: Top: view of building facing Oak Street; bottom: example of empty space outside museum on north side.

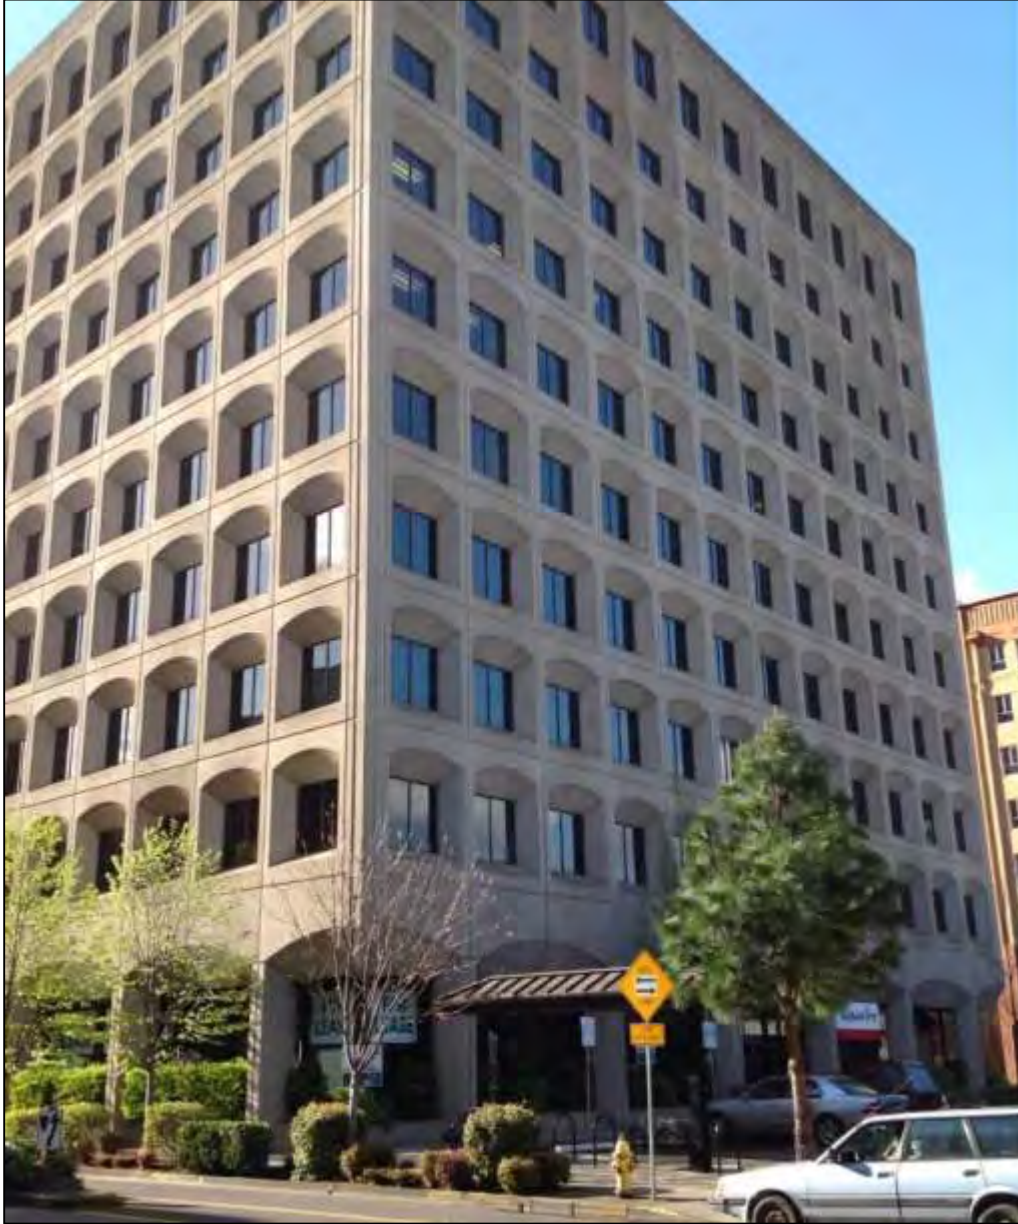
Property: 21	Name: Citizens building	Determination of Blight: No
Taxlot(s): 1703311406900		Depreciation Ratio: 16.22
Property Notes:	The property appears in good condition. The property has a ten story office building, however half of bottom floor appears to be vacant.

Photos: View of building on Oak Street.
