**Summary of Council Discussions/Actions
on Downtown Improvements**

Map to Accompany Downtown Urban Renewal Slums and Blight Report 2016

Downtown Urban Renewal District – Determination of Slums and Blight - Detailed Property Survey

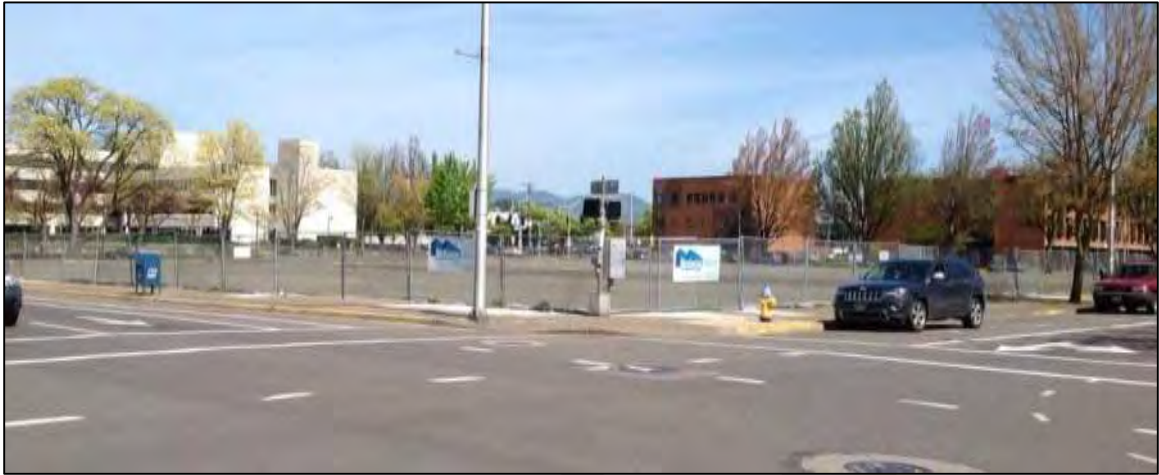
Property: 22	Name: City Hall block	Determination of Blight: Yes
Taxlot(s): 1703311110600		Depreciation Ratio: 0
Property Notes:	Future development site of Eugene City Hall. Land is a vacant one block parcel with buildings removed. Current standing is determination of blight based on ORS 457.010 (1)(g) and (h).

Photos: View of property from East 8th Avenue and Pearl Street.

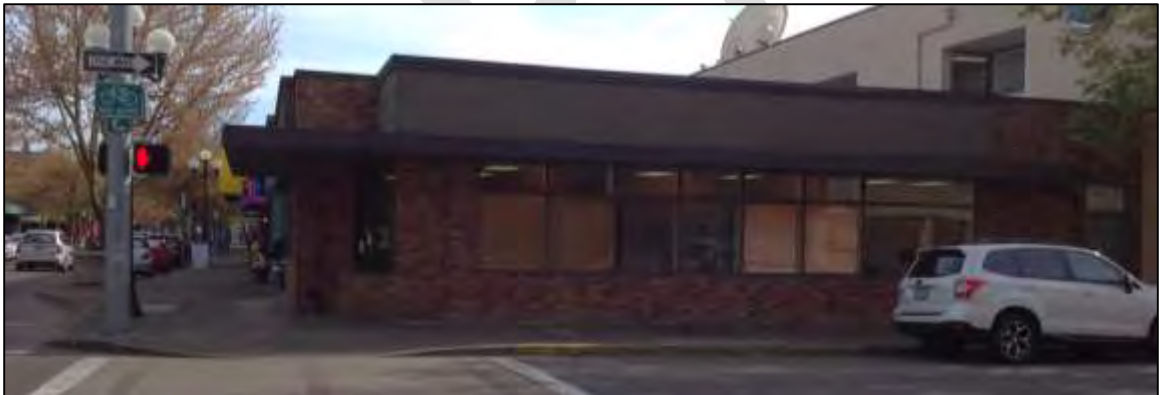
Property: 23	Name: City of Eugene Auditor	Determination of Blight: Yes
Taxlot(s): 1703311303900		Depreciation Ratio: 2.05
Property Notes:	Building appears to be in good condition. Determination of blight based on ORS 457.010 (1)(g) and (h).

Photos: View of building on 8th Avenue.

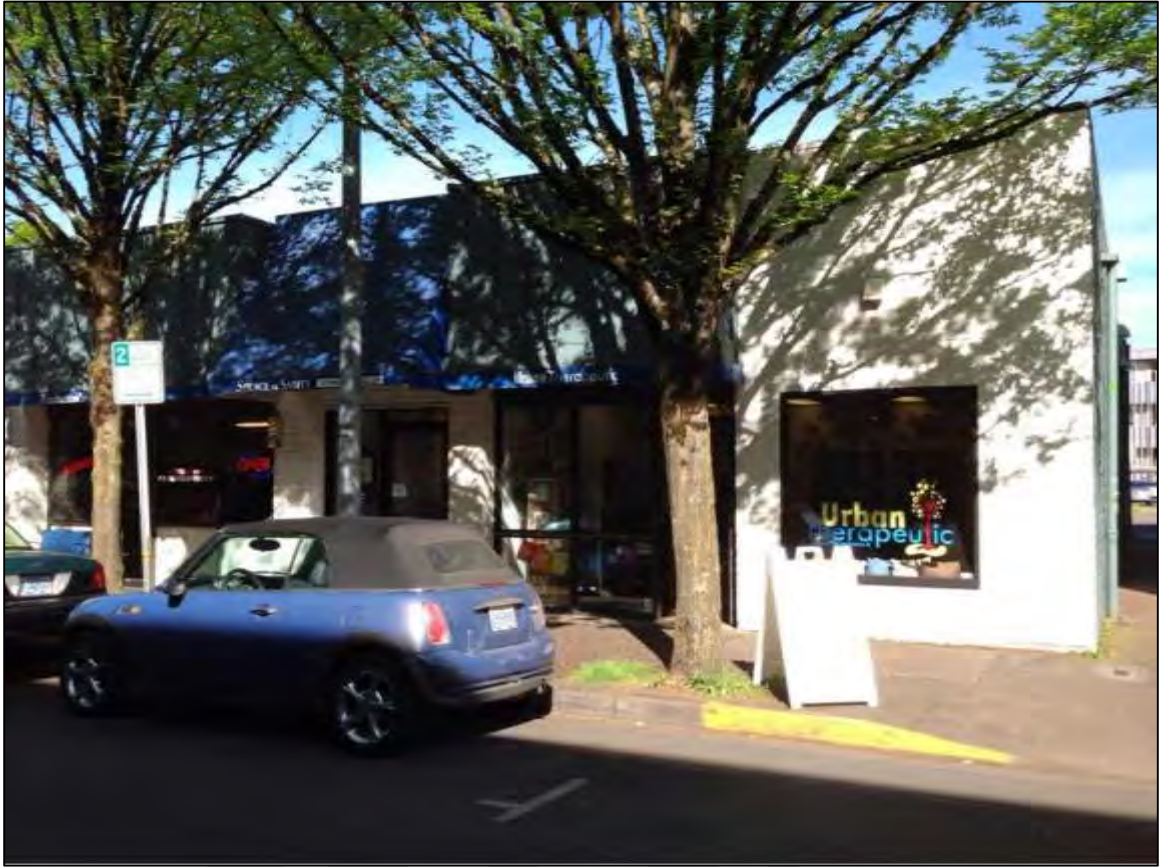
Property: 24	Name: Commercial and office	Determination of Blight: Yes
Taxlot(s): 1703311109000		Depreciation Ratio: 2.75
Property Notes:	Property appears in good condition. Building is a single story with commercial and office uses. Determination of blight based on ORS 457.010 (1)(g) and h.

Photos: Front of building facing Willamette Street.

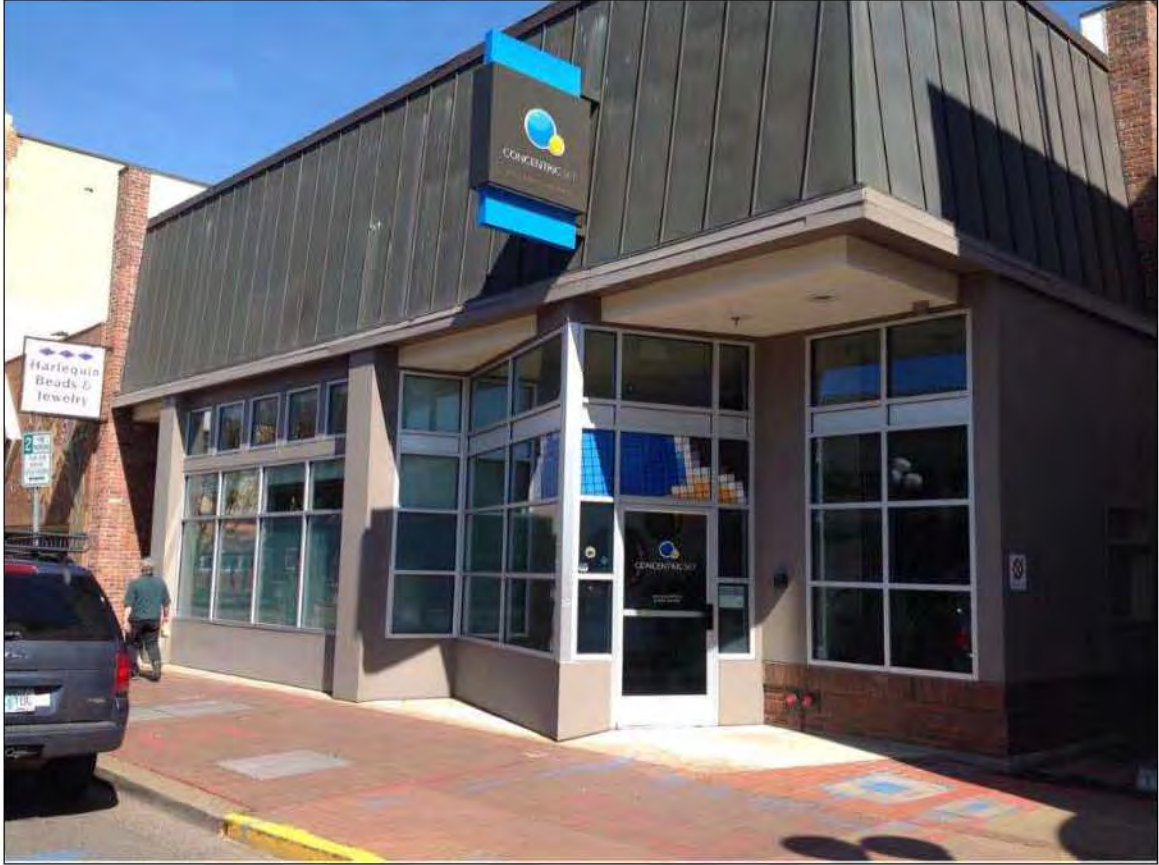
Property: 25	Name: Concentric Sky	Determination of Blight: No
Taxlot(s): 1703311412700		Depreciation Ratio: 4.76
Property Notes:	Property appears in good shape. There is a large hole in pavement in back of building.

Photo: Top: front of building facing Willamette Street; bottom: damage in pavement in back of building.

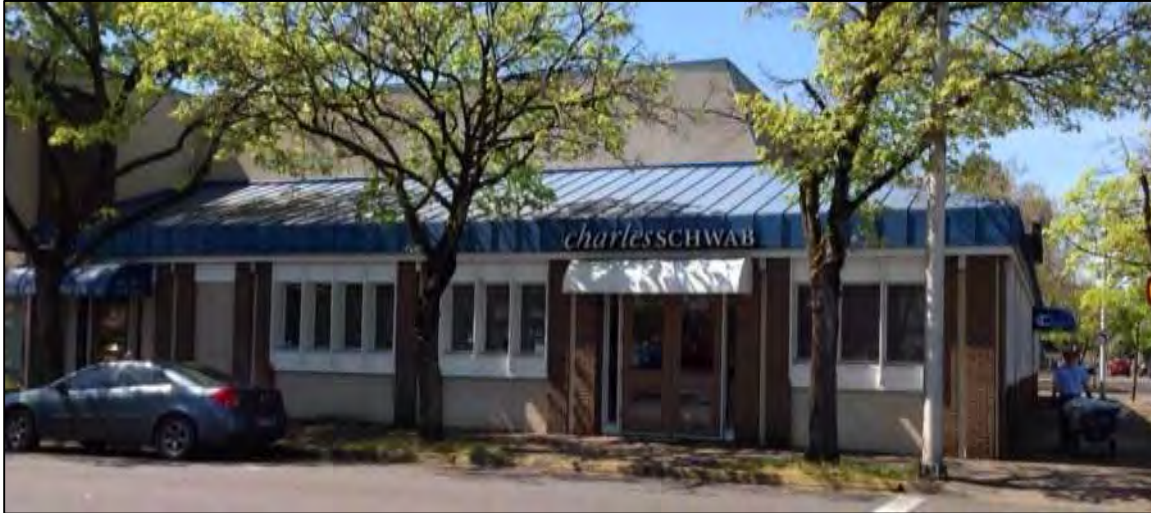
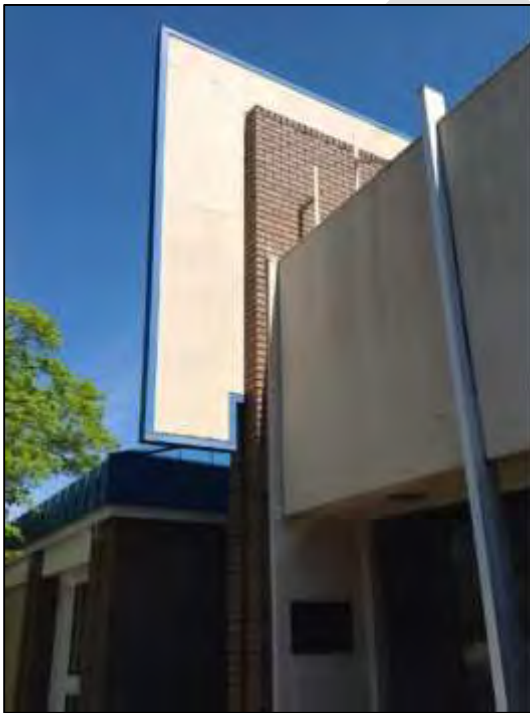
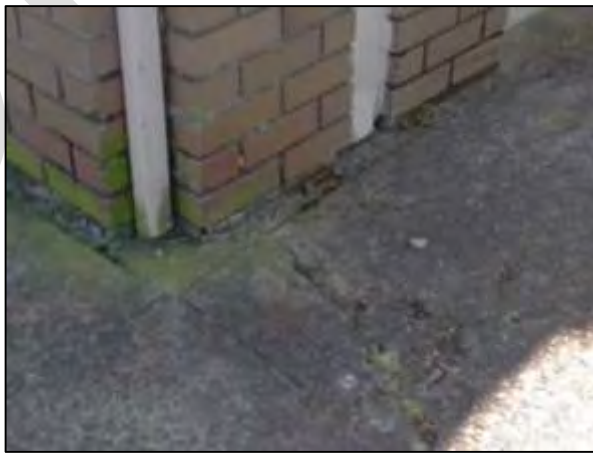
Property:	26	Name:	Court Reporters and law offices.	Determination of Blight:	Yes
Taxlot(s):	1703311402300			Depreciation Ratio:	2.07
Property Notes:	Building appears to be in good shape. Has minor blemishes from ages, rust from outdated metal awning, cracks in facade in a spot. Building shows evidence of graffiti that has been painted over in multiple locations. Building has a part of façade that extends out over sidewalk. Determination of blight based on ORS 457.010 (1)(g) and (h).

Photos: Top: View of property East 8th Avenue and Pearl Street; bottom left: façade piece that extends our over sidewalk; bottom right: damaged and cracked cement walkway at base of building.

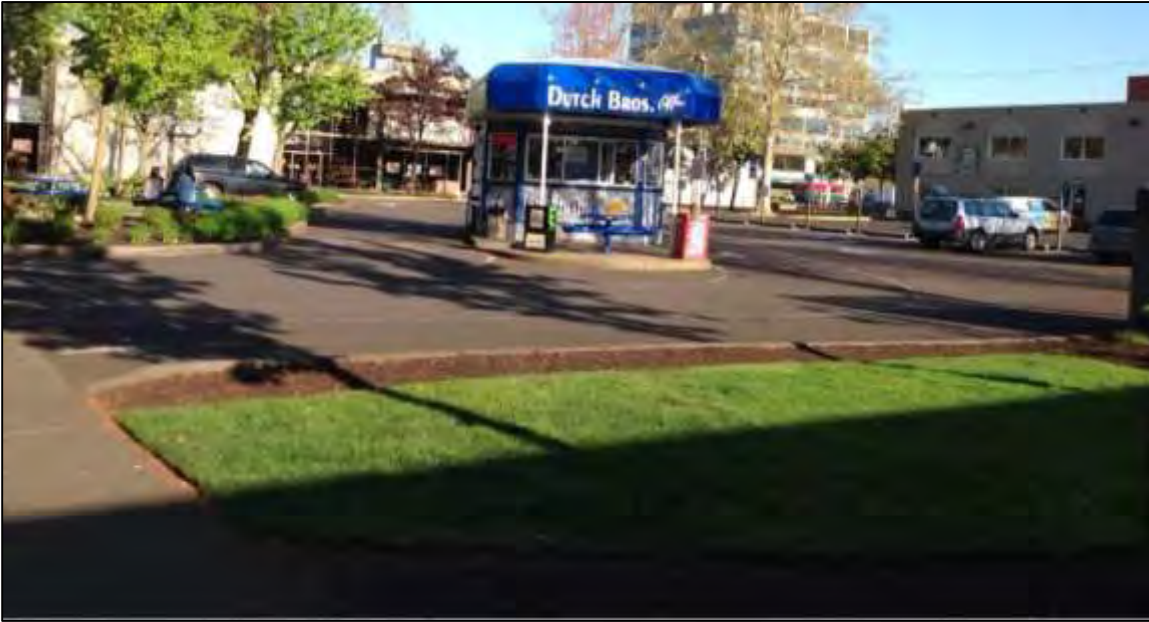
Property: 28	Name: Dutch Bros	Determination of Blight:	Yes
Taxlot(s): 1703311215201		Depreciation Ratio:	0.11
Property Notes:	Property is large, almost 1/4 block, mostly parking. Property has underutilization of space. Determination of blight based ORS 457.010 (1)(g) and (h).

Photos: View of property from West 7th Avenue.

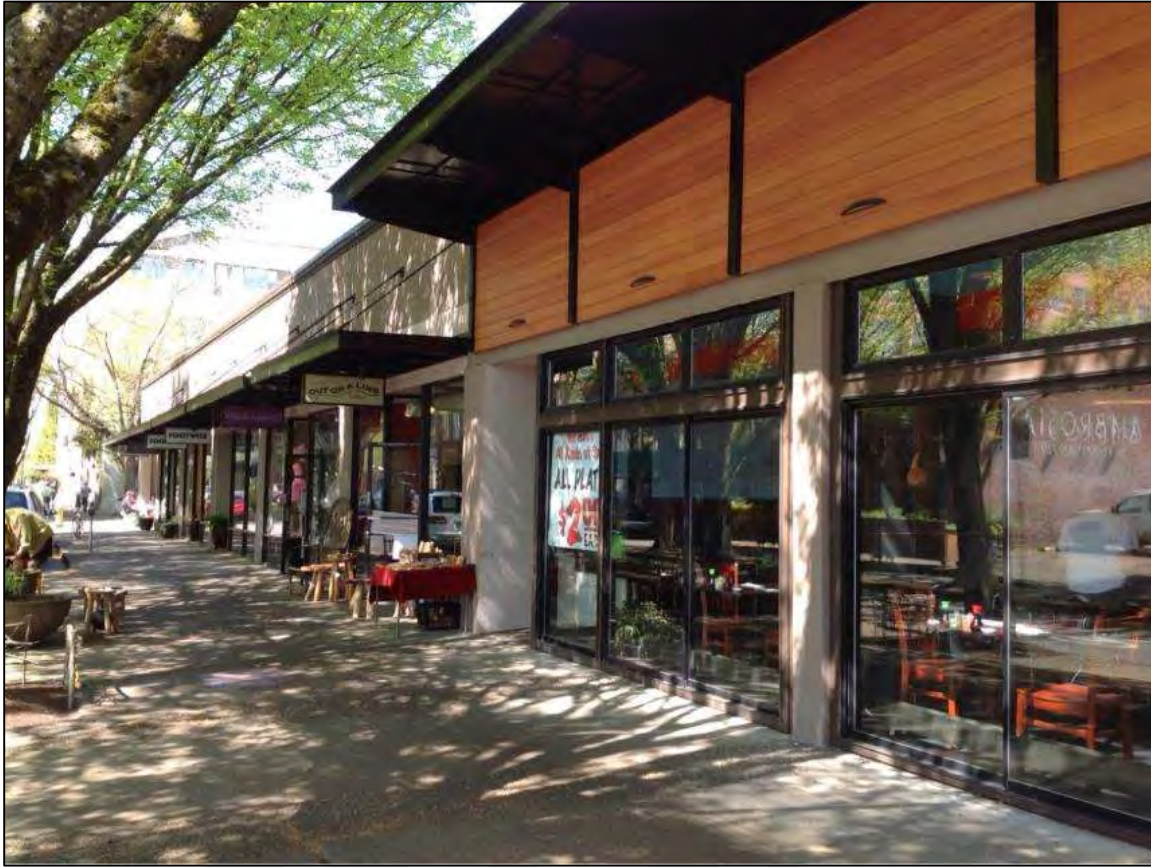
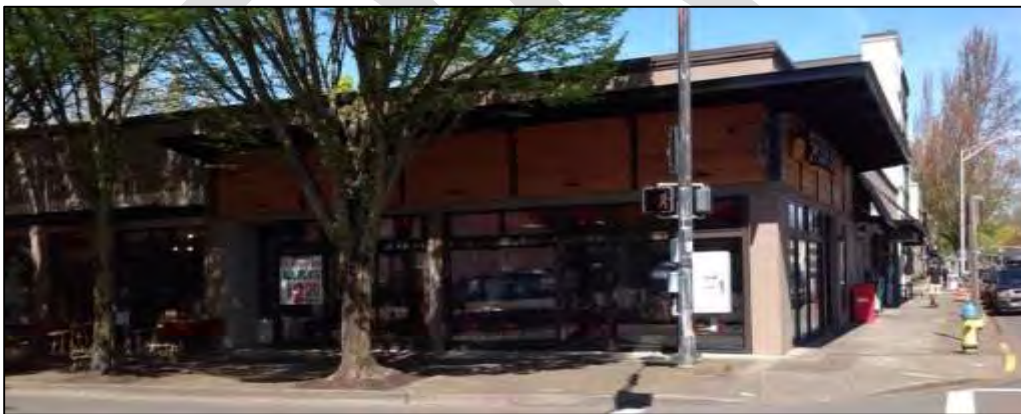
Property:	29	Name:	East Broadway Shopping	Determination of Blight:	Yes
Taxlot(s):	1703311402800			Depreciation Ratio:	2.34
Property Notes:	Property appears in good conditions. Building is single level commercial with multiple shops and restaurants. Determination of blight based ORS 457.010 (1)(g) and (h).

Photos: Top: view of property along East Broadway; bottom: view of building from East Broadway and Pearl Street.

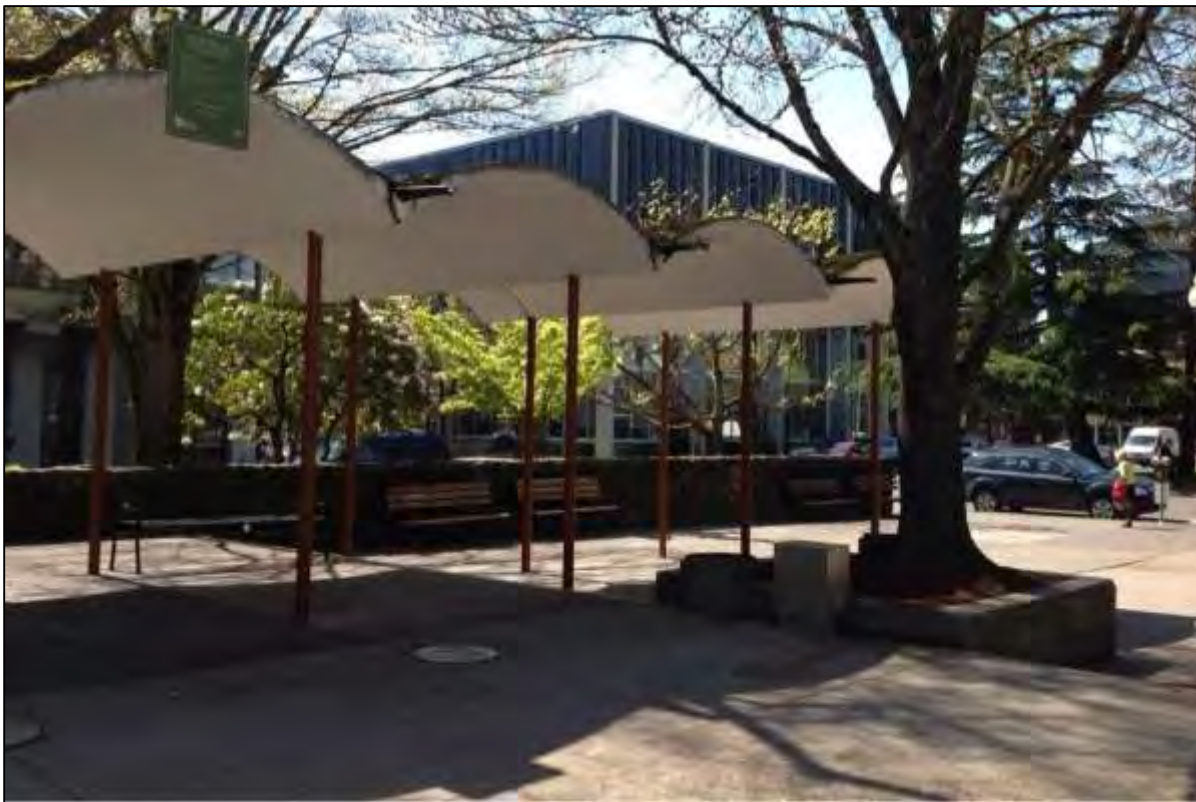
Property: 30	Name: East Park block	Determination of Blight: Yes
Taxlot(s): 1703311404700		Depreciation Ratio: 0.05
Property Notes:	East park block. Sidewalk is broken and uneven. Ramps not flush with sidewalk (ne corner). Structure does not appear maintained with plants visibly growing on top. There is metal protruding from open area in multiple places, garbage littered around., some benches have rusty metal frames with peeling paint and an area with a broken light fixture in wall. Property does not have a permanent, but has a portable restroom. Determination of blight based ORS 457.010 (1)(b), (e), (g), (h), and (i).

Photo: Top: view of shelter; bottom left: growth on shelter; bottom right: broken and exposed light fixture

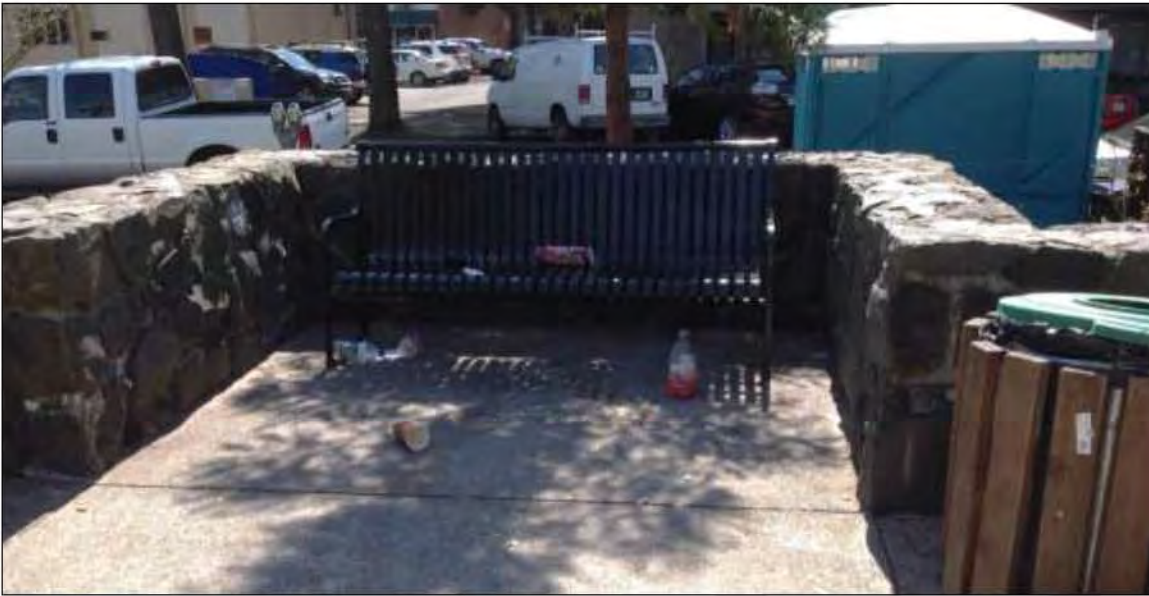
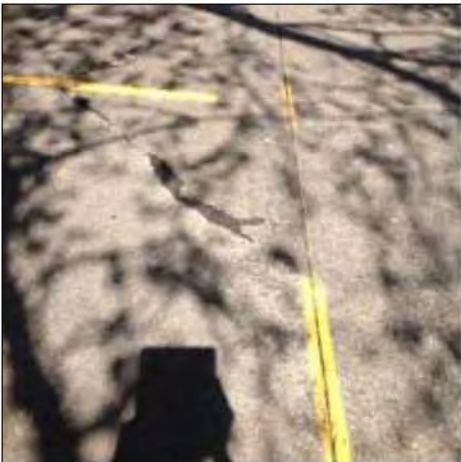
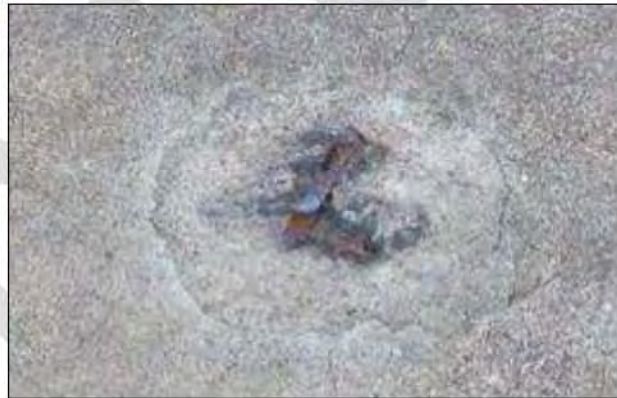
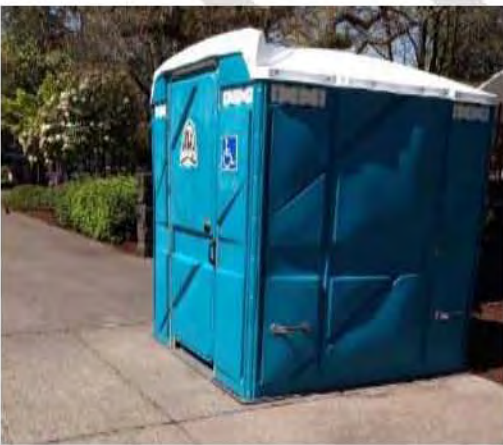
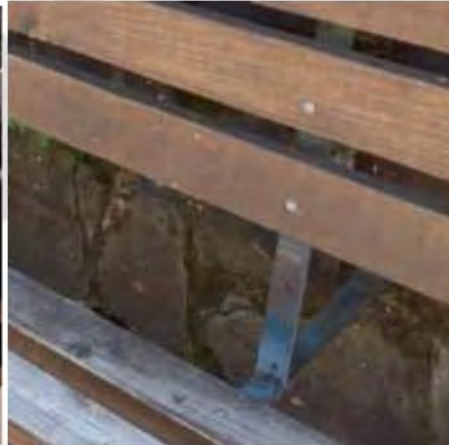
Property 30 images continued.

Photo: Top: Garbage in areas; middle left: example of areas with broken, uneven walkways; middle right: example of areas with metal coming out of walkways; bottom left: portable restroom; bottom right: park bench with peeling paint and rust.

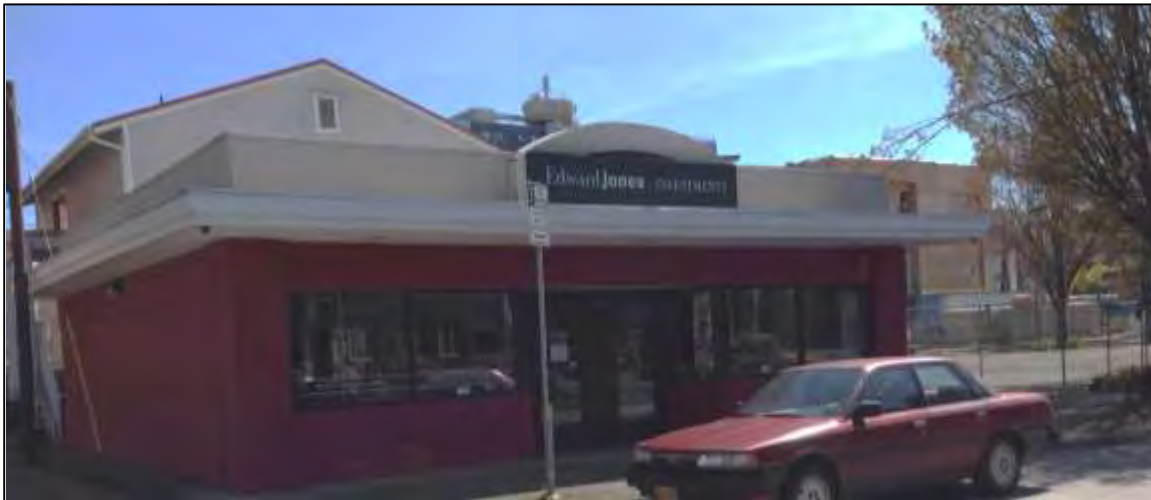
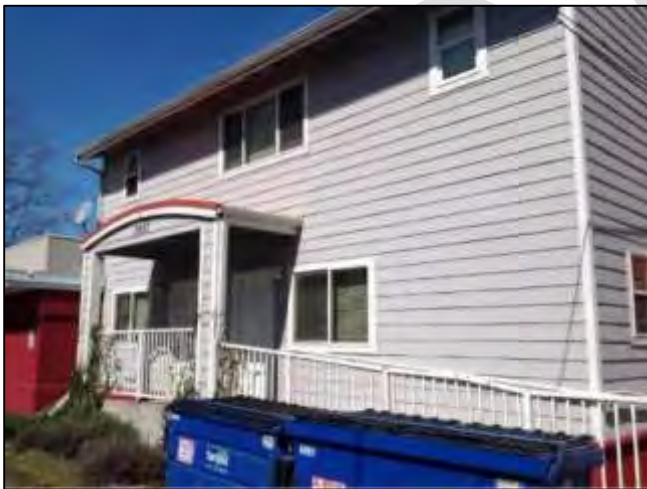
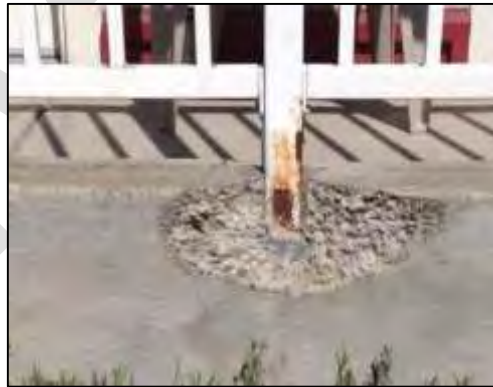
Property:	31	Name:	Edward Jones Investment and housing	Determination of Blight:	Yes
Taxlot(s):	1703311306400			Depreciation Ratio:	3.22
Property Notes:	Property is in fair condition and has two buildings. The buildings are built out to the lot line resulting in no open space for tenants. This also results in garbage for the residential units being placed very close to doors. Minor cement damage noted on patio. Units are accessible by ramp. Also, units are bounded east and south by blighted vacant property. Determination of blight based ORS 457.010 (1)(g).

Photo: Top: front of building facing Charnelton Street; bottom left: image shows proximity of garbage to front door; bottom right: image shows concrete deterioration.

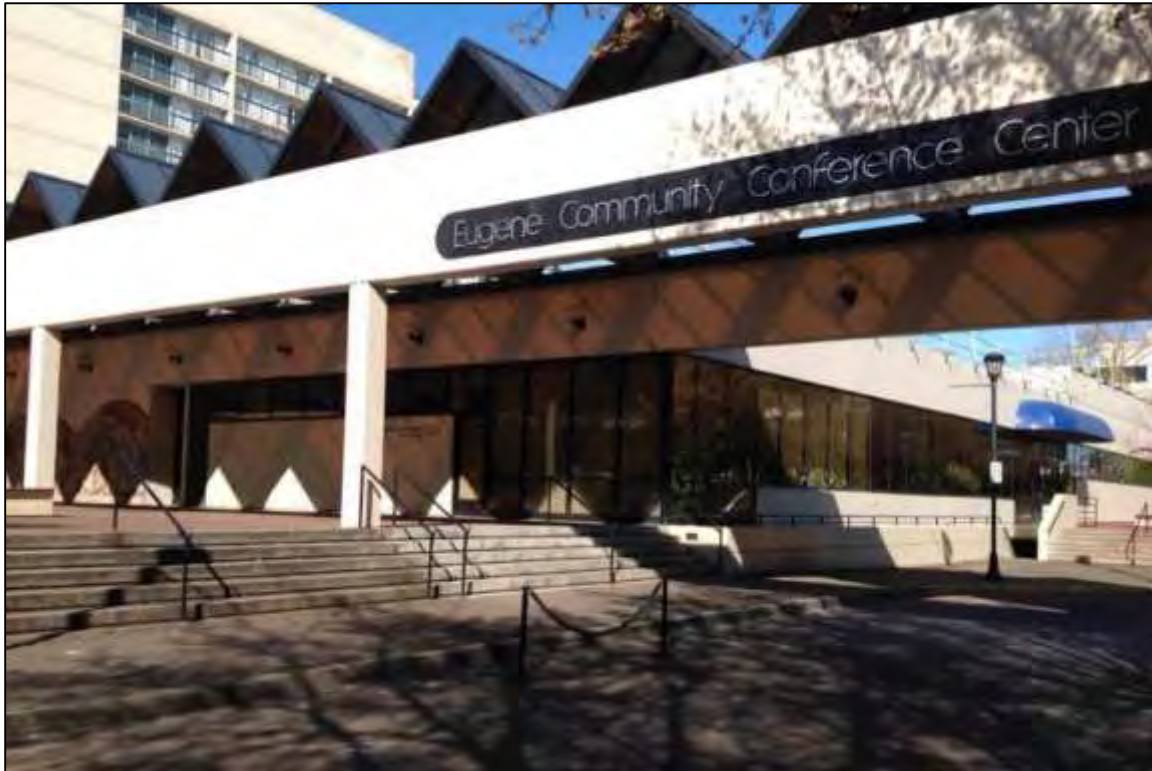
Property: 32	Name: Eugene Conference Center	Determination of Blight: Yes
Taxlot(s): 1703311107600	1703311107700	Depreciation Ratio: 6.39
Property Notes:	Property consists of outdoor area and building. Building appears in good shape. Outdoor area is in poorer shape with broken tiles and cracked cement, this area also appears underutilized. This property is next to the Eugene Hilton. Building appears to be getting re-roofed. Determination of blight based ORS 457.010 (1)(a)(A), (a)(B), and (h), including seismic stability concerns.

Photo: Top: View of property from East 7th Ave; bottom left: damage on outdoor awning, bottom right: image shows example of uneven sidewalk.

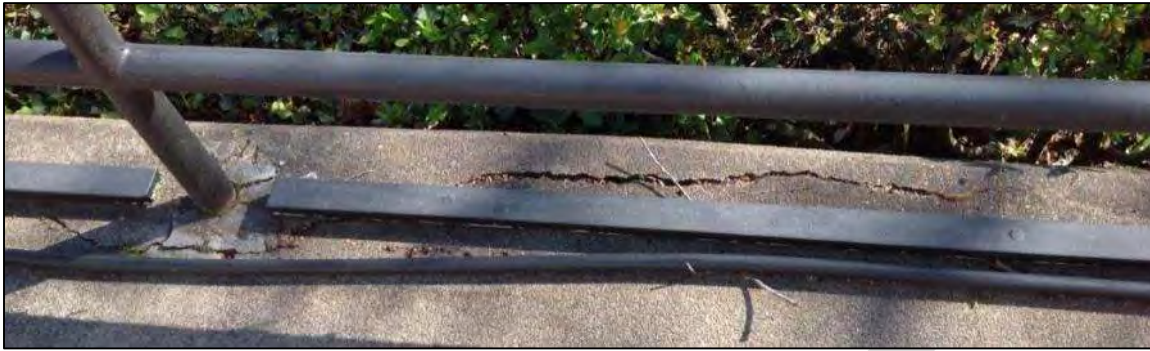
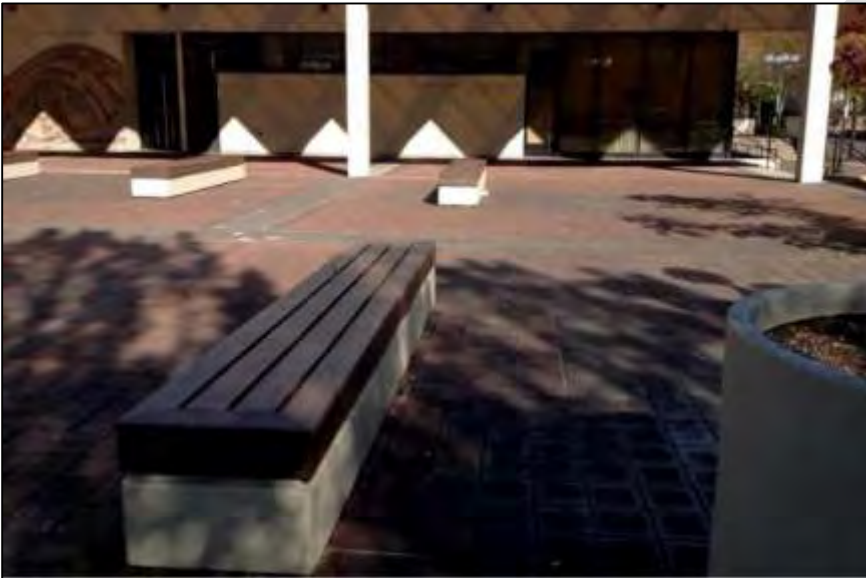
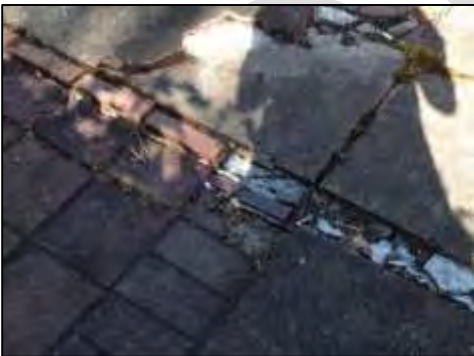
Property #32 images continued.

Photo: Top: image shows cracked cement along railing; middle: large open space; bottom: example of broken walkway.

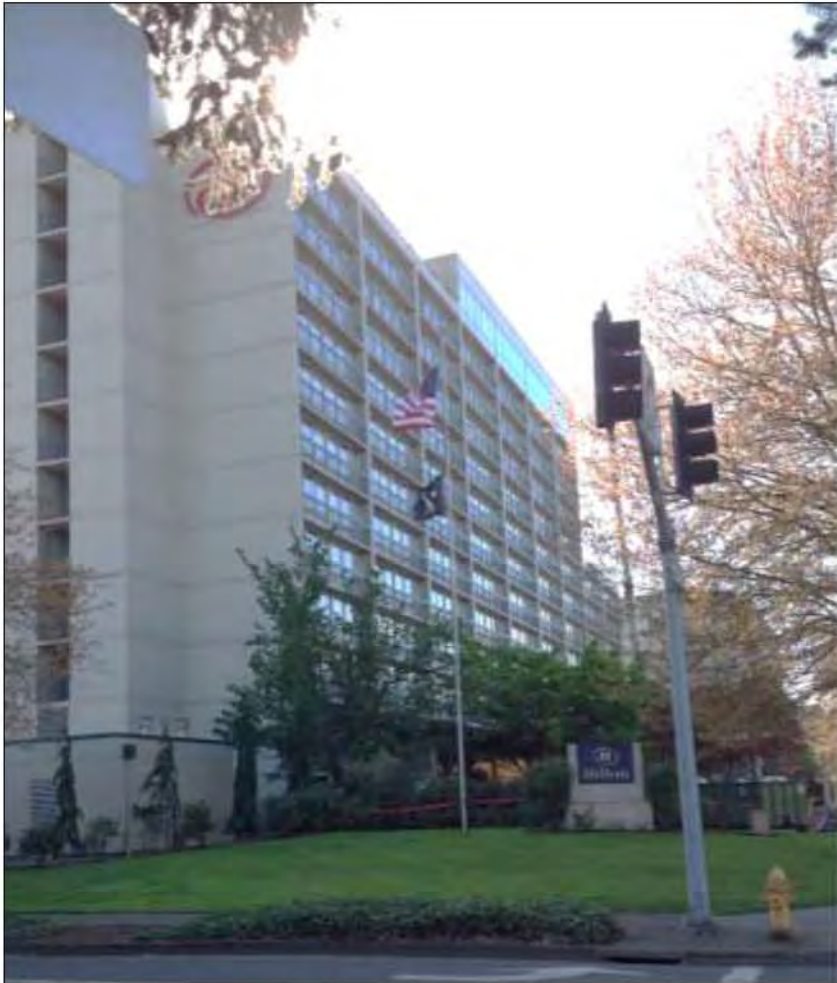
Property: 33	Name: Eugene Hilton Hotel	Determination of Blight:	No
Taxlot(s): 1703311107601		Depreciation Ratio:	11.30
Property Notes:	Building appears in fair shape. The steps from the sidewalk have deteriorated so rebar shows. There are lines visible on building cement surface, and the walkway on east side has steep ramp with cracked tiles.

Photo: Top: image of property from Oak Street and East 6th Avenue; bottom left: image shows rebar in deteriorated stairs; bottom middle: cracks shown on stairwell; bottom right: image shows example of visible repairs.

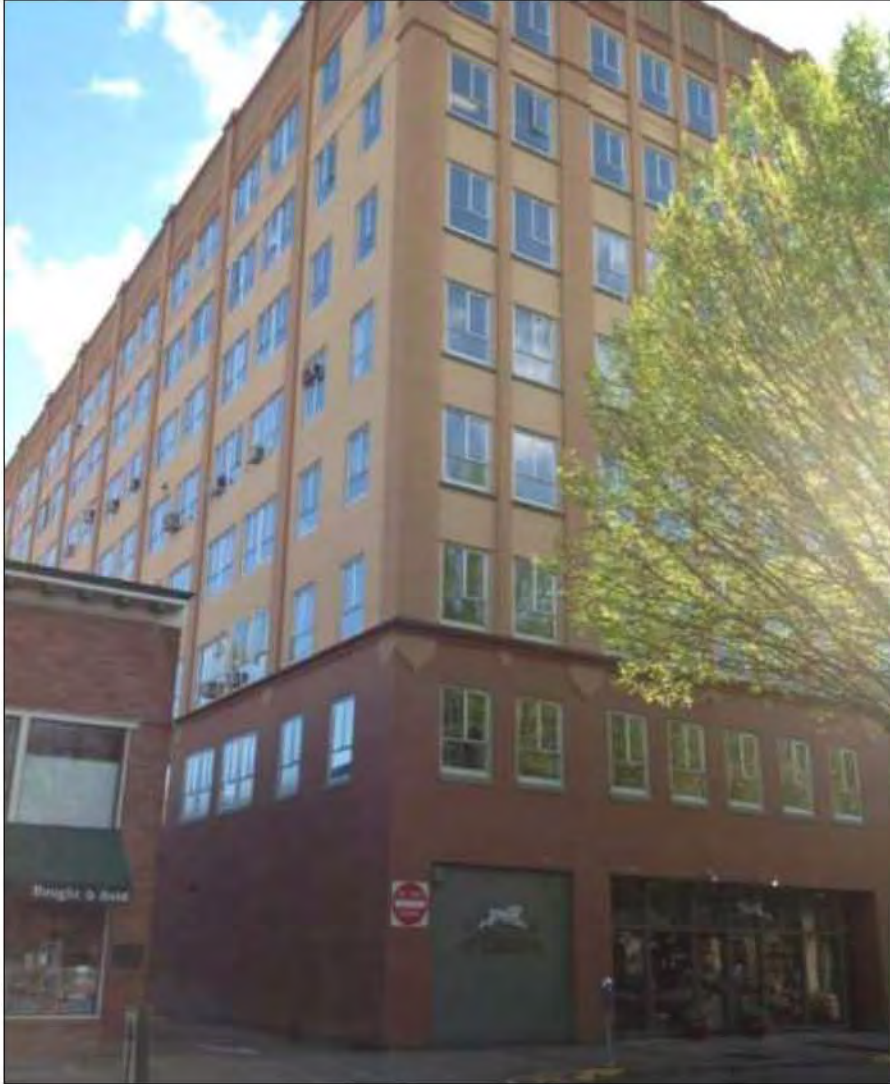
Property: 34	Name: Eugene Professional Building	Determination of Blight: No
Taxlot(s): 1703311406600		Depreciation Ratio: 7.99
Property Notes:	Building appears in good condition and has a few blemishes such as cracks at base of building. Locations area also visible where building exterior has wear.

Photo: Top left: view of property from East Broadway; top right: image shows example of façade wear; bottom: cracks in pavement at base of building.

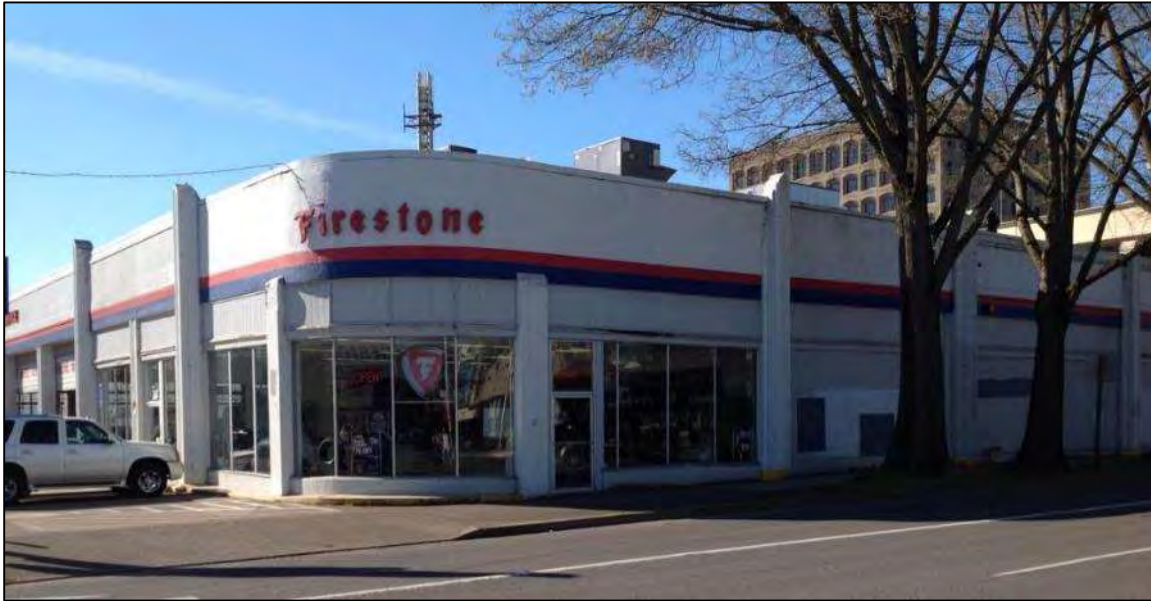
Property: 35	Name: Firestone Auto Center	Determination of Blight: Yes
Taxlot(s): 1703311411200	1703311411300	Depreciation Ratio: 0.21
Property Notes:	Property is a large single level building and is old but appears in fair condition. Has large possible graffiti removal spots on east side. Locations with wood in structure appear to be rotting. Determination of blight based ORS 457.010 (1)(g) and (h).

Photo: View of property from East 11th Avenue and Pearl Street.

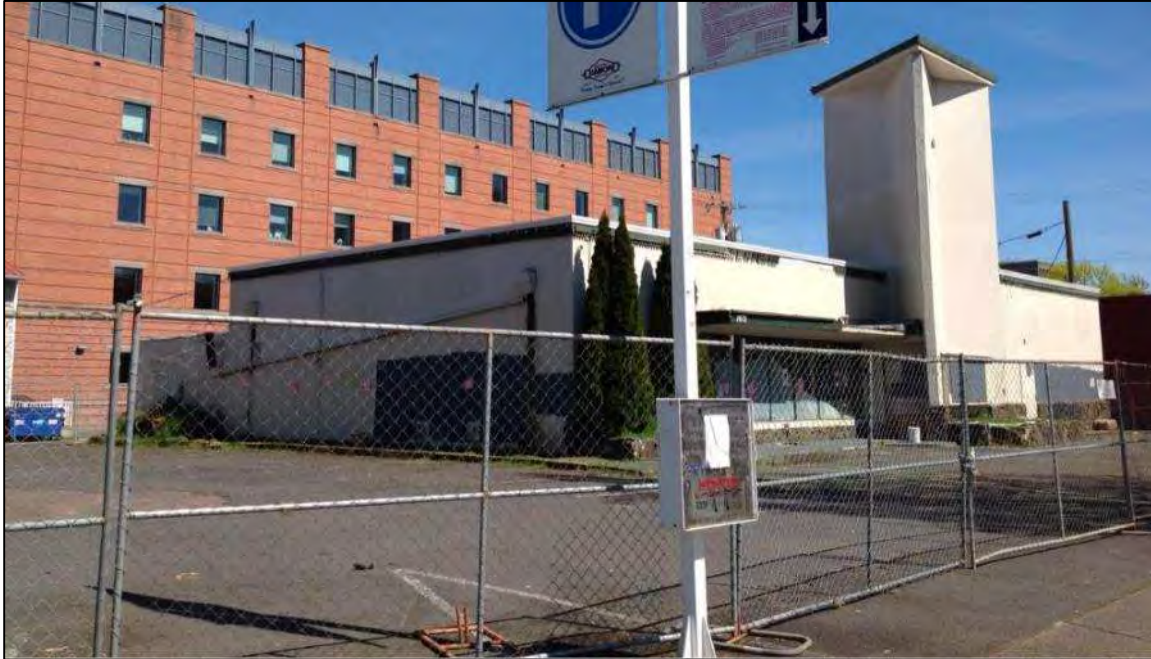
Photo: Top: shows property from SW corner of 11th Ave and Charnelton St, Library can be seen in background; bottom left: shows property from se corner; bottom right: damage to pavement that provides access to parking area behind building.

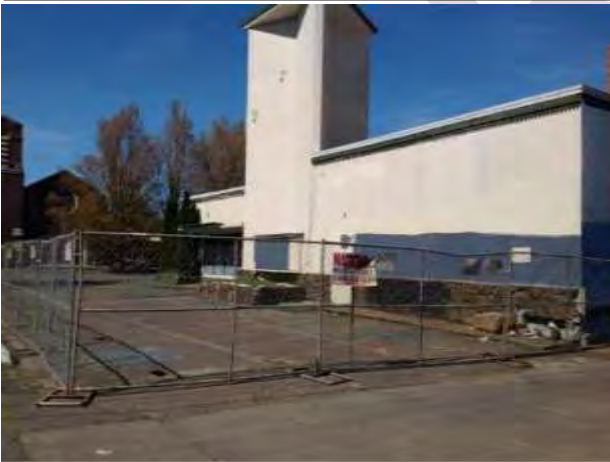
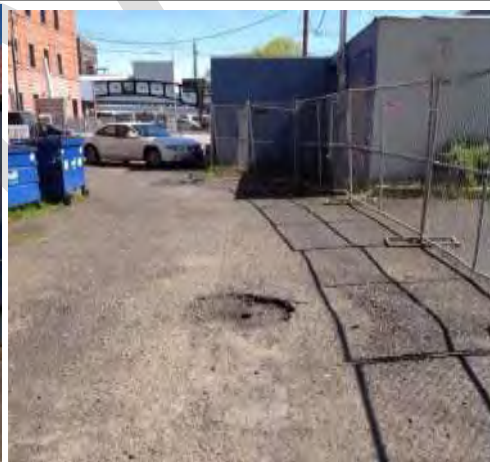
Property: 37	Name: Former Docs Pad	Determination of Blight: Yes
Taxlot(s): 1703311306200	1703311306300	Depreciation Ratio: 0.14
Property Notes:	Property is formers "Docs Pad", then a salon. Property contains a dilapidated building and parking. This property did have paid parking for a while. Currently property and parking is fenced off. Old light fixtures abut property on south side. An area behind the building is used for parking and pavement is broken with large holes. Building itself has graffiti, large cracks, broken pieces, and garbage. Determination of blight based ORS 457.010 (1)(a)(A), (a)(B), (a)(E), (b), (e), (g), (h), and (i).

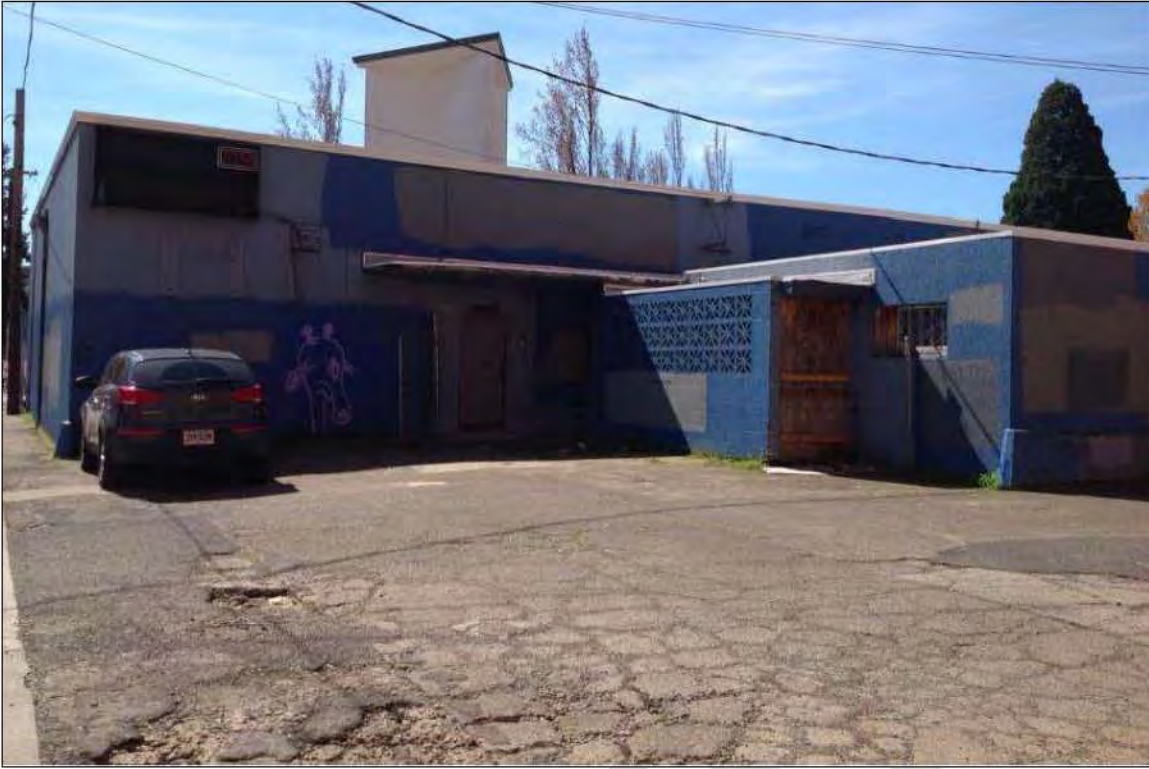
Property #37 images continued on next page.

Photo: top and bottom images show back side of building with damage, broken fencing, deteriorated building, overgrown vegetation, graffiti and damaged pavement.

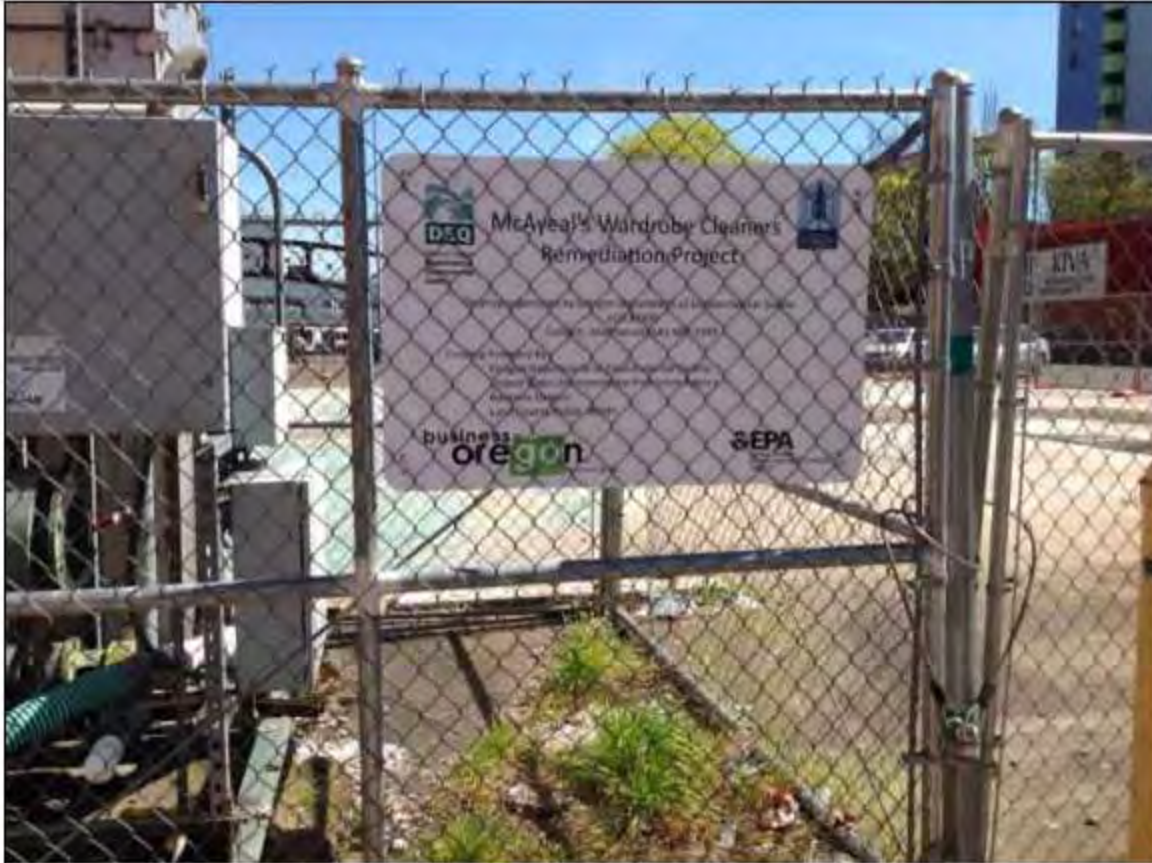
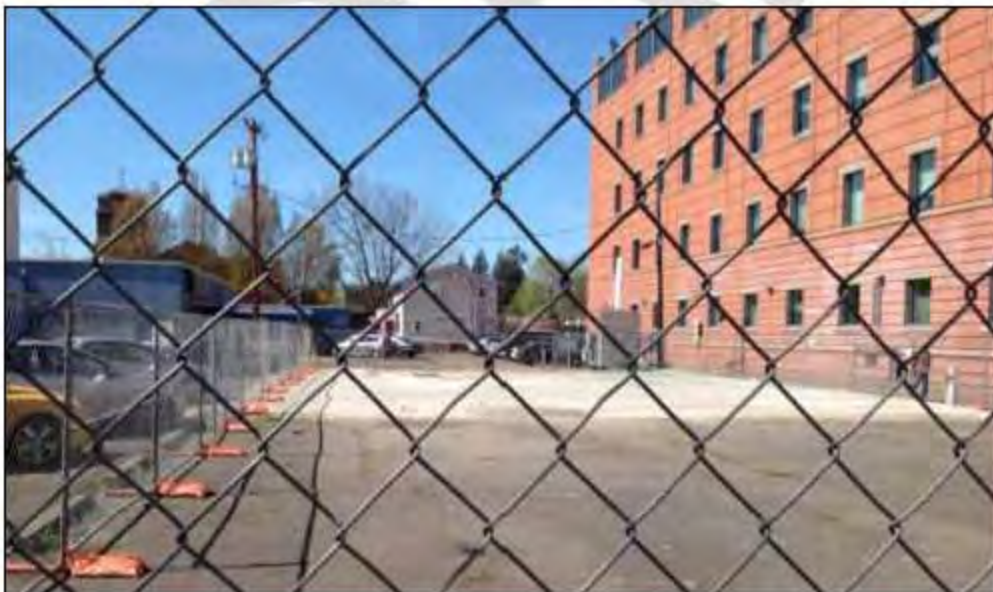
Property: 38	Name: Former McAyeals Cleaners	Determination of Blight: Yes
Taxlot(s): 1703311305900	1703311306000	Depreciation Ratio: 0.38
Property Notes:	This property had a dry cleaners which was removed and is currently under public ownership. This property was contaminated and is now being cleaned up. The future of this property unknown. Determination of blight based ORS 457.010 (1)(b), (g), (h), and (i).

Photo: View of property, with library to the right and Former Doc's Pad visible in background, indicating another blighted property on same block.

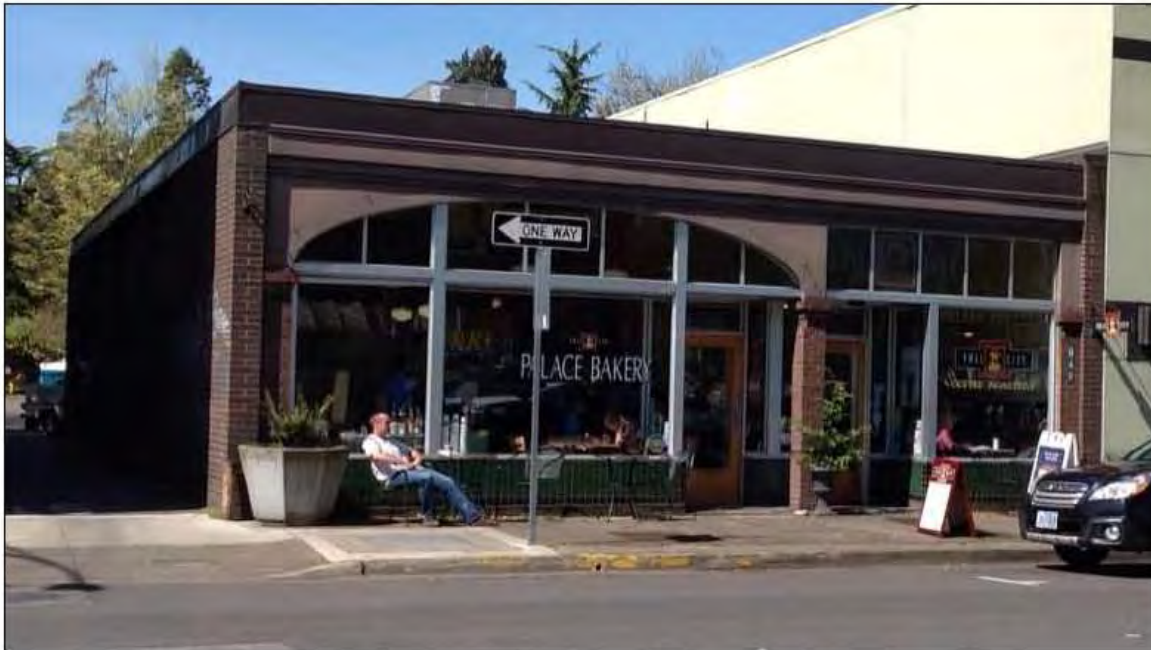
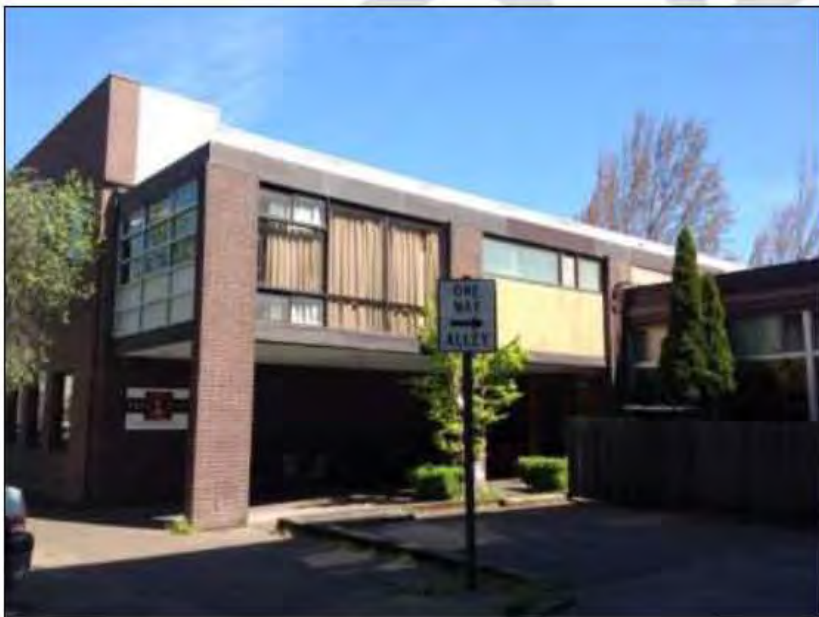
Property: 39	Name: Full City Coffee	Determination of Blight:	Yes
Taxlot(s): 1703311402600		Depreciation Ratio:	2.72
Property Notes:	This property appears in good condition. Building has two levels, second level is on west side and appears older. Alley has evidence of graffiti in several spots indicating a possible public safety issue. Determination of blight based ORS 457.010 (1)(g).

Photo: Top: front of building on Pearl Street; bottom: image shows back of building on Park St.
