**Summary of Council Discussions/Actions
on Downtown Improvements**

Map to Accompany Downtown Urban Renewal Slums and Blight Report 2016

Downtown Urban Renewal District – Determination of Slums and Blight - Detailed Property Survey

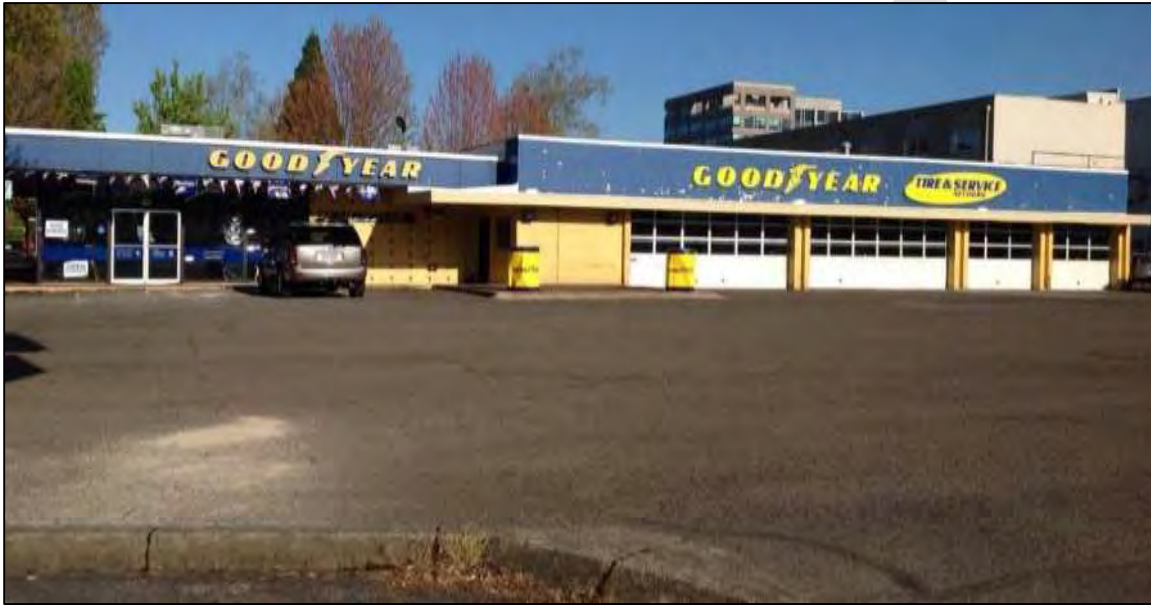
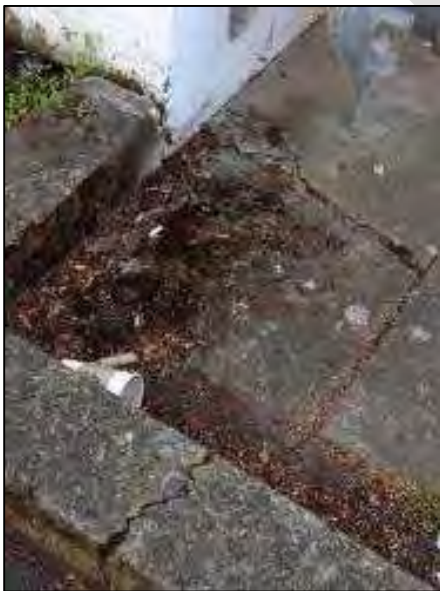
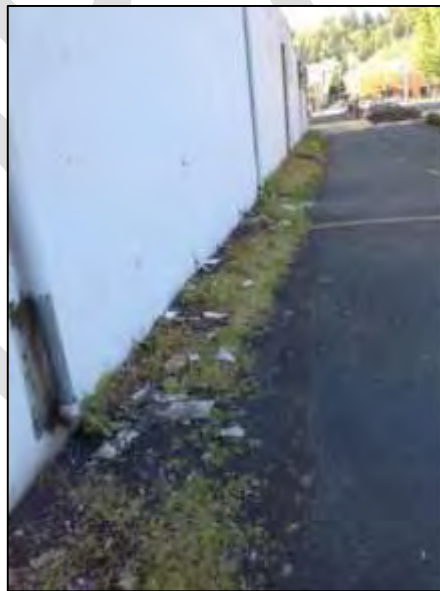
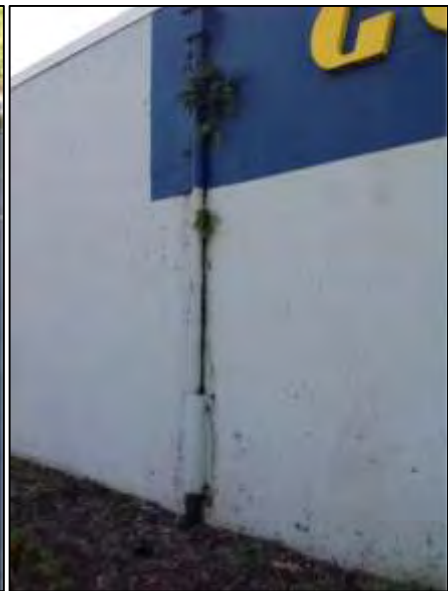
Property:	41	Name:	Goodyear Tires	Determination of Blight:	Yes
Taxlot(s):	1703311214600		1703311214700	Depreciation Ratio:	0.29
	1703311215100				
Property Notes:	Property appears in poor shape. Building has peeling paint with moss and plants growing on back. There are garbage and overgrown weeds on rear east location. The property is large about 1/4 block and half appears to be parking. Public sidewalks around building do not look maintained, this adds to further deterioration and perceptions of blight in area. Determination of blight based on ORS 457.010 (1)(g) and (h)

Photo: Top: view of property from Charnelton Street; bottom left shows example of cement damage; middle: shows garbage and overgrown vegetation on east side of building; bottom right: shows plants growing on side of building.

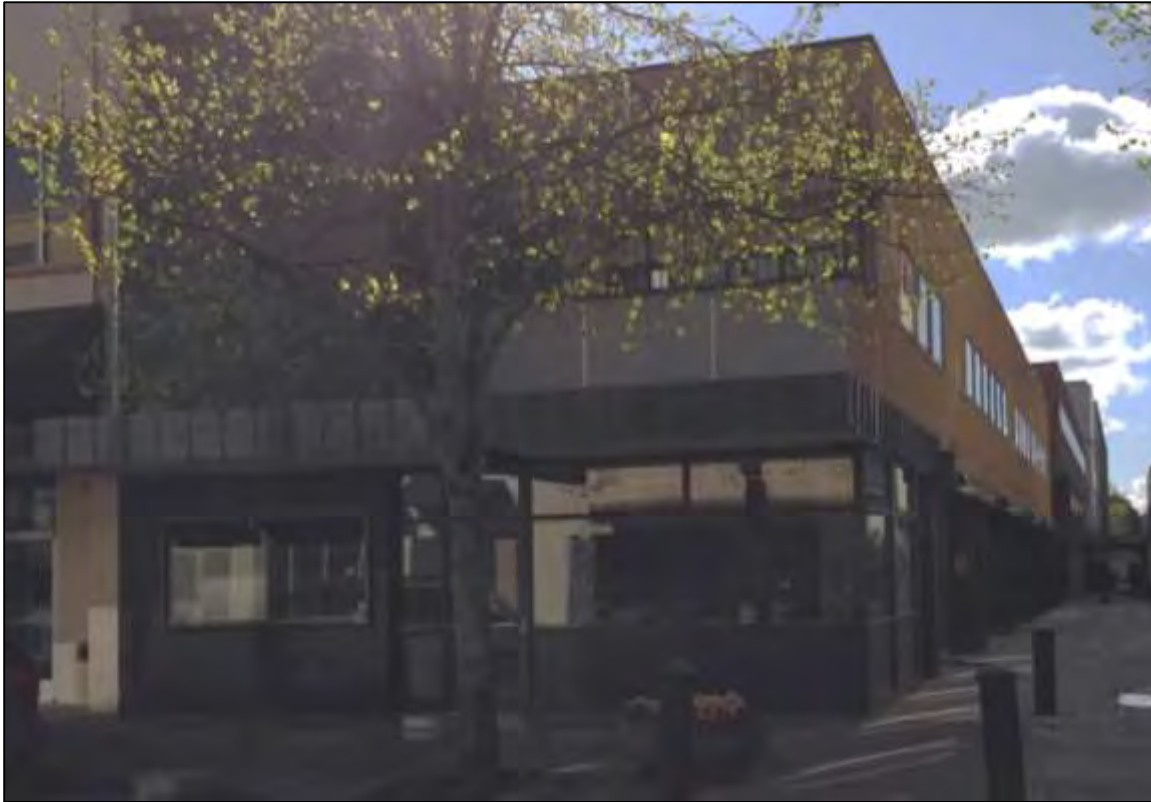
Property: 43	Name: Harry Ritchie Jewelers	Determination of Blight:	Yes
Taxlot(s): 1703311301600		Depreciation Ratio:	4.42
Property Notes:	Property is older but in relatively good condition. The building has graffiti and evidence of safety concerns along northern pedestrian walkway. First floor windows are closed off. Along north perimeter of building is Eugene mall remnant. Determination of Blight ORS 457.010 (g).

Photo: View of property from Willamette Street.

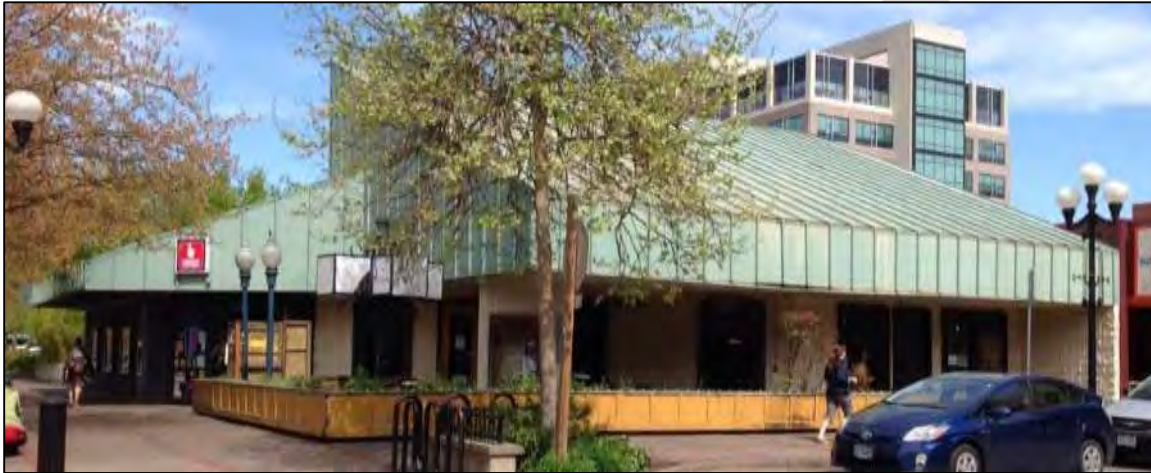
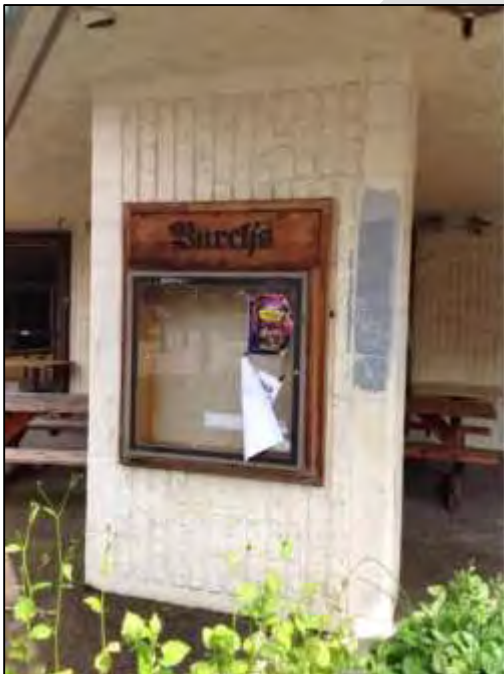
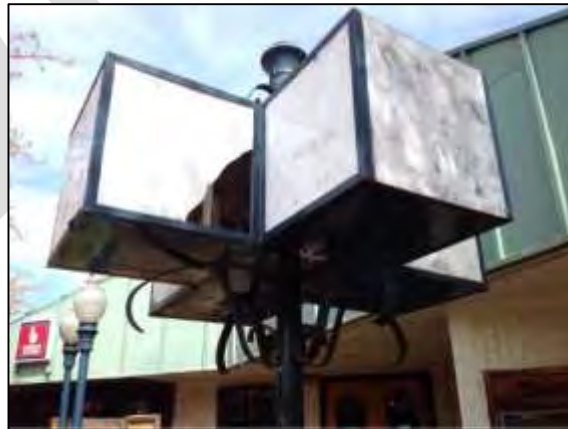
Property: 45	Name: Horsehead	Determination of Blight: Yes
Taxlot(s): 1703311303000		Depreciation Ratio: 0.54
Property Notes:	Property is in poor condition. The building is older and deteriorating. The property has two outdoor seating areas: one south and the other north. South seating area has broken fixtures, graffiti, and the building has damage. The south area has a wooden enclosure that look like planter boxes, which are broken with metal exposed and the planters are overgrown and not maintained. Northern outside area has tables and looks to be used as lunch area. There is a small store in the building on the west side of the building. The building is deteriorated with peeling and broken sections. Determination of blight based on ORS 457.010 (1)(a)(B), (b), (g), and (h)

Photo: Top: image shows south side of property, viewed from Broadway and Olive Street; bottom left shows deterioration of property and graffiti; bottom right: image shows broken light in south area.

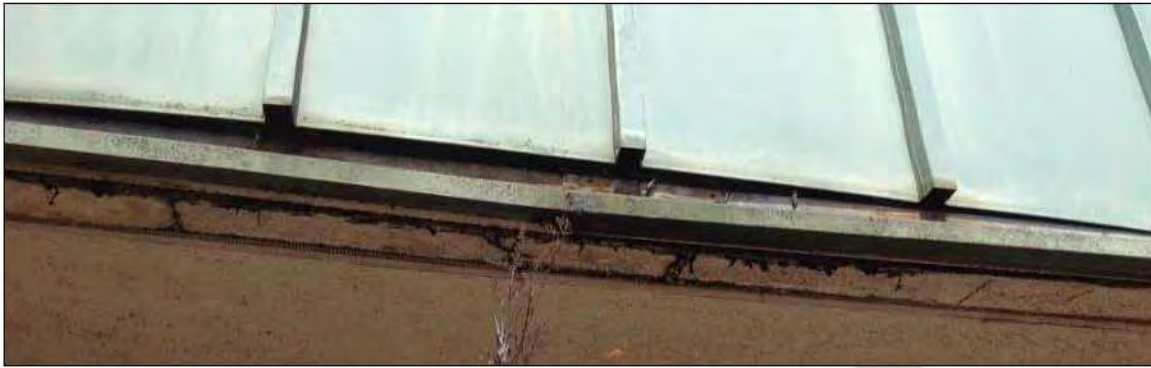
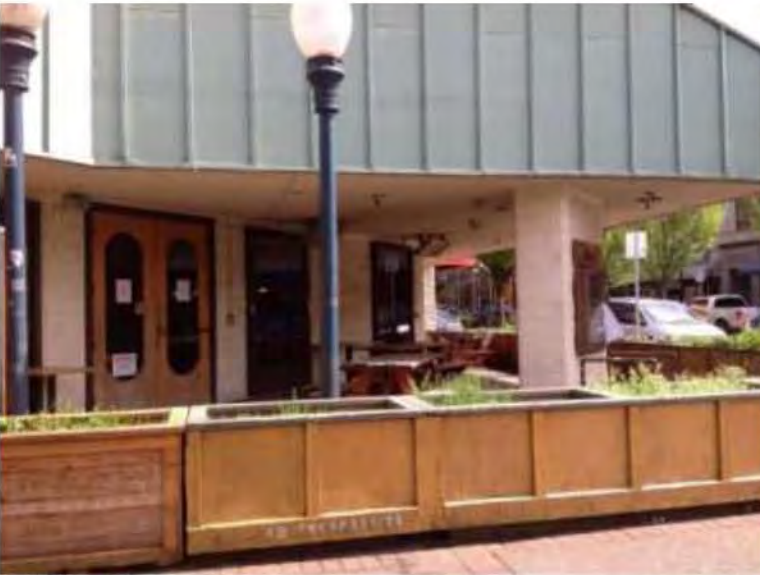
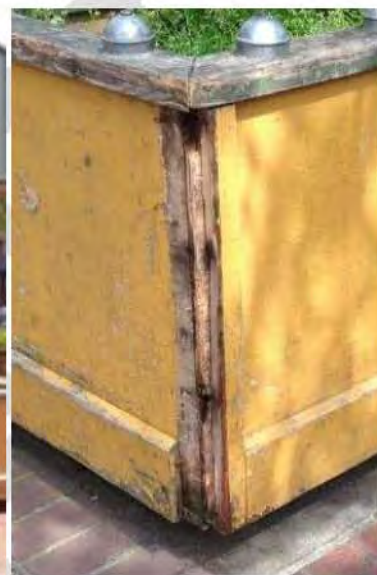
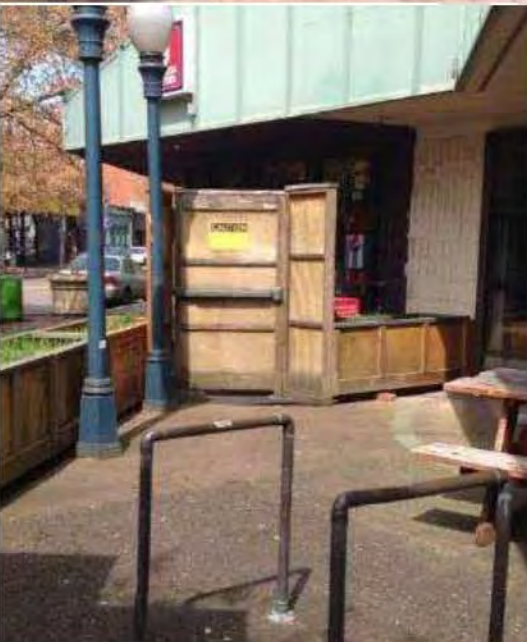
Property #45 images continued.

Photo: Top: image shows building deterioration; middle left: image shows south outside seating area, middle right: shows damage to planter in south outside seating area; bottom: shows exit door for south outside seating area.

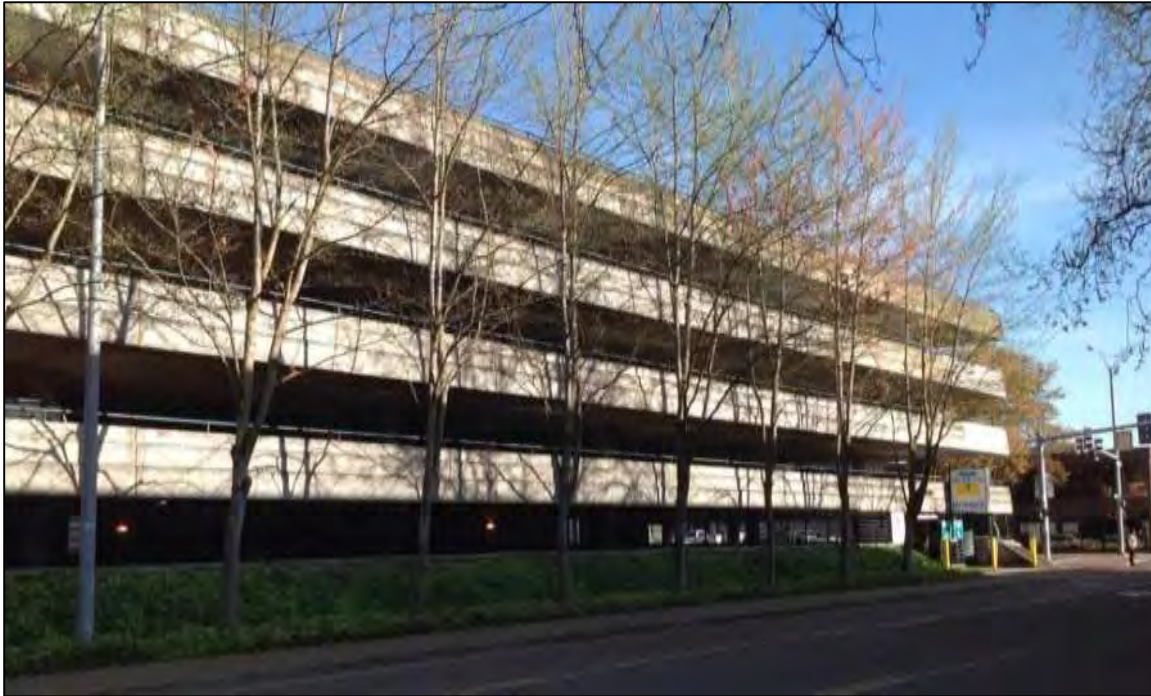
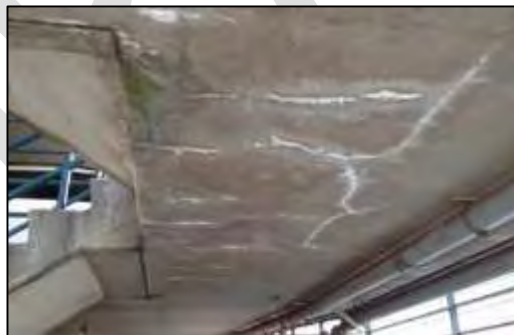
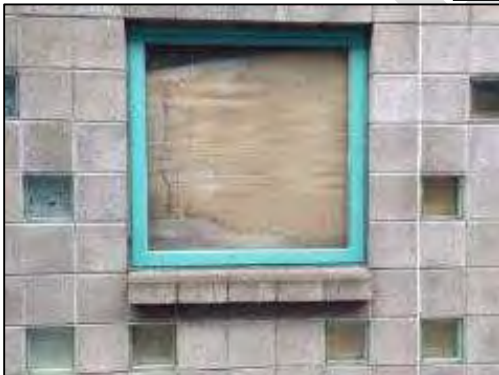
Property: 46	Name: Hult Center parking	Determination of Blight: Yes
Taxlot(s): 1703311206400		Depreciation Ratio: 11.43
Property Notes:	Property is a cement parking garage. The property has visible surface cracks, some that have a white substance coming out of them. There are windows on alley side that have visible water damage inside. Determination of blight based on ORS 457.010(1)(a)(A).

Photo: Top: view of property from Olive Street; middle left: cracks visible on structure; middle right: image shows an example of white material in cracks in structure; bottom: image shows example of window with water damage inside.

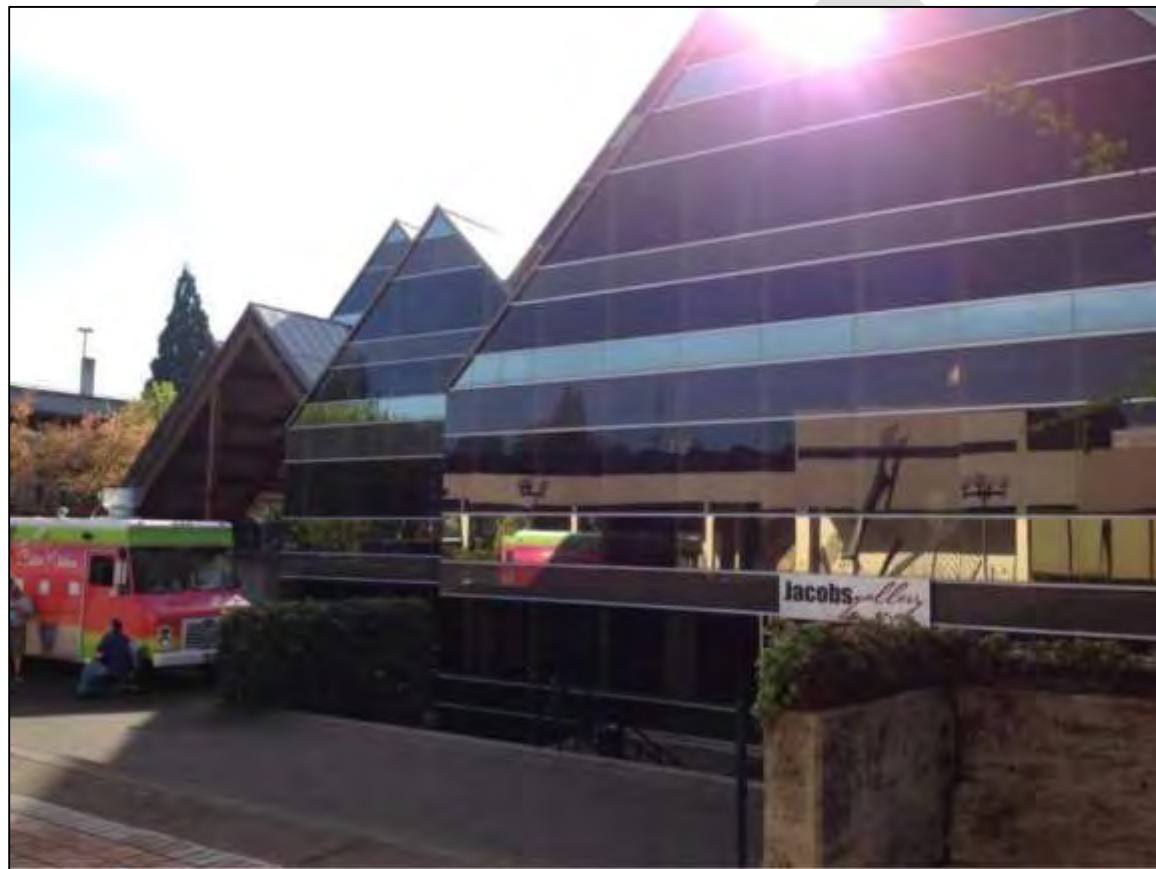
Property: 47	Name: Hult Center	Determination of Blight:	Yes
Taxlot(s): 1703311206400		Depreciation Ratio:	11.43
Property Notes:	Property is in fair condition. The property consists of a building, alley and open space. A large portion of the property is underutilized open space and combined with adjacent underutilized open space of conference center these areas are underperforming their potential. Accessibility is low for those with assisted walking devices or wheelchairs, even strollers with steep ramps, bumpy sidewalks. The property has deteriorating features and cracks are visible on building facade. In the building, a large gallery has closed leaving even greater underutilization. The building also has potential seismic stability concerns. Blight determination based on ORS 457.010 (1)(a)(A) and (h).

Photo: View of building from pedestrian pathway between conference center and Hult Center.

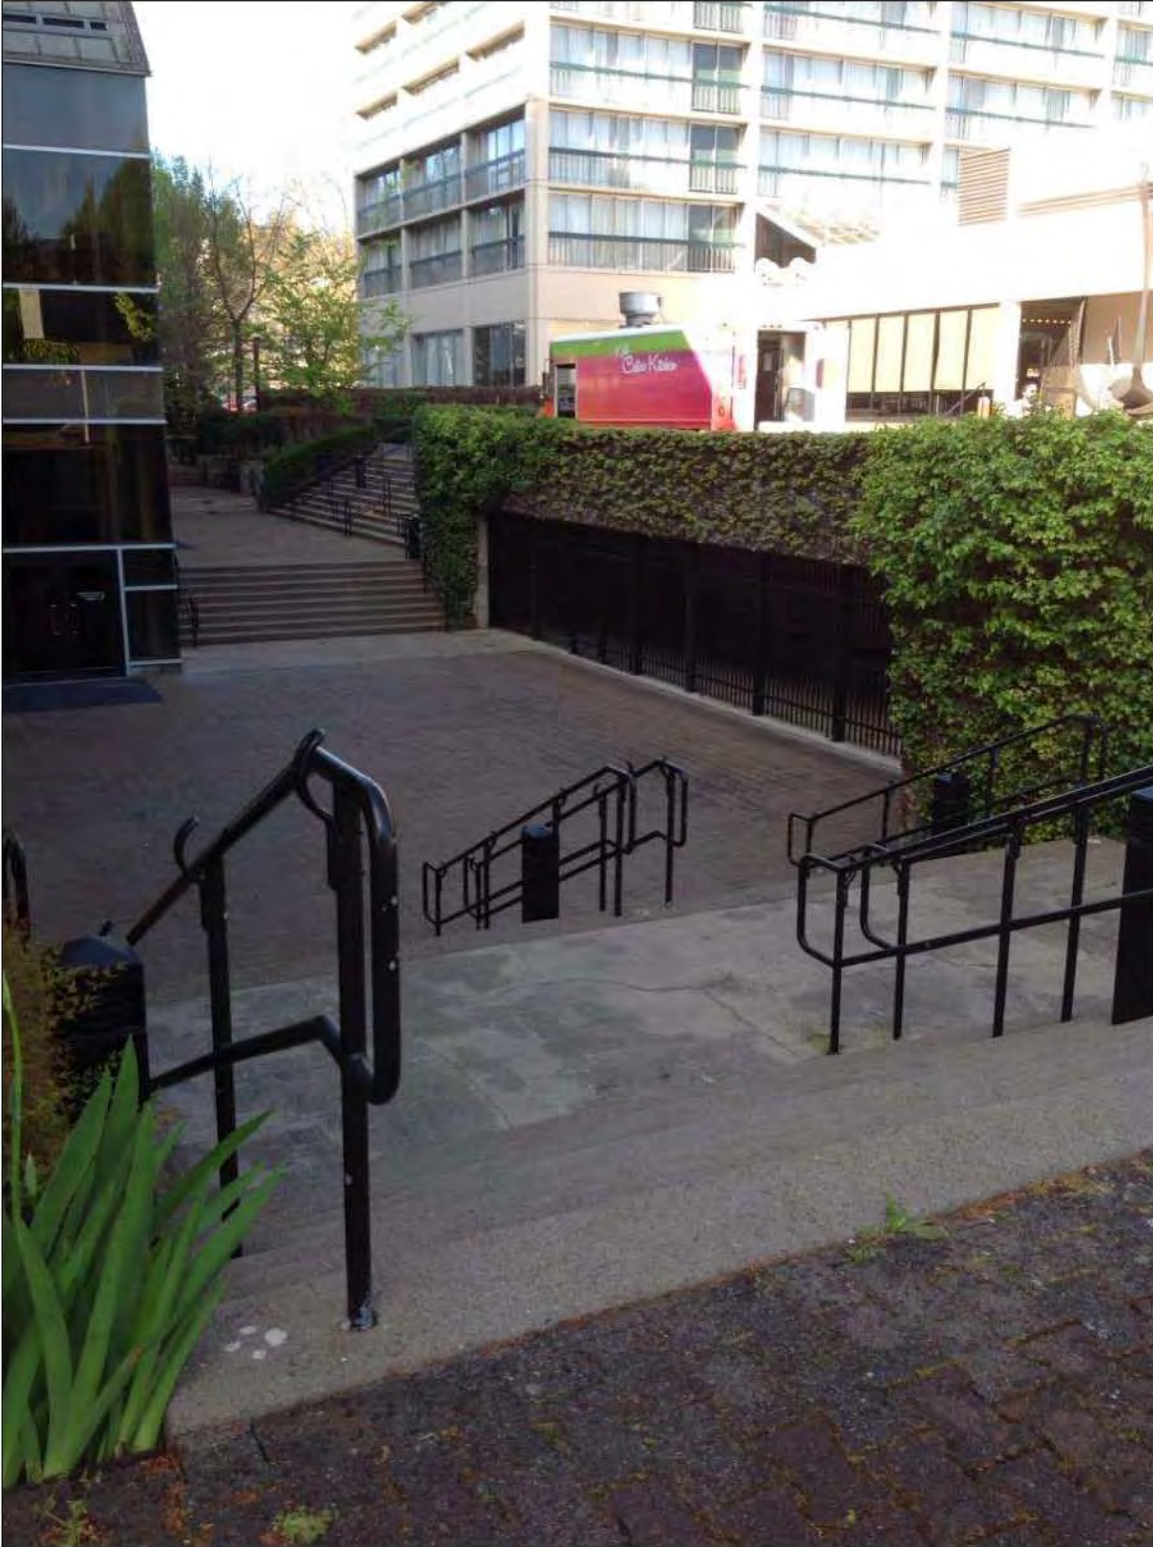
Photo: Image shows open space area, cracks in pavement in stairs landing, and bricks used to create pathways.

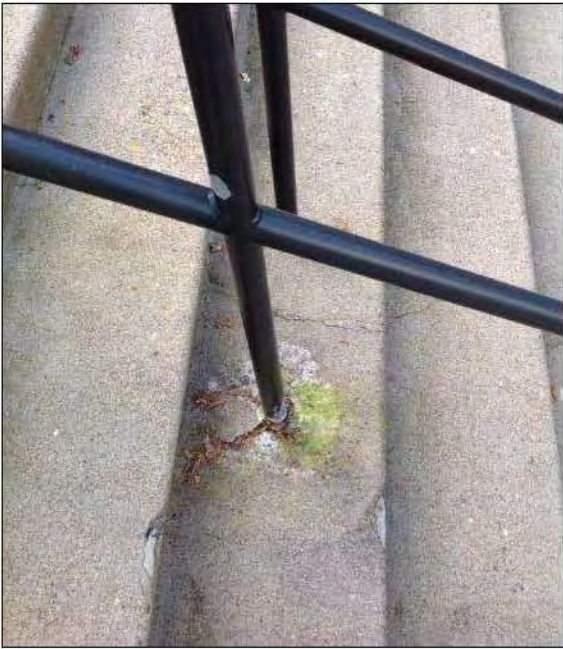
Property #47 images continued.

Photo: Top: image shows deterioration of steps; bottom: image shows cracks in cement of structure

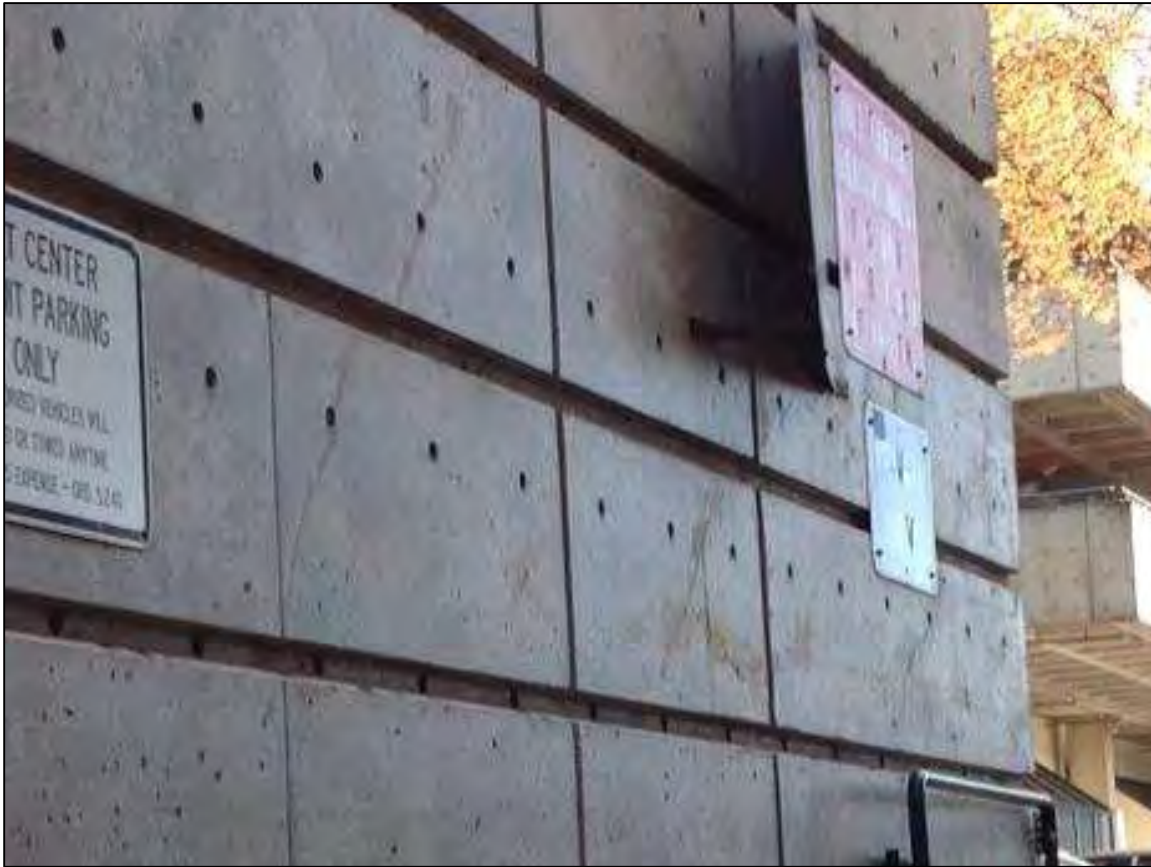
Photo: Image shows example of cracks along surface (diagonal lines).

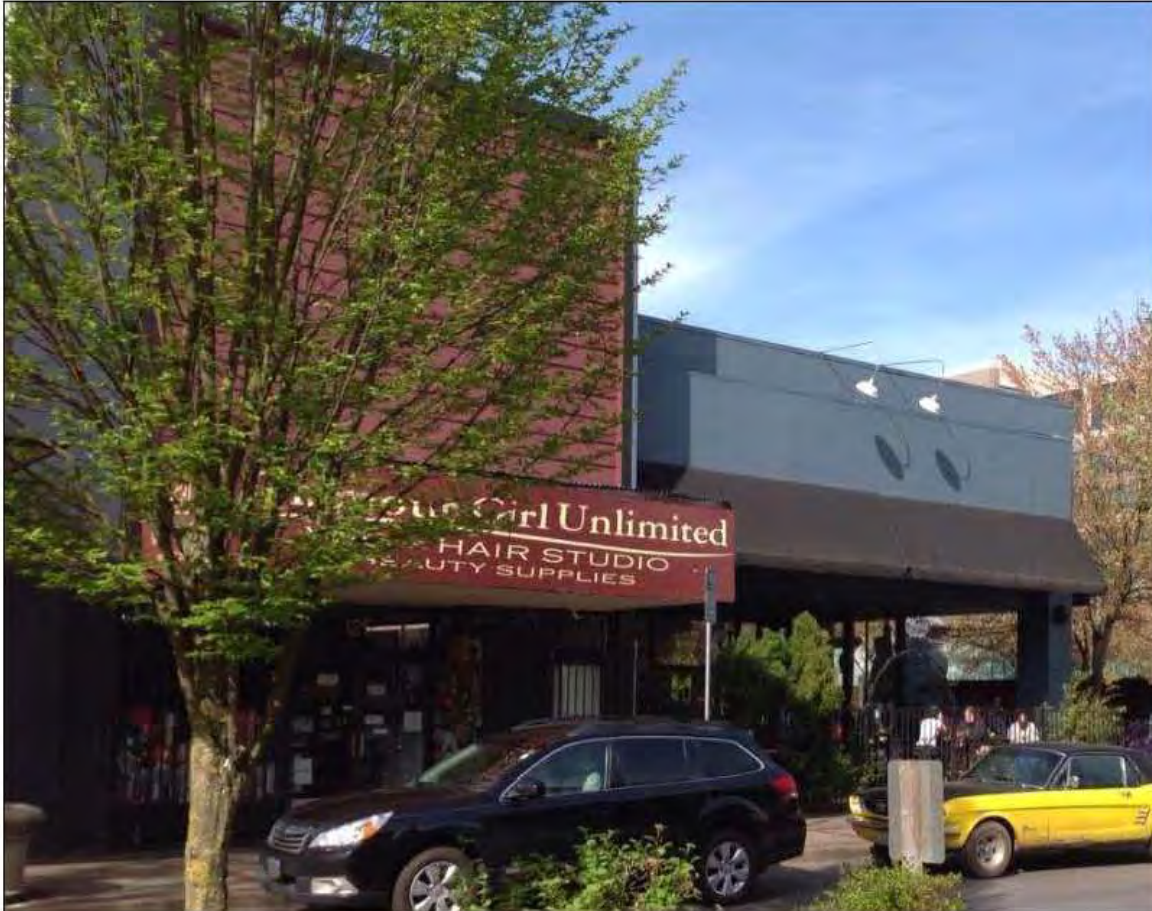
Photo: Top: view of property from Broadway; bottom: image shows damage to awning top.

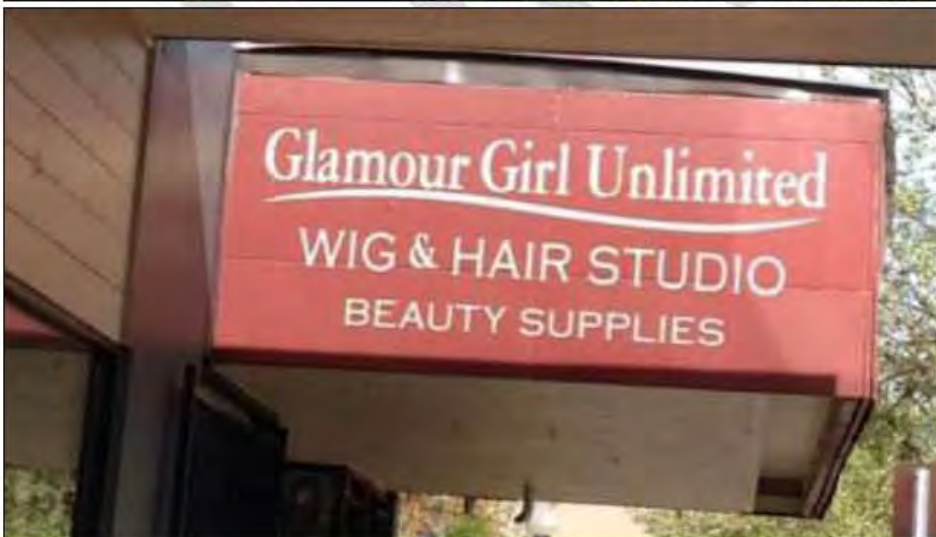
Property: 49	Name: Jamesons and Glamour Girls	Determination of Blight: Yes
Taxlot(s): 1703311304800		Depreciation Ratio: 1.65
Property Notes:	Building appears in good shape. Awning on Glamour Girls has damage along top section. Determination of blight based on ORS 457.010 (1)(g) and (h)

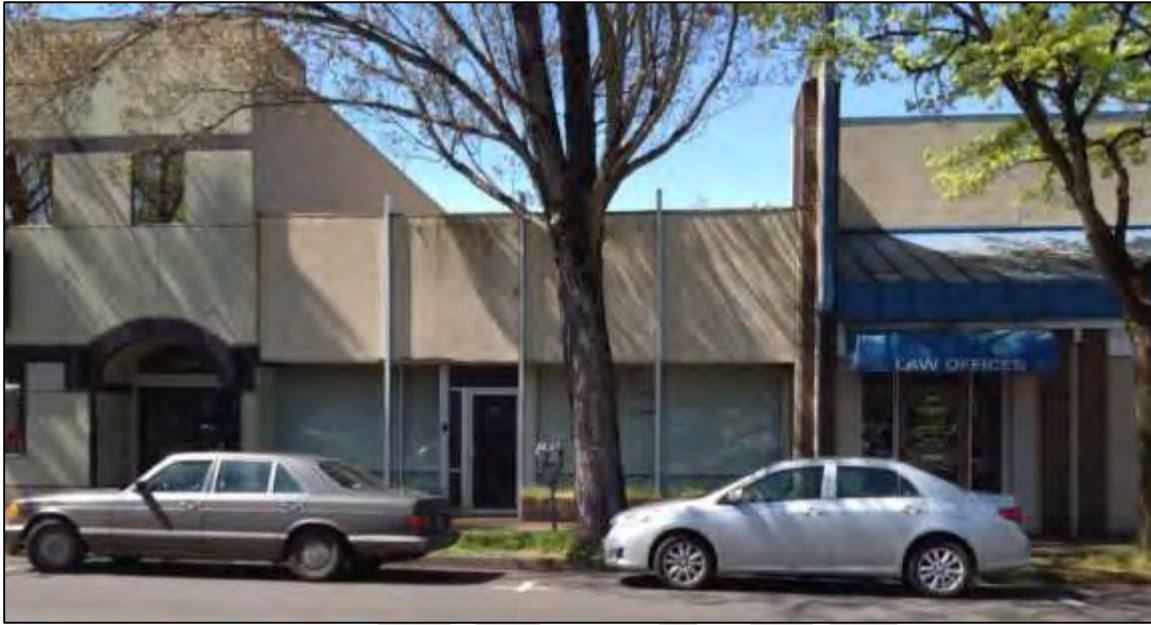
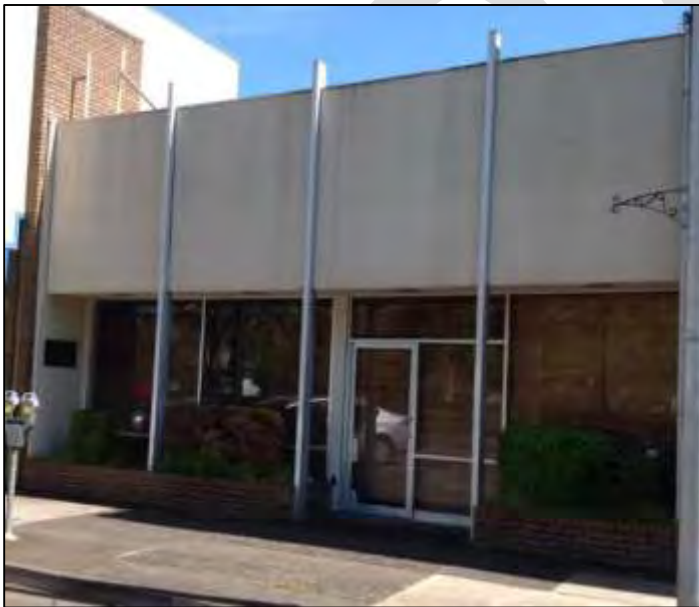
Property:	50	Name:	Jaqua & Wheatley Law Office	Determination of Blight:	Yes
Taxlot(s):	1703311402400			Depreciation Ratio:	3.44
Property Notes:	Building is in poor condition. There is moss growing out of a crack in front, the raised beds made of brick in front and back have garbage, are overgrown, and are damaged. The building is has closed up windows on both. Determination of blight based on ORS 457.010 (1), (g), and (h).

Photo: Top and bottom images shows front and back of building

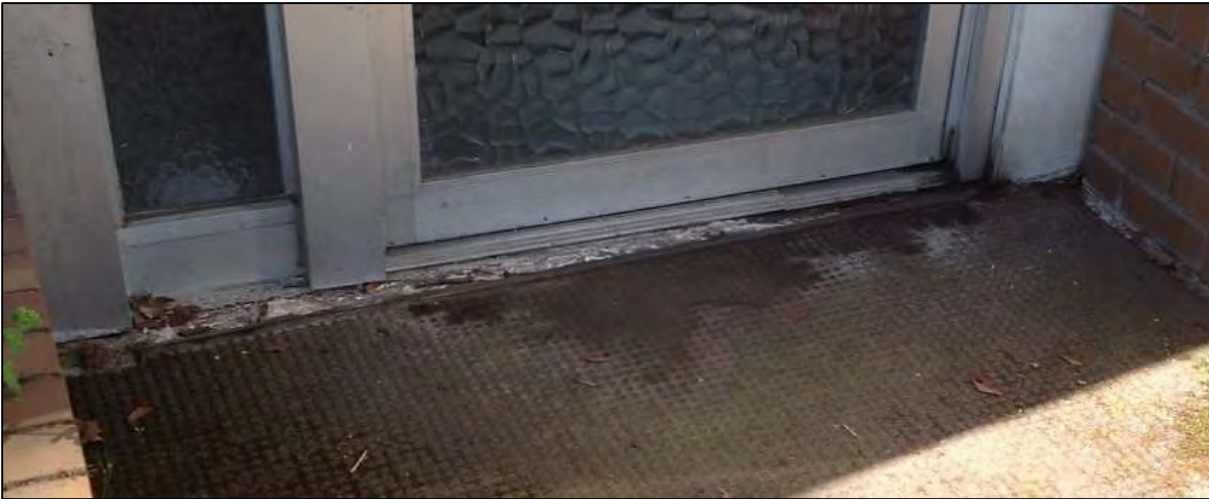
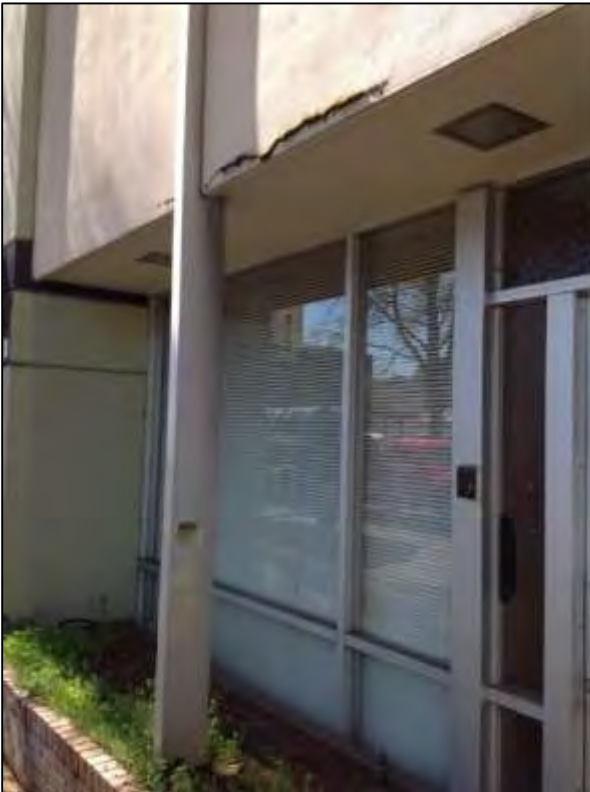
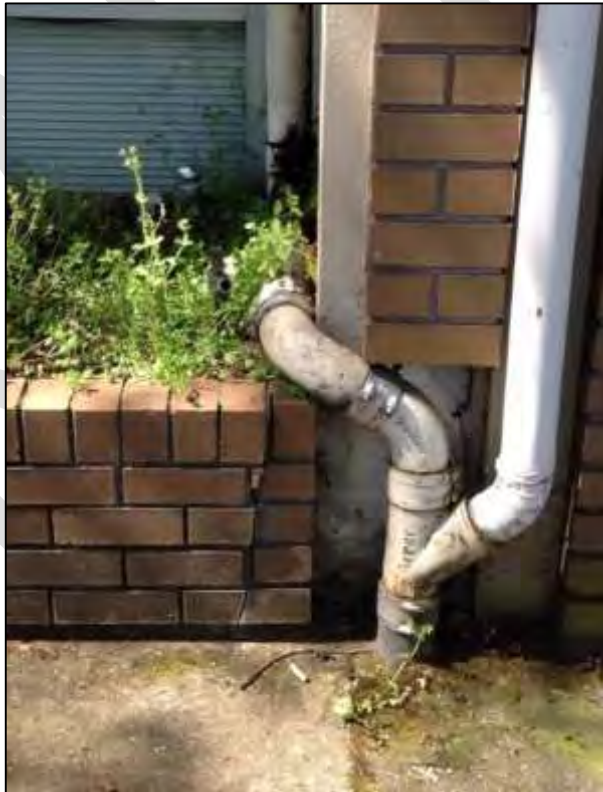
Property #50 images continued.

Photo: Top: damage at door base; bottom left: façade deterioration; bottom right: broken bricks, overgrown vegetation.

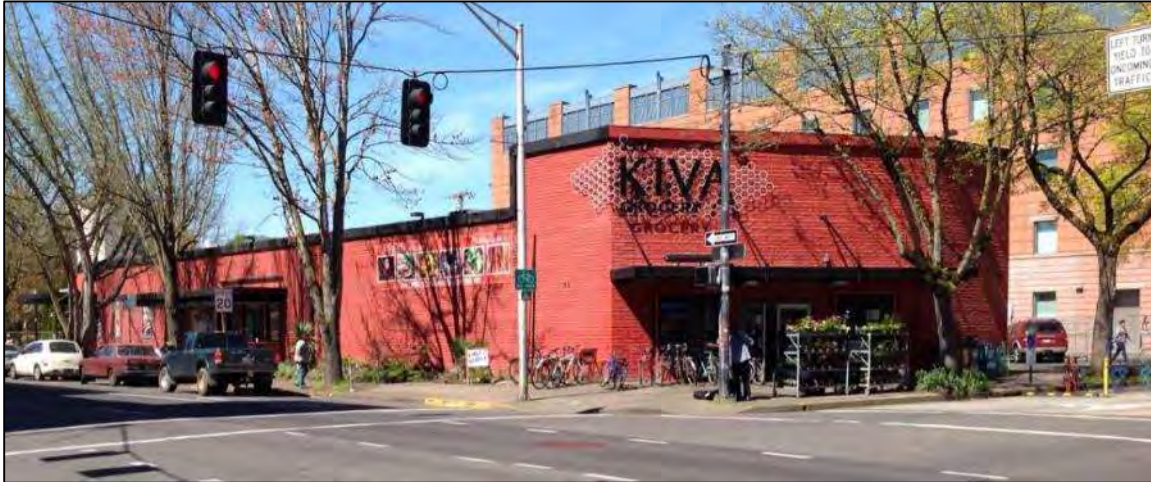
Property: 51	Name: Kiva Grocery	Determination of Blight:	Yes
Taxlot(s): 1703311306100		Depreciation Ratio:	1.73
Property Notes:	Property is in good condition. There are city installed artistic bike racks out front but the sidewalk outside of property in poor condition. The property includes a large parking area and is adjacent to 2 blighted properties. Determination of blight based on ORS 457.010 (1)(g) and (h).

Photo: View of property from 11th Avenue and Olive Street.

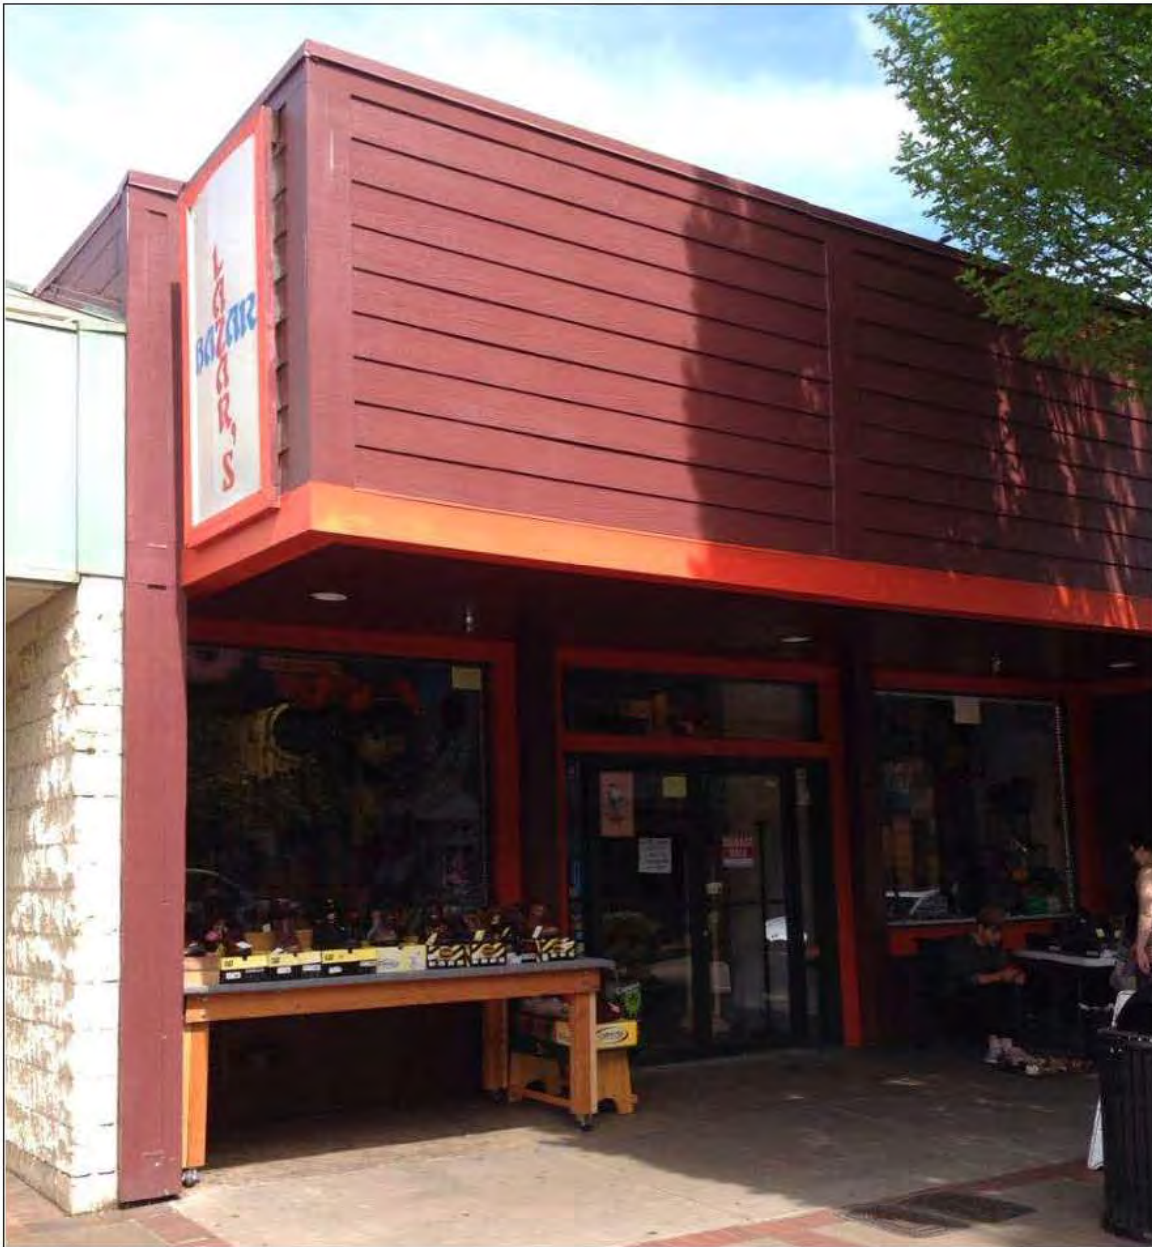
Property:	56a	Name:	Lazar's Bazaar (Shoe Closeout Center)	Determination of Blight:	Yes
Taxlot(s):	1703311303100			Depreciation Ratio:	2.13
Property Notes:	Building appears in good shape. The ground in front and back are worn. The rear entrance has torn up AstroTurf. Lot shape is very long and thin. Determination of blight based on ORS 457.010 (1)(c),(g), and (h).

Photo: Image shows front of property from Broadway.

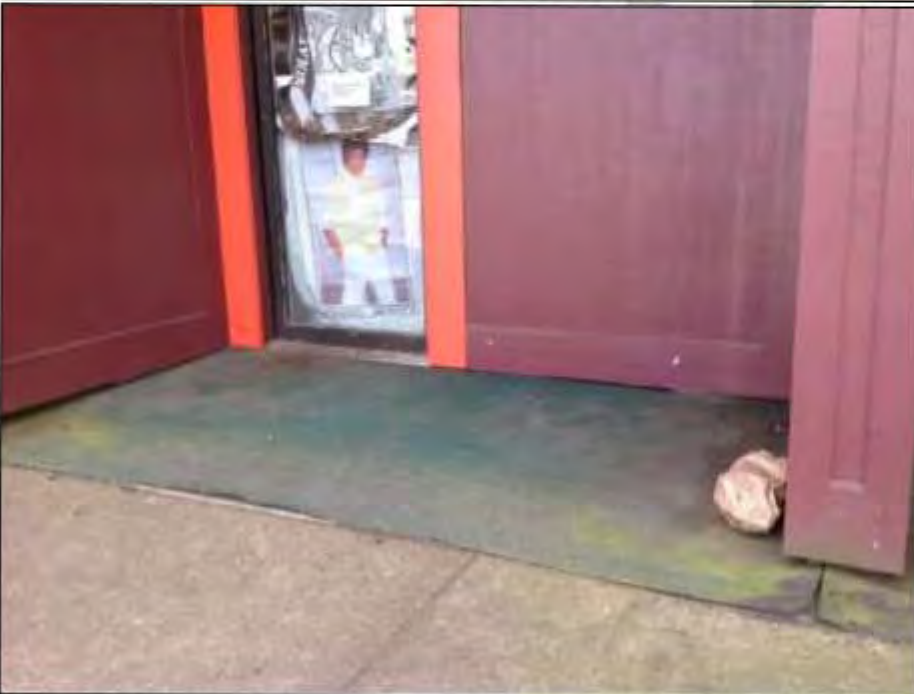
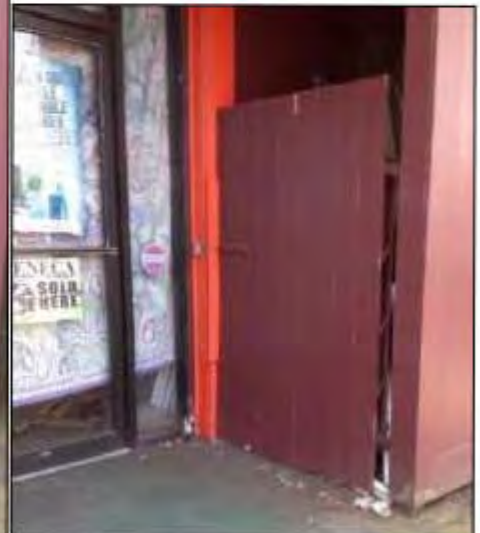
Property #56a images continued.

Photo: Top image shows back entrance of property; bottom: image shows close-up view of back entrance ground level; bottom right: shows back entrance storage area.

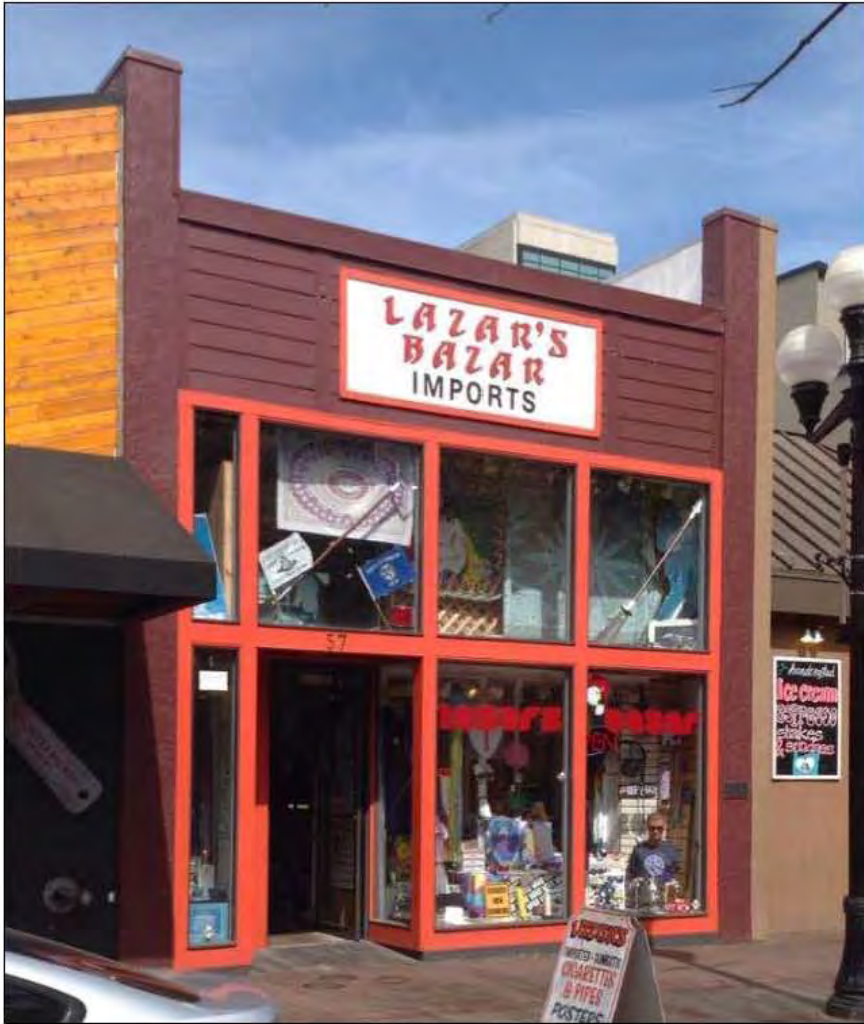
Photo: Top: front of building facing Broadway; bottom: front entrance wear.

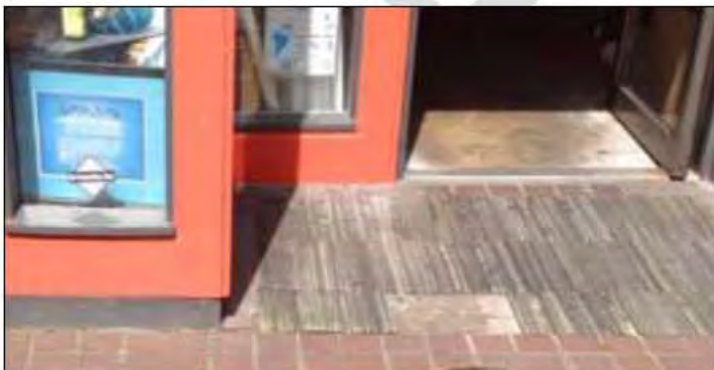
Property: 56b	Name: Lazar's	Determination of Blight:	Yes
Taxlot(s): 1703311303300		Depreciation Ratio:	2.88
Property Notes:	Building appears in good condition. The front entrance has some minor wear. This property is related to property #56a, a store on the same property, one business to the west. Lot shape is long and very thin. Determination of blight based on ORS 457.010 (1)(c), (g), and (h).

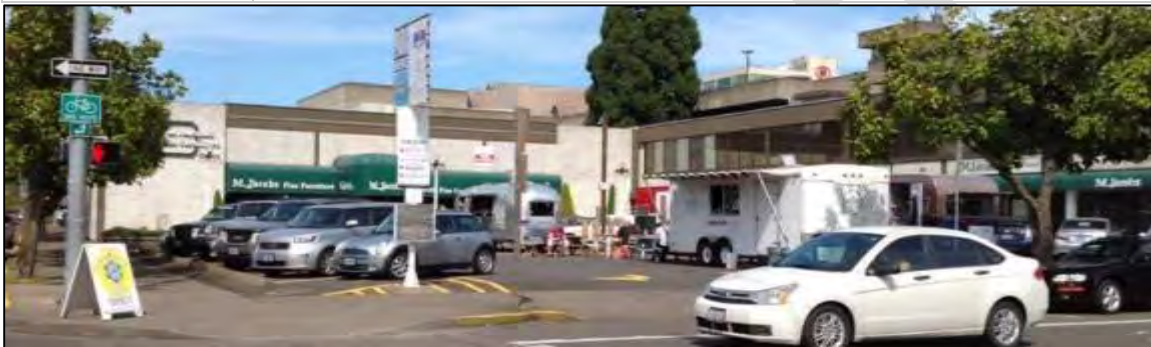
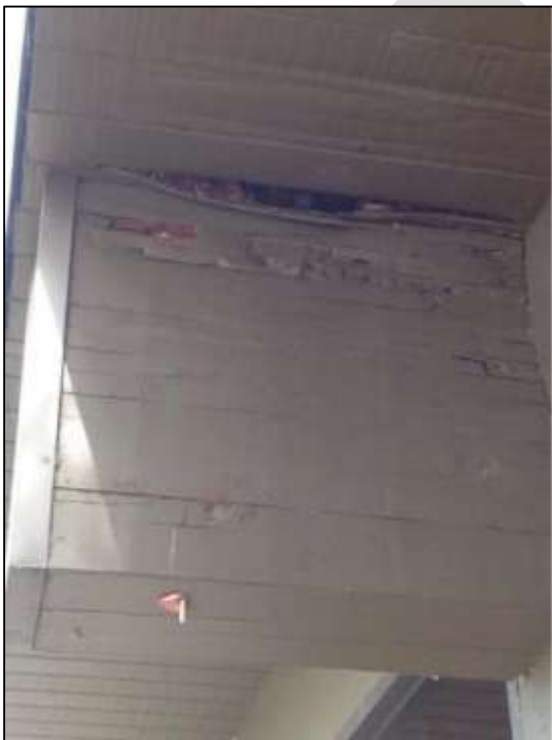
Property Notes: Property is in fair condition. Property consists of a large building and multiple parking lots. The building contains multiple businesses, the north parking lot is a paid parking lot, and the southern lot is general parking and has food carts. The building has fresh paint and shows signs of deterioration, including wood rot on exterior, and a concave sidewalk that could also be an accessibility area. Building deterioration also includes the outdoor walkway ceiling panels are broken and falling out in places, a light with electrical wires showing, and a broken drainpipe on alley. The parking lot is made up of multiple lots with irregular shapes. Lot is used for food carts, sometimes, or is vacant and represents 1/4 block underutilized space. Determination of blight based on ORS 457.010 (1)(a)(A), (c), (g), and (h).

Photo: Top: View of property from East 8th Avenue and Olive Street; bottom images show damaged wood on structure.
