**Summary of Council Discussions/Actions
on Downtown Improvements**

Map to Accompany Downtown Urban Renewal Slums and Blight Report 2016

Downtown Urban Renewal District – Determination of Slums and Blight - Detailed Property Survey

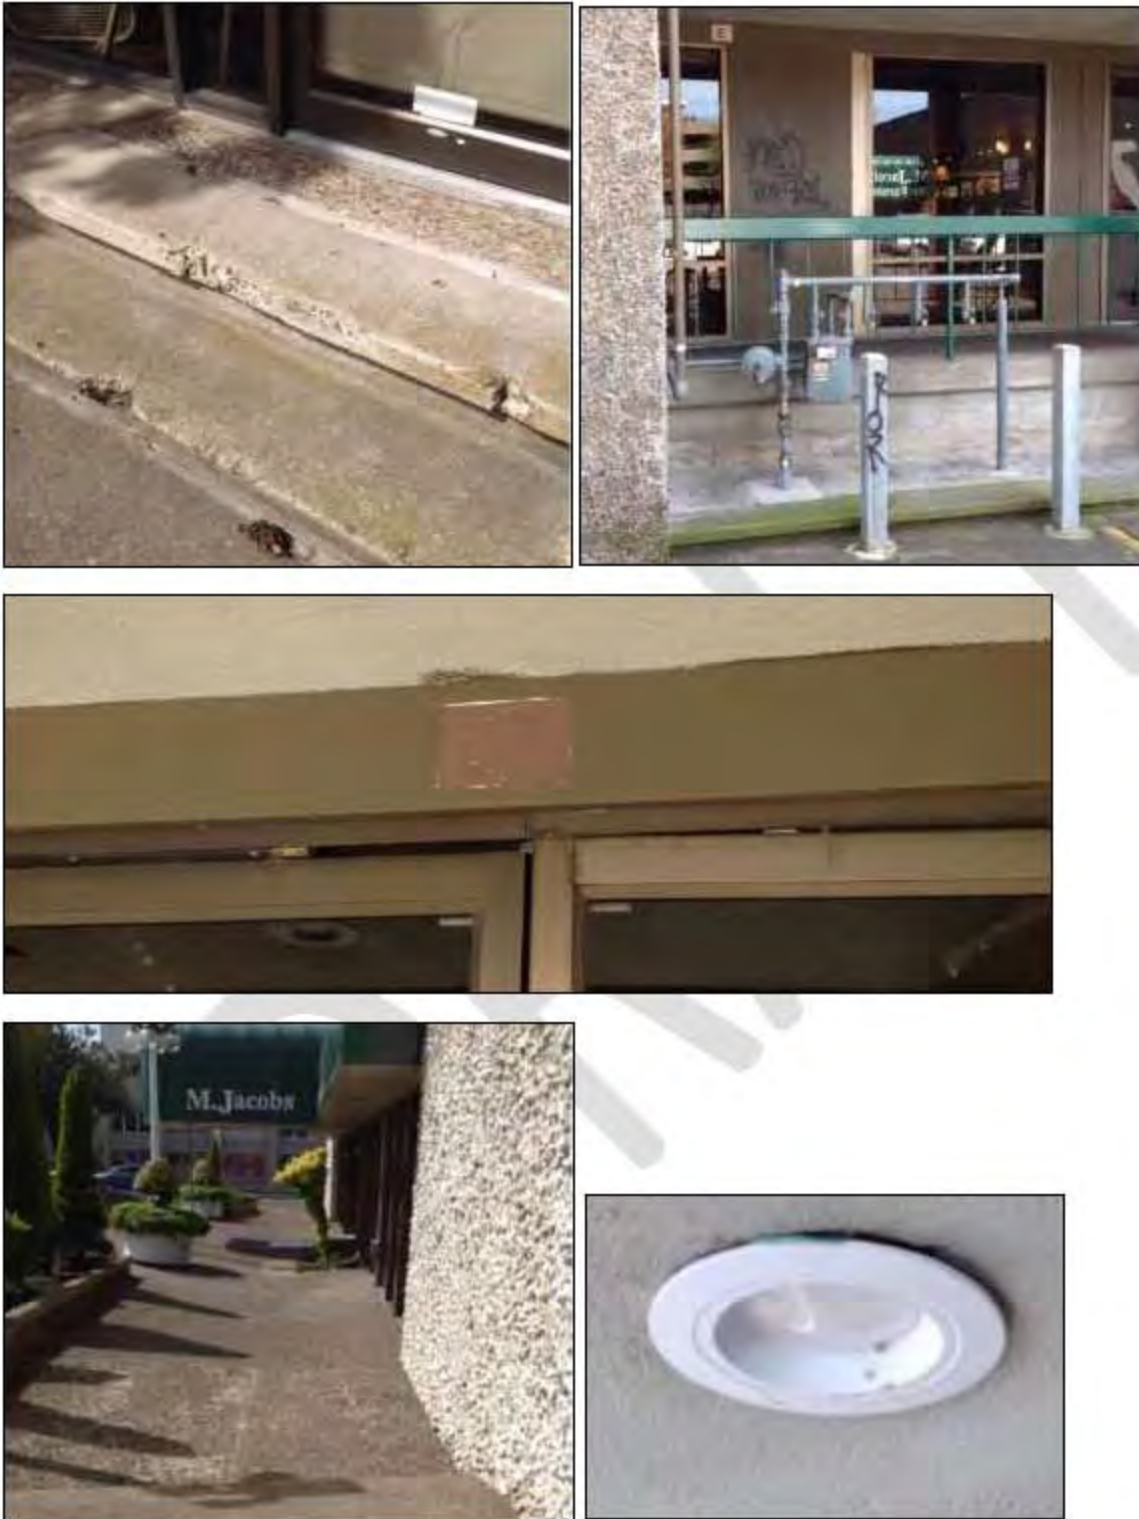
Photo: Top left: example of deteriorated cement; top right: property damage; middle: top of exterior door that is mis-aligned with structure; bottom left: entrance with concave entryway; bottom right: outside light fixture with wires exposed.

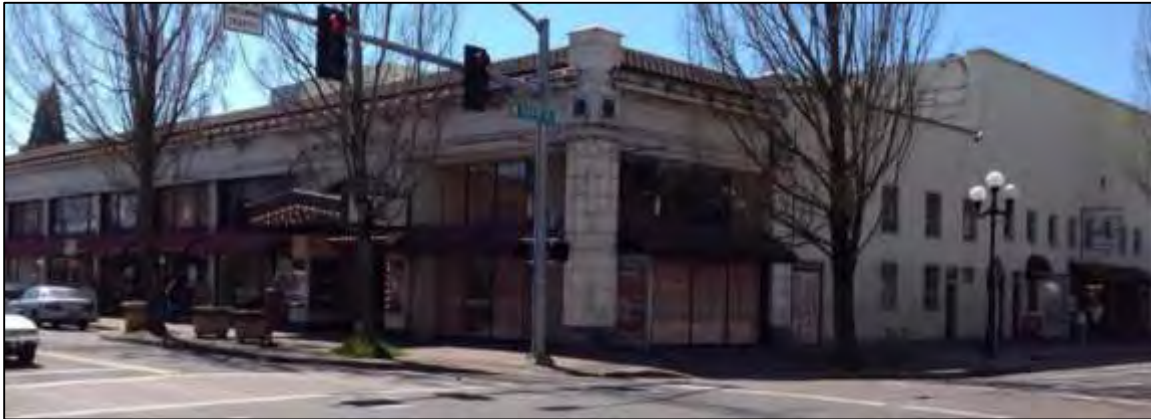
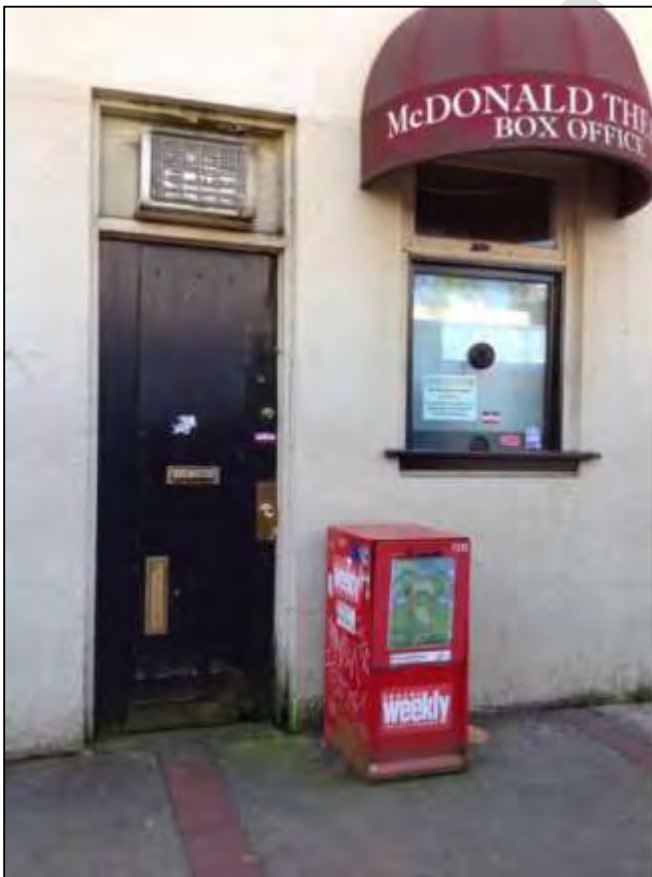
Property: 62	Name: McDonald Theater building	Determination of Blight: Yes
Taxlot(s): 1703311301900		Depreciation Ratio: 1.34
Property Notes:	Property is in fair condition. Property contains a large building that holds not only the Theater, but also a restaurant and several shops, there are also some vacant storefronts with windows covered. The building has cracks along surface on West 10th Avenue. This section also has rot visible in a door, poor quality, and mildew/moss on building edge and a drainage pipe has no connection to drain. Determination of blight based on ORS 457.010 (1)(a)(E) and (g).

Photo: Top: View of property from West 10th Avenue and Willamette Street; bottom: shows example of damage on building, especially where the door meets the sidewalk

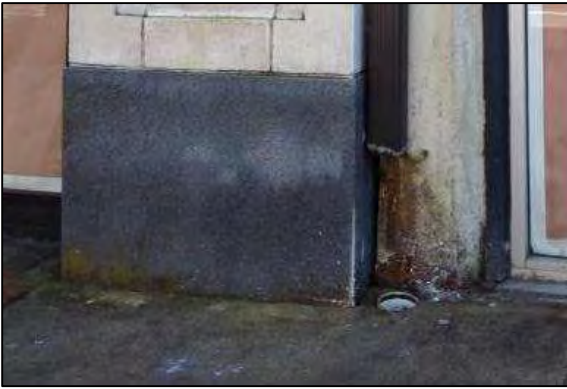
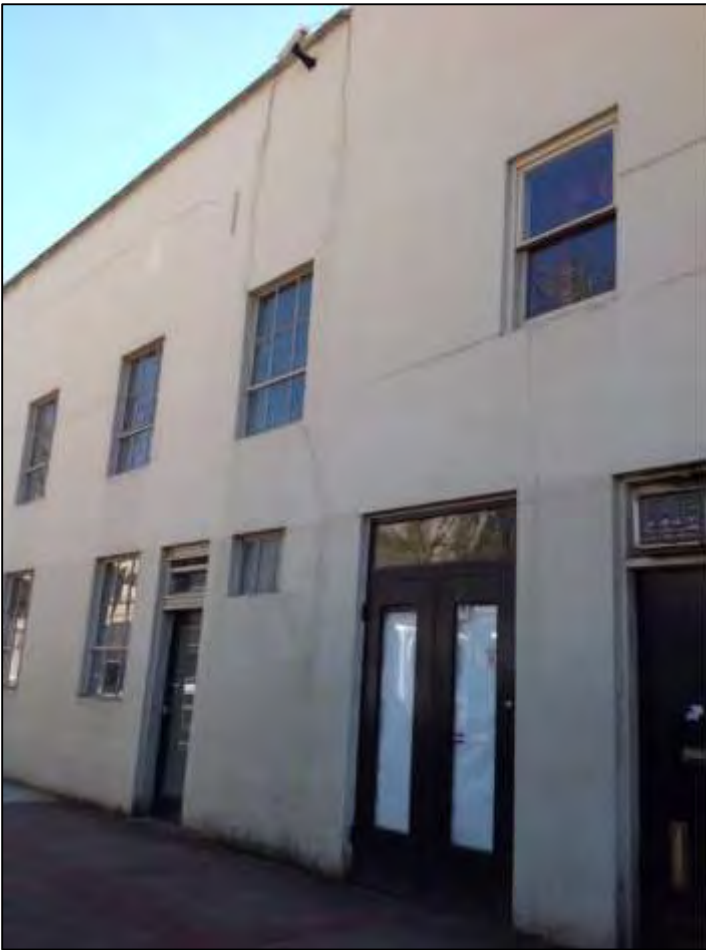
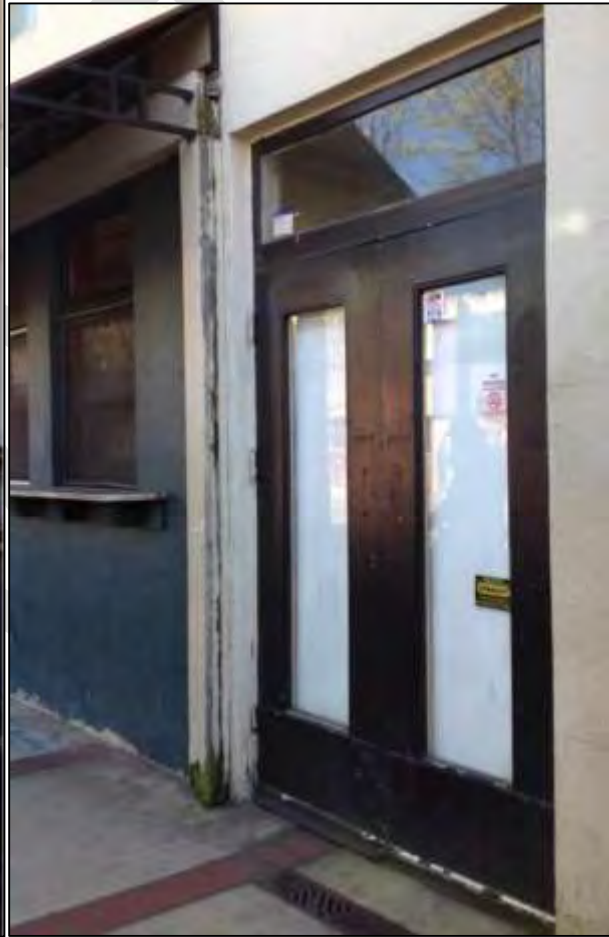
Property #62 images continued.

Photo: Top: image shows where drainpipe does not meet drainage; bottom left: shows cracks in building surface; bottom right: shows damage and deterioration in building.

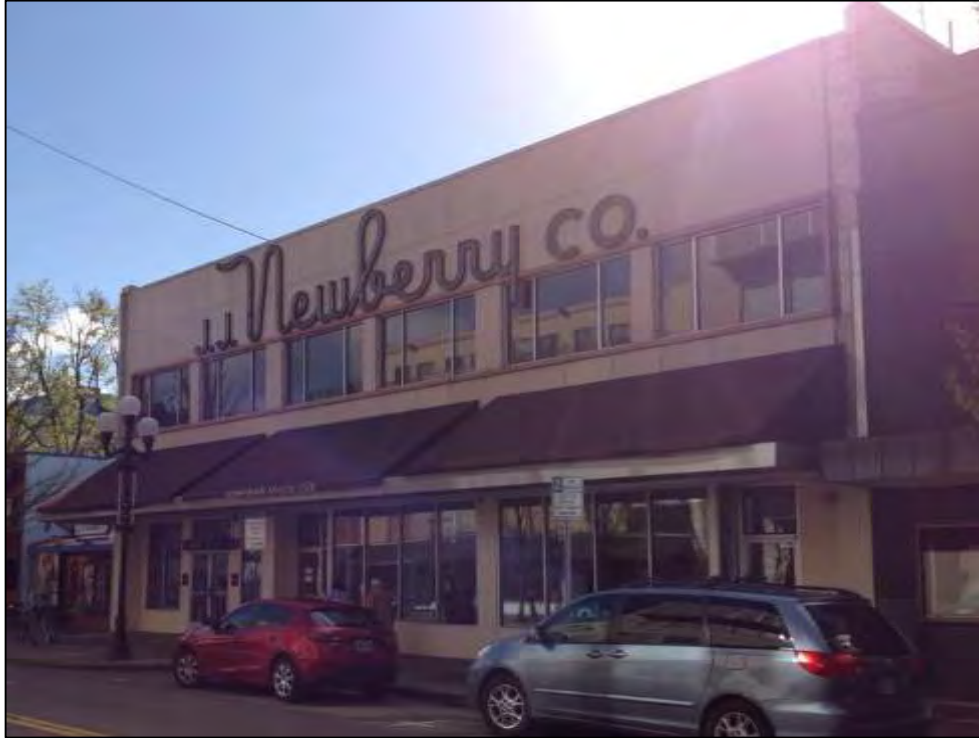
Property: 63	Name: Newberry's	Determination of Blight:	Yes
Taxlot(s): 1703311301700		Depreciation Ratio:	2.25
Property Notes:	Building appears in good condition. Building is in good shape at ground floor, and upper levels seem to have more wear around windows. Determination of blight based on ORS 457.010 (1)(g).

Photo: View of property from Willamette Street.

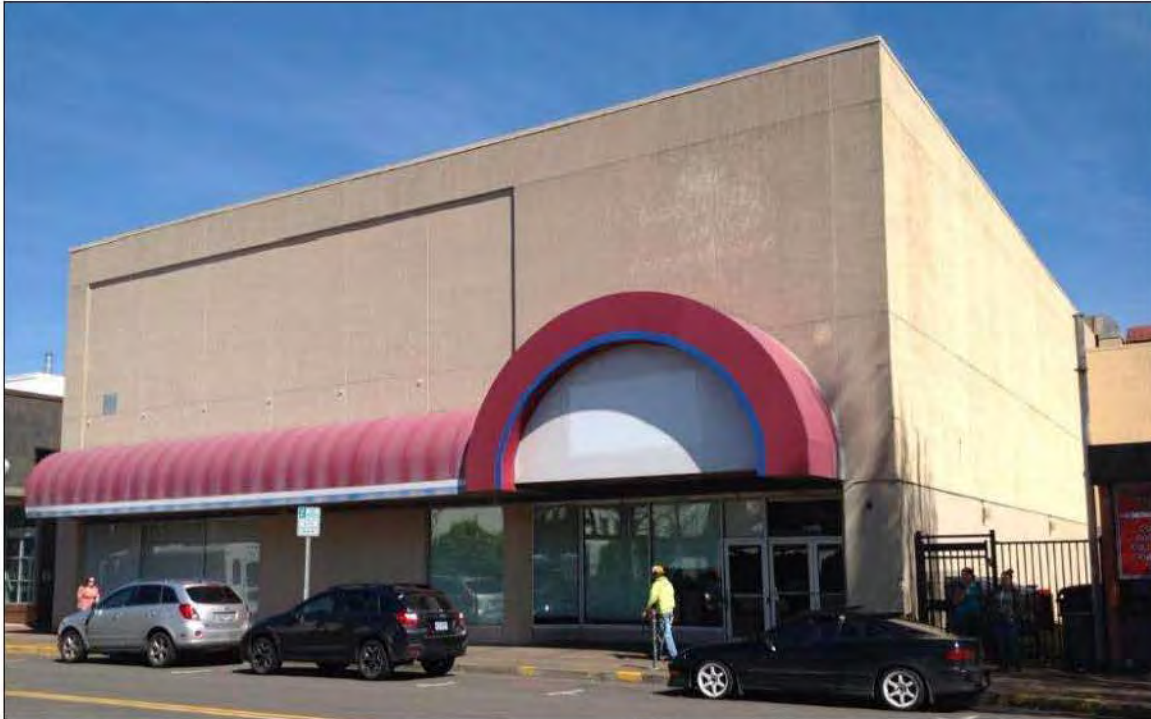
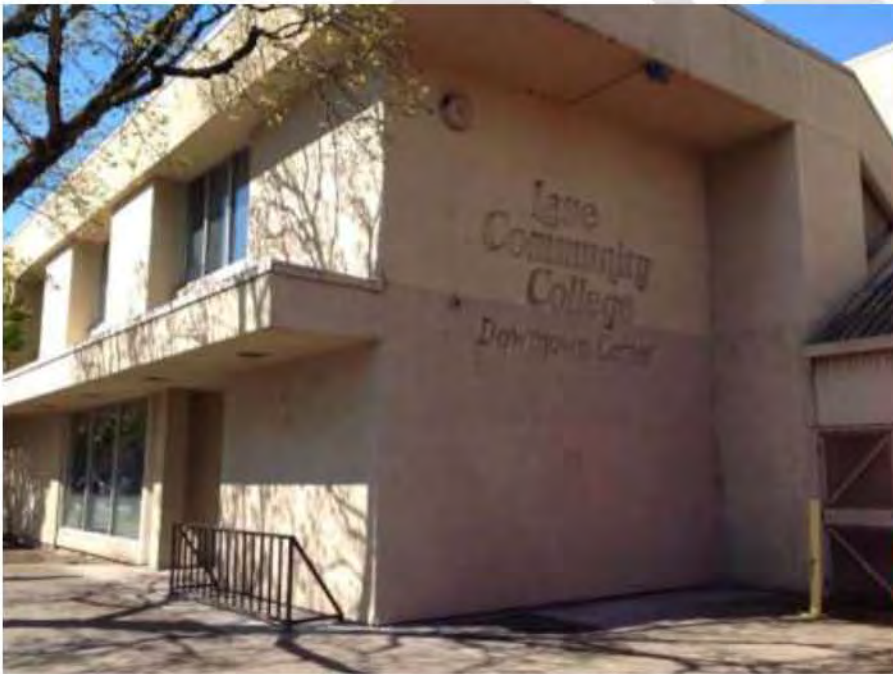
Property: 65	Name: Old LCC Downtown Building	Determination of Blight: Yes
Taxlot(s): 1703311412800		Depreciation Ratio: 6.54
Property Notes:	Property is in fair condition. Property consists mainly of the building, which is large, vacant, and lacks windows.. Determination of blight based on ORS 457.010 (1)(a)(E), (b), (h), and (i).

Photo: Top: view of property from Willamette Street; bottom: view of property from East 11th Avenue.

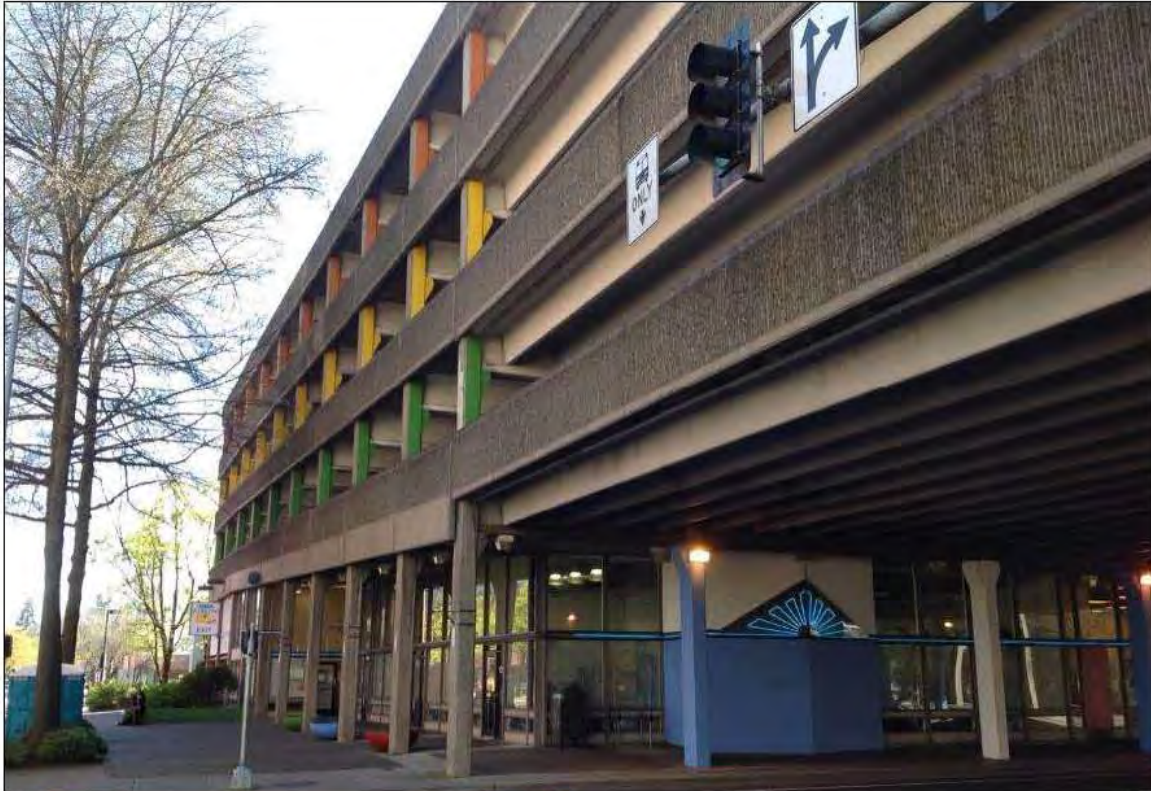
Photo: Top: View of property from East 10th Avenue; bottom: example of oversize pedestrian walkways and underutilization of space.

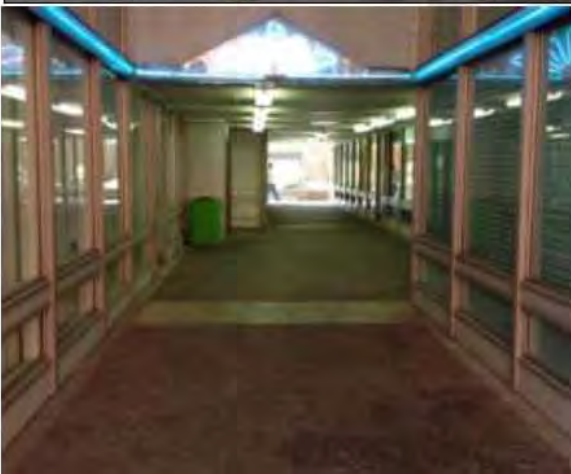
Property: 66	Name: Overpark Garage South	Determination of Blight: Yes
Taxlot(s): 1703311412300		Depreciation Ratio: 5.12
Property Notes:	Property is in good condition. This is a cement parking garage with ground floor commercial, including a dance studio and gym. Property contain oversized pedestrian walkways that are underutilized space. Determination of blight based on ORS 457.010 (1)(h).

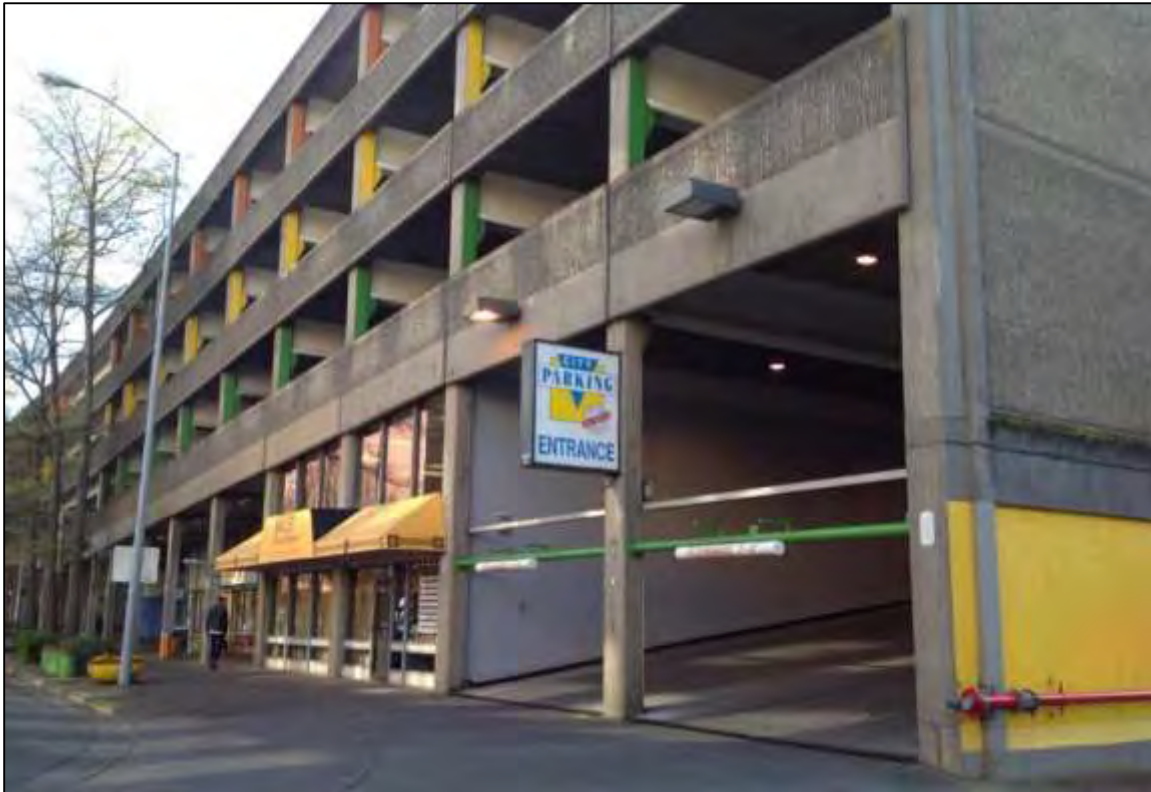
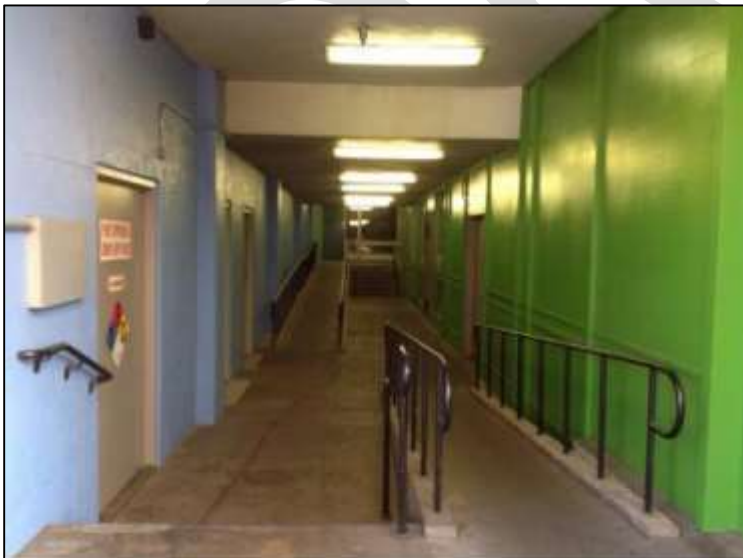
Property:	67	Name:	Overpark Garage North	Determination of Blight:	Yes
Taxlot(s):	1703311405800			Depreciation Ratio:	4.42
Property Notes:	The property is in good shape. Property is a cement parking garage that extends over East 10 th Avenue, connecting with Property 66. This property has ground floor commercial. The building has underutilized and poorly designed spaces that were formerly public restrooms and open space in pedestrian pathways. Determination of blight based on ORS 457.010 (1)(a)(E), (b), (h) and (i).

Photo: Top: view of property from Oak Street; bottom: area with closed restrooms and example pedestrian walkways.

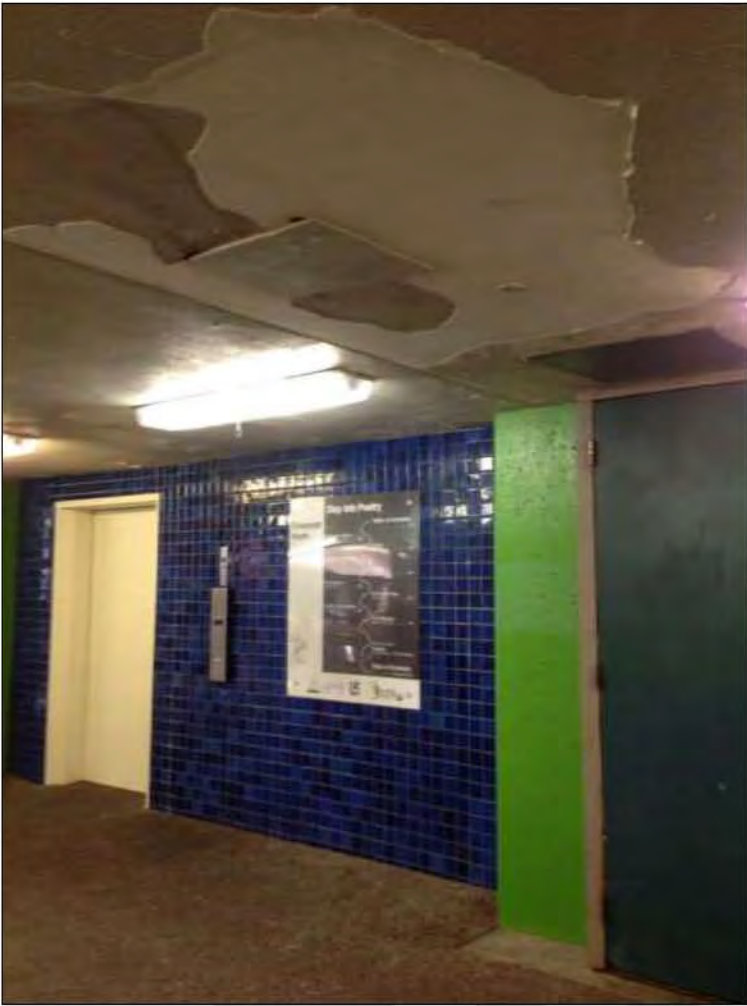
Photo: Top: example of building condition in interior pathways; bottom: view of alley and area of access to pedestrian walkway to restroom.

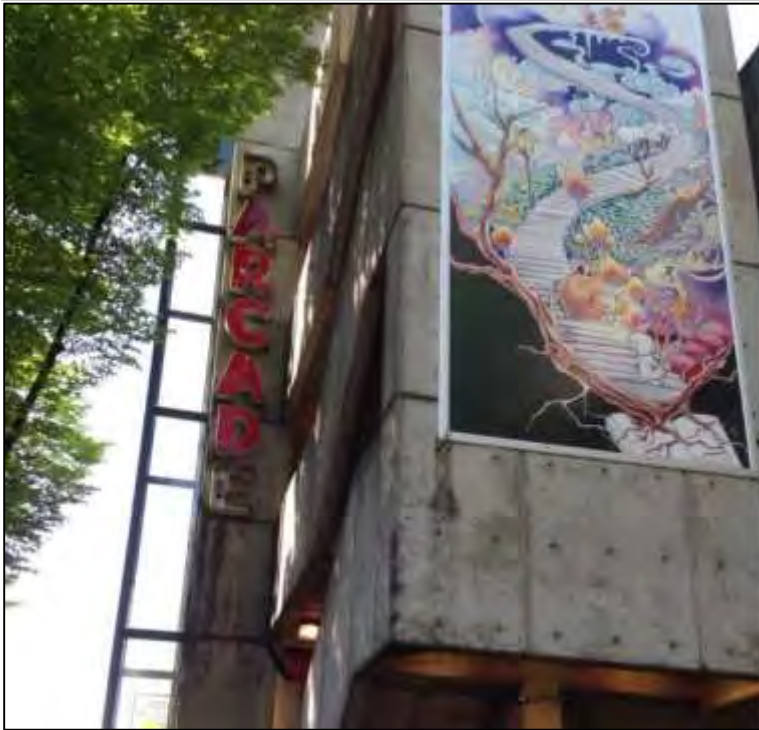
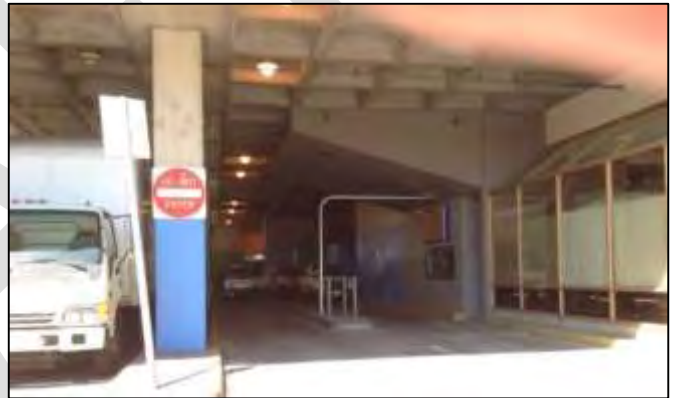
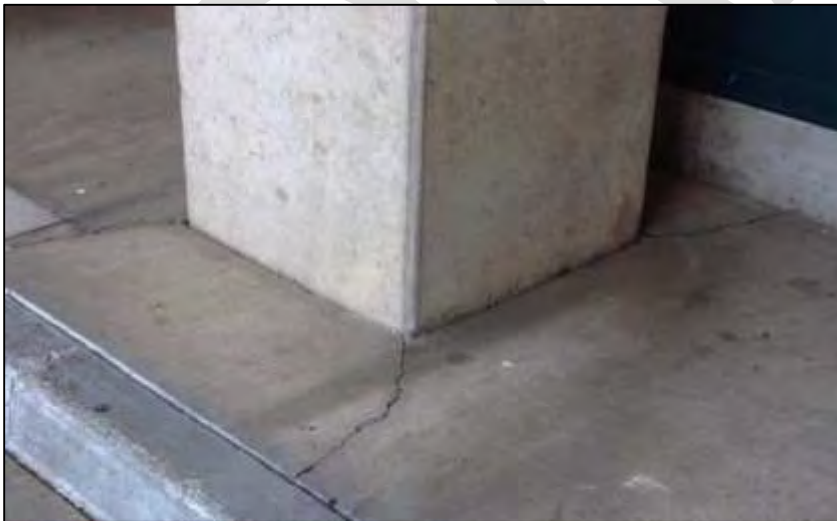
Property: 70	Name: Parcade	Determination of Blight: Yes
Taxlot(s): 1703311216801		Depreciation Ratio: 2.58
Property Notes:	Property is in fair condition. Property is a large, older parking garage with ground floor commercial. The garage building appears deteriorated with broken signs, wood areas at street level are broken and look damaged, there are large cracks at the base of the large cement pillars, and the garage surface has areas with deterioration and wear. The sidewalk space near the bars small. The property has a large interior open space that looks like it is used by City maintenance crews, this is potentially underutilized space. Determination of blight based on ORS 457.010 (1)(a)(A) and (g).

Photo: Top left: image shows broken sign; top right: large open space; bottom: image shows cracks at base of pillar.

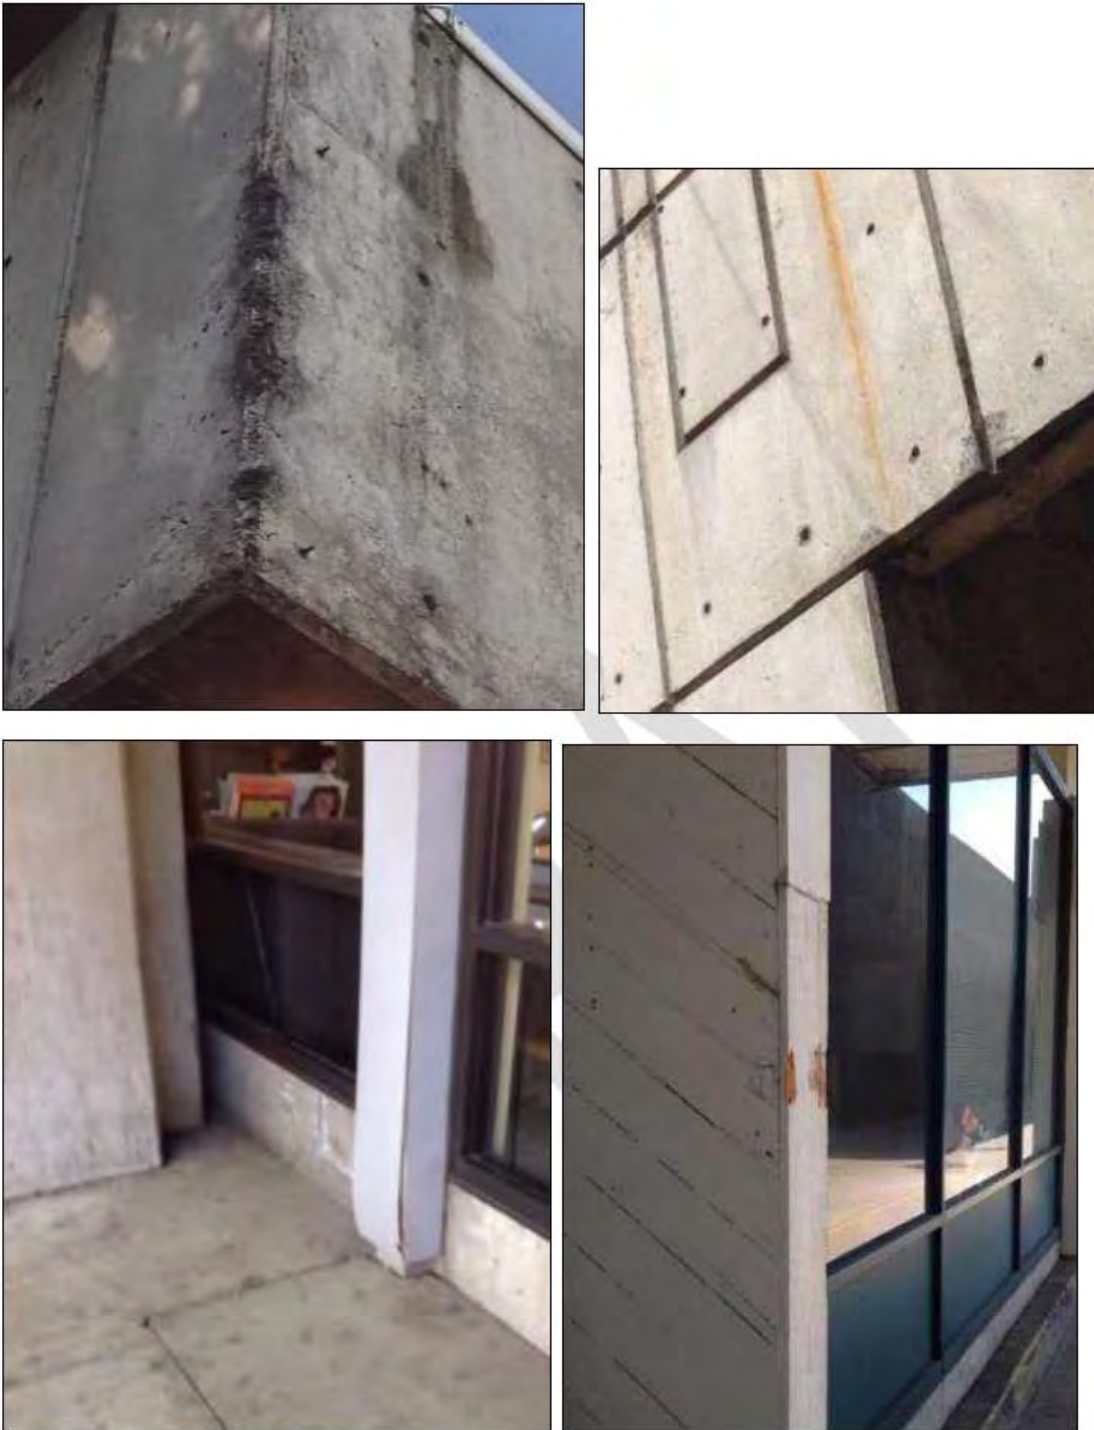
Photo: Top: examples of damage on exterior of structure; bottom: images showing examples of façade damage.

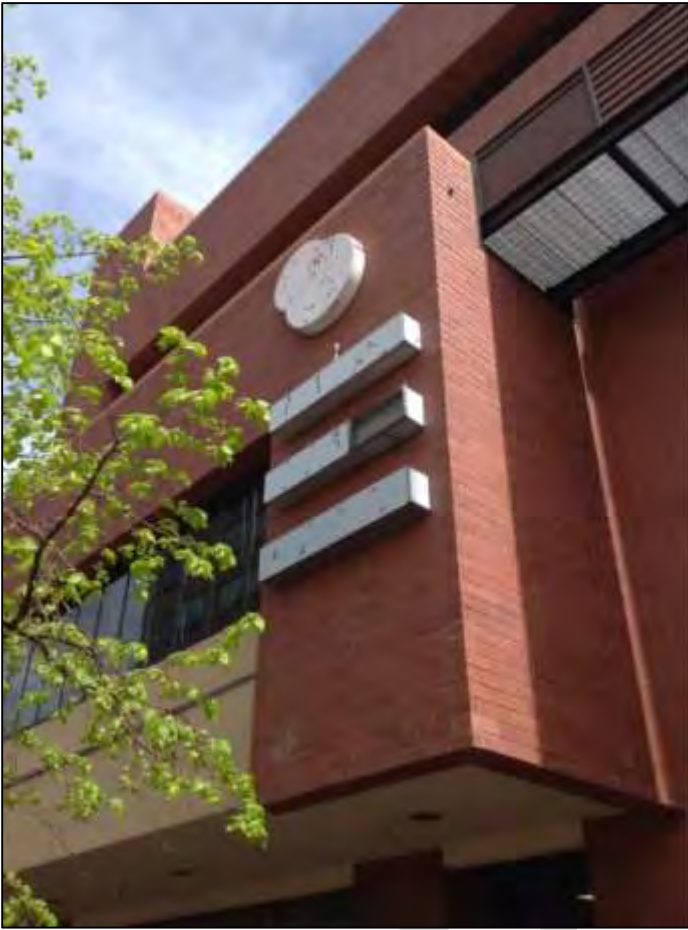
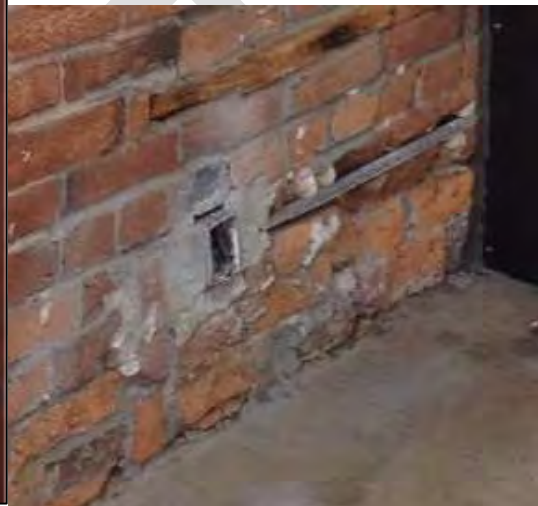
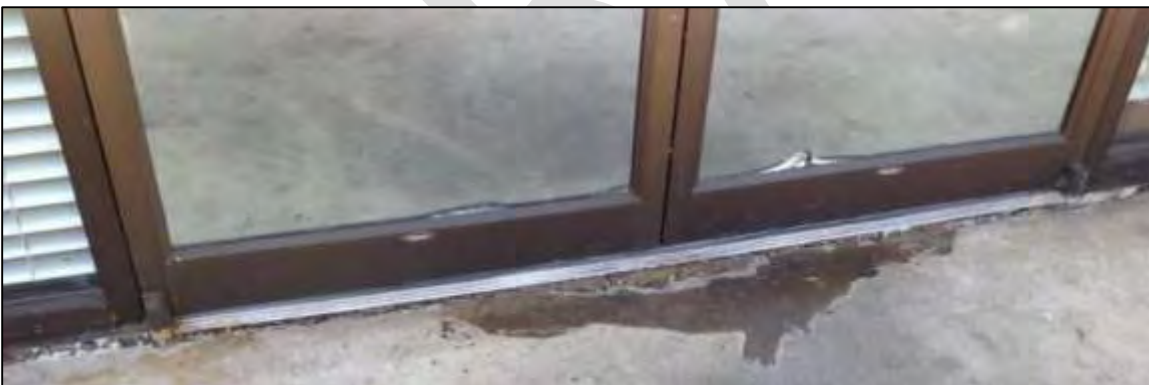
Property #62 images continued.

Photo: Top left shows where sign was partially removed; top right: damaged exterior brick work; bottom: damaged entryway.

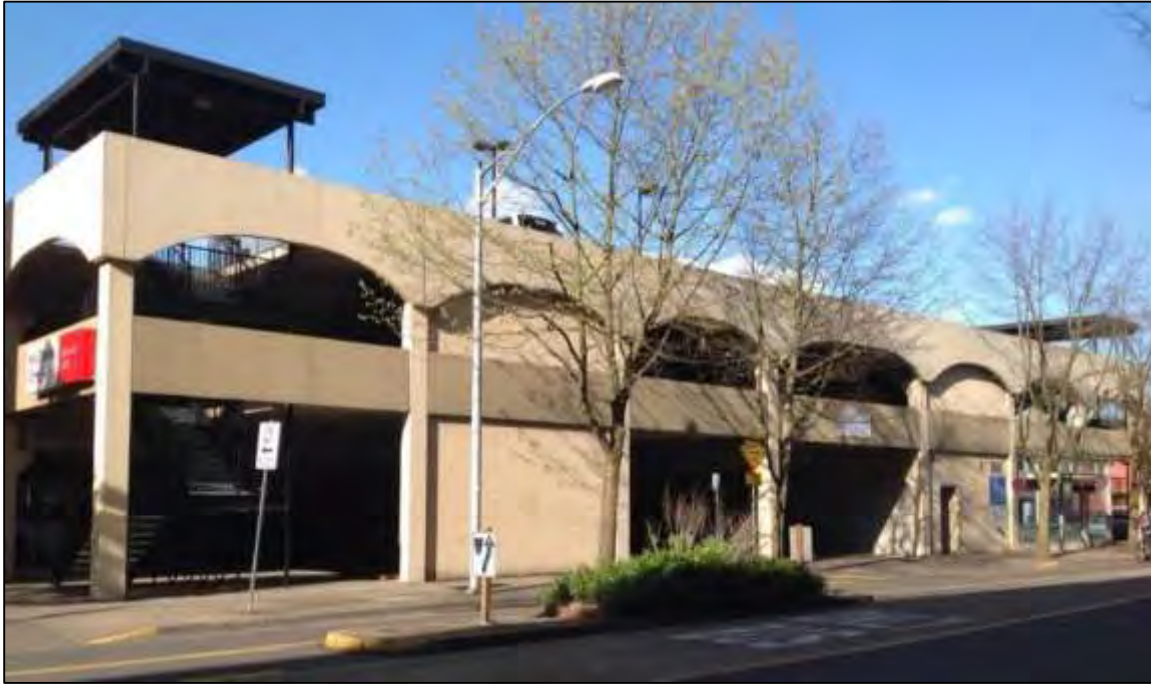
Photo: Top: view of property from Pearl Street; bottom photo shows ramp with questionable angle for accessibility.

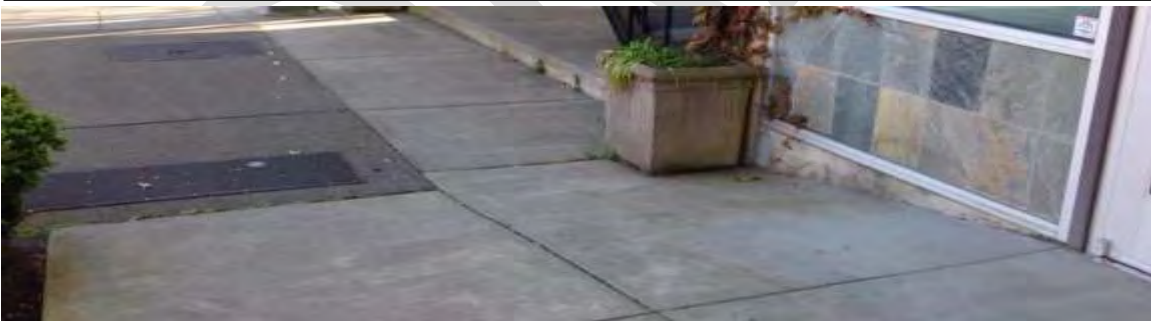
Property:	76	Name:	Parking and Commercial		Determination of Blight:	Yes
Taxlot(s):	1703311407401	1703311407402	1703311407403	1703311407409	Depreciation Ratio:	N/A
	1703311407403	1703311407404	1703311407410			
	1703311407405	1703311407406	1703311407411			
	1703311407407	1703311407408	1703311407412	1703311407413		
Property Notes:	Property is in good condition. The property is a parking garage with ground floor commercial which appears over mostly vacant. There is a ramp on the sidewalk with a questionable angle. Property is underutilized Determination of blight based on ORS 457.010 (1)(h).

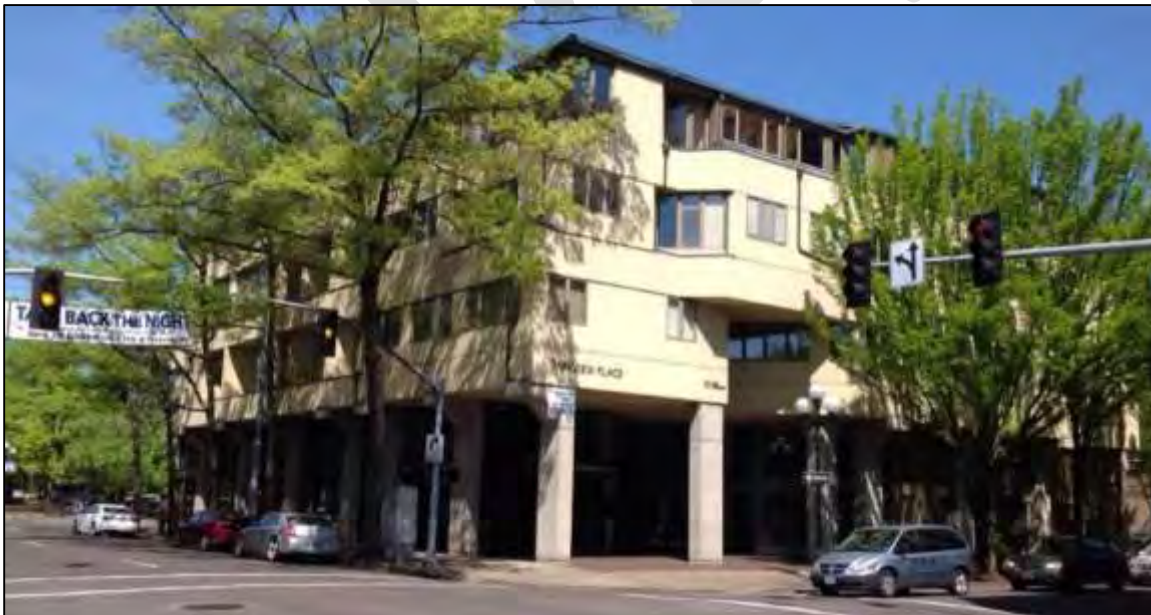
Property: 78	Name: Parkview Place	Determination of Blight:	No
Taxlot(s): 1703311402900		Depreciation Ratio:	7.98
Property Notes:	Property appears in good condition. The building is older and has a few spots where cement looks worn. The Building also has wood which appears buckled under one window.

Photo: View of property from East Broadway and Oak Street.

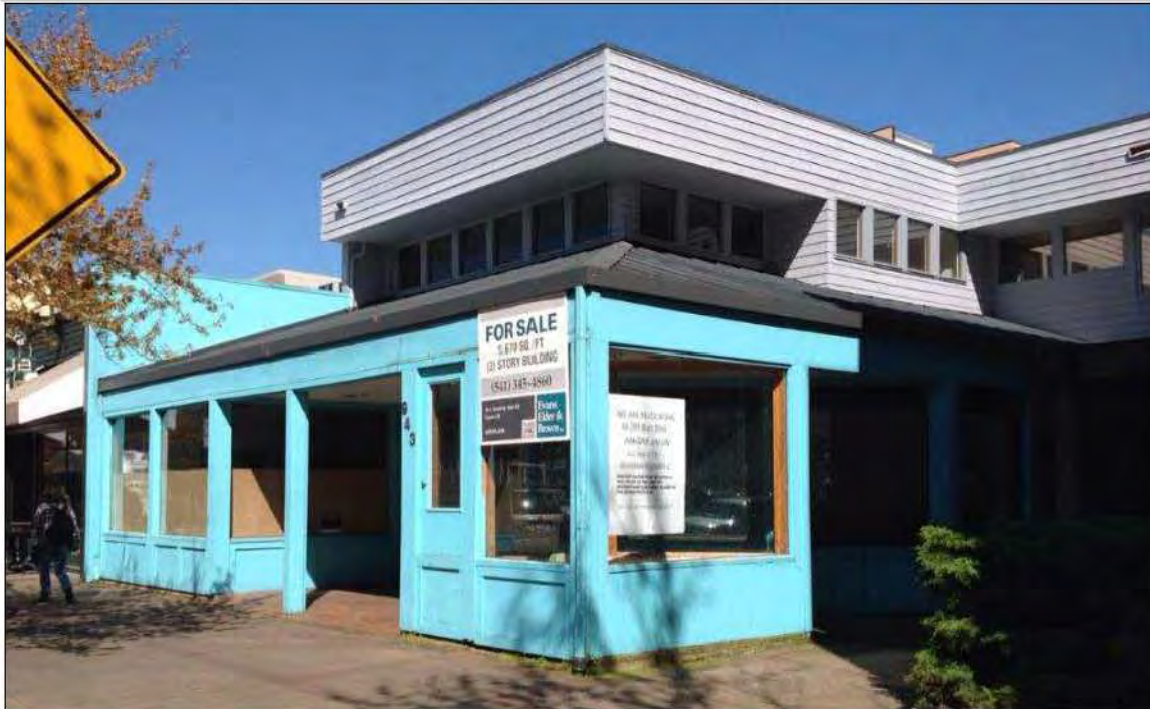
Photo: Top: view of property west side from Olive Street; middle left: photo is east side of building from service court; middle right: detail photo of entryway off Olive Street; bottom: example of wood damage on exterior.

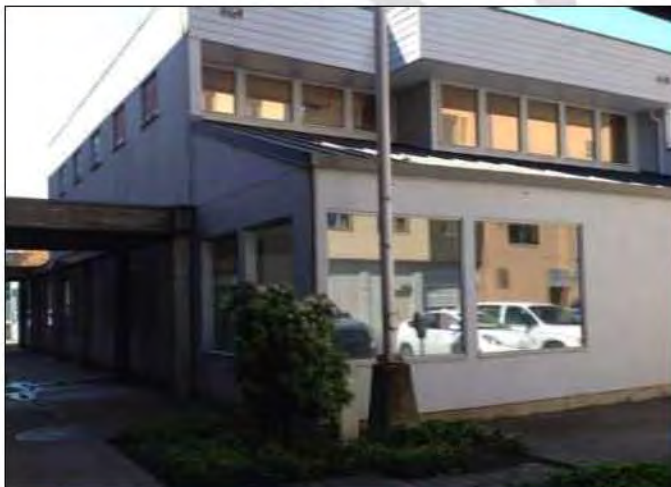
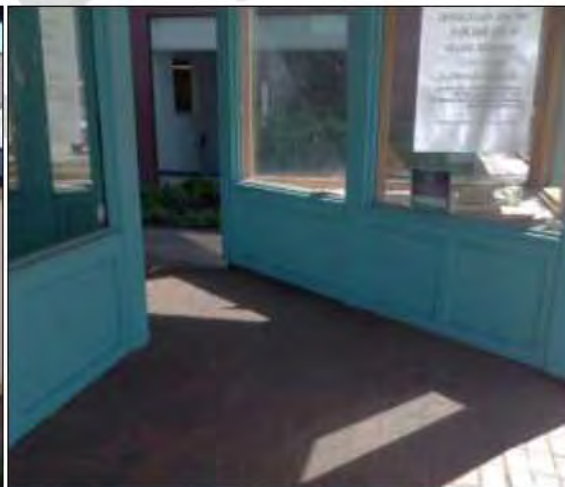
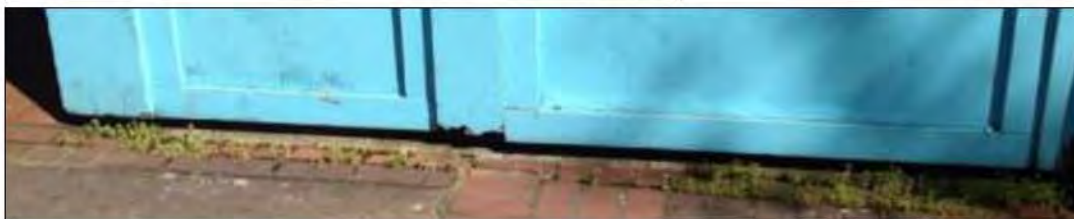
Property: 79	Name: Partially Vacant - former hair salon	Determination of Blight:	Yes
Taxlot(s): 1703311302700		Depreciation Ratio:	2.83
Property Notes:	Property is in poor condition. On the building, there is rotting wood visible in structure on the west side. The storefront is vacant. The east side of the building appears to be office. Condition on the side is good. Blight determination based on ORS 457.010(a)(E), (g), and (h).

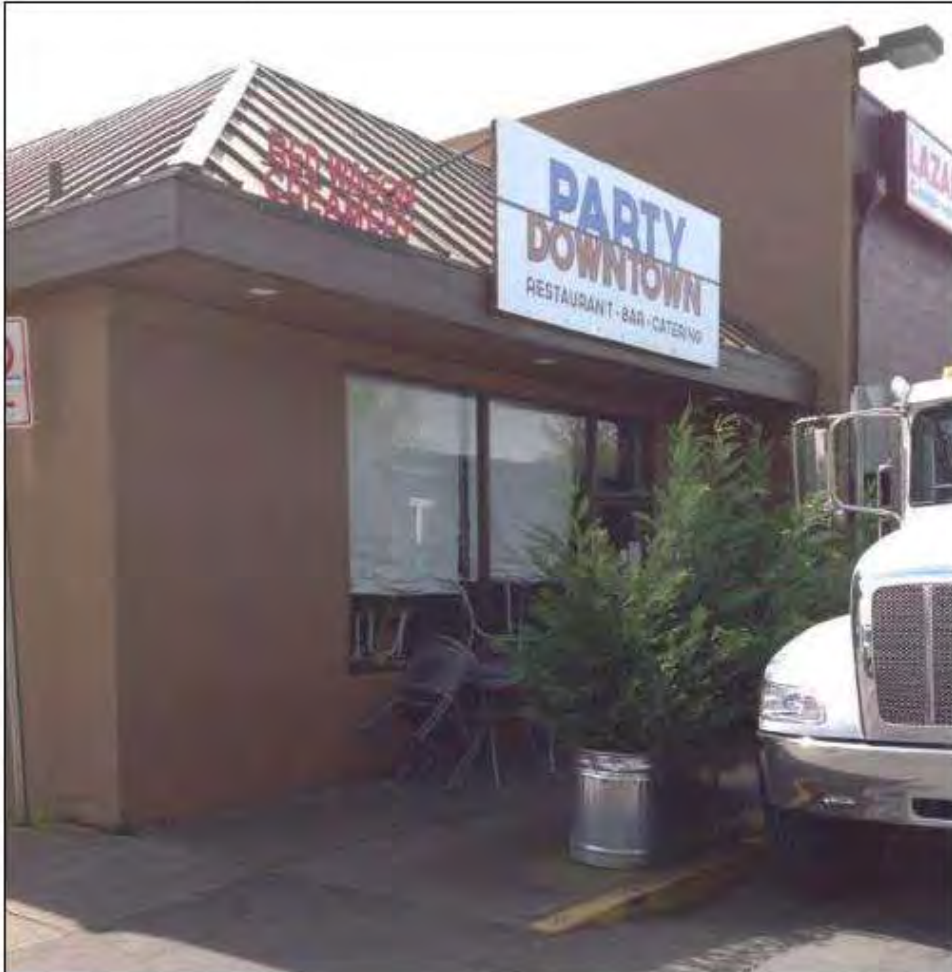
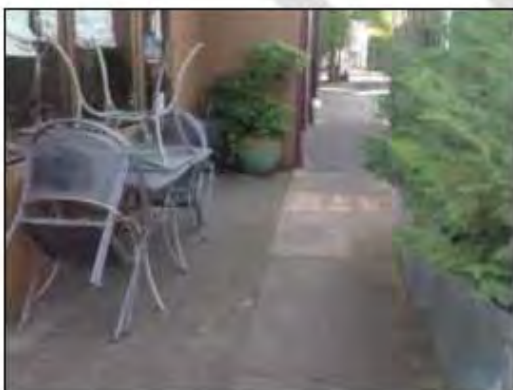
Property:	80	Name:	Party Downtown & Red Wagon Creamery	Determination of Blight:	Yes
Taxlot(s):	1703311303400	Depreciation Ratio:	3.80		
Property Notes:	Building appears in good condition. Lot shape is long and thin. Back sidewalk seating area is narrow and accessibility questioned. Blight determination based on ORS 457.010 (1)(c), (g), and (h).

Photo: Top: View of property from West 8th Avenue Alley; bottom: image shows seating area width on alley.

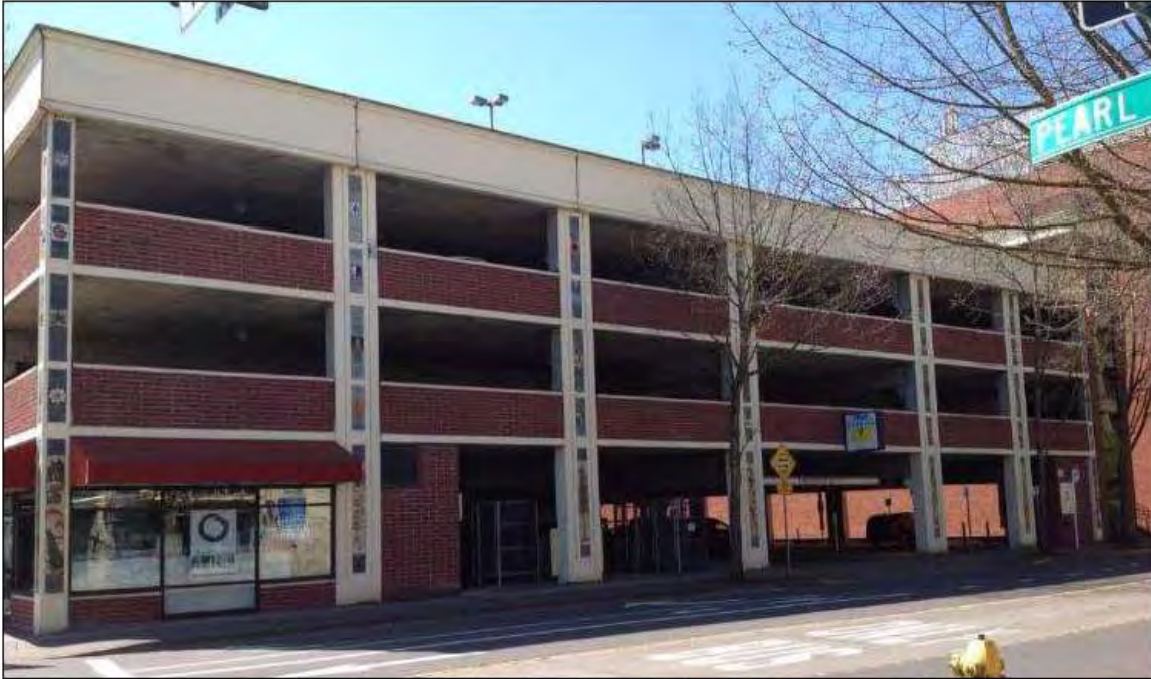
Photo: Top: view of property on East 10th Avenue; bottom left: example of surface damage on building; bottom right: example of rust on stairs.

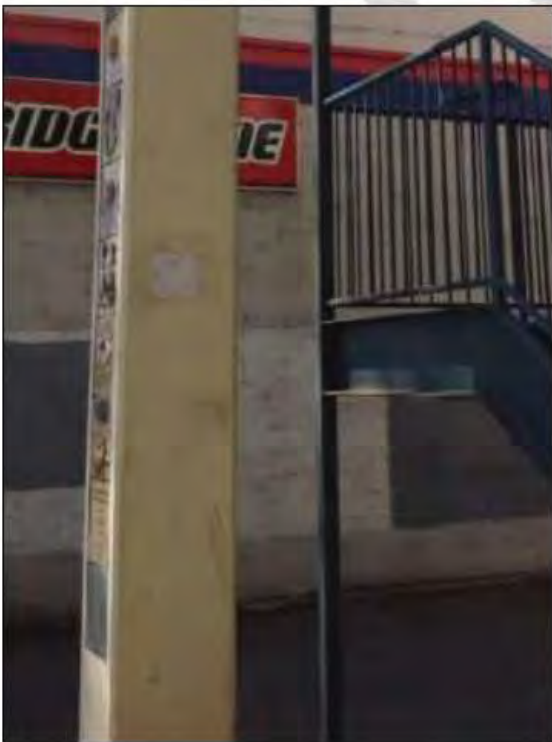
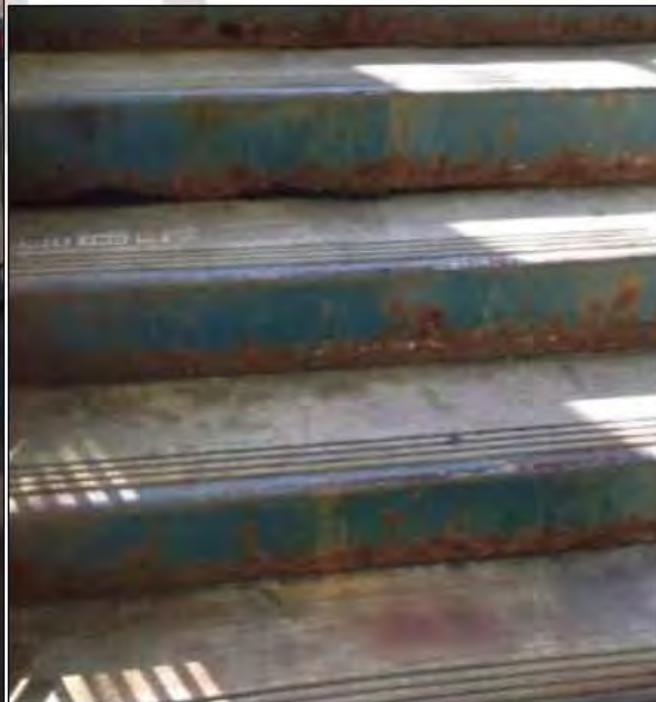
Property: 81	Name: Pearl Street Garage	Determination of Blight:	No
Taxlot(s): 1703311303400		Depreciation Ratio:	5.44
Property Notes:	Property appears in good condition. This property has ground floor commercial. The stairs show rust damage and some damage visible to surface of structure.

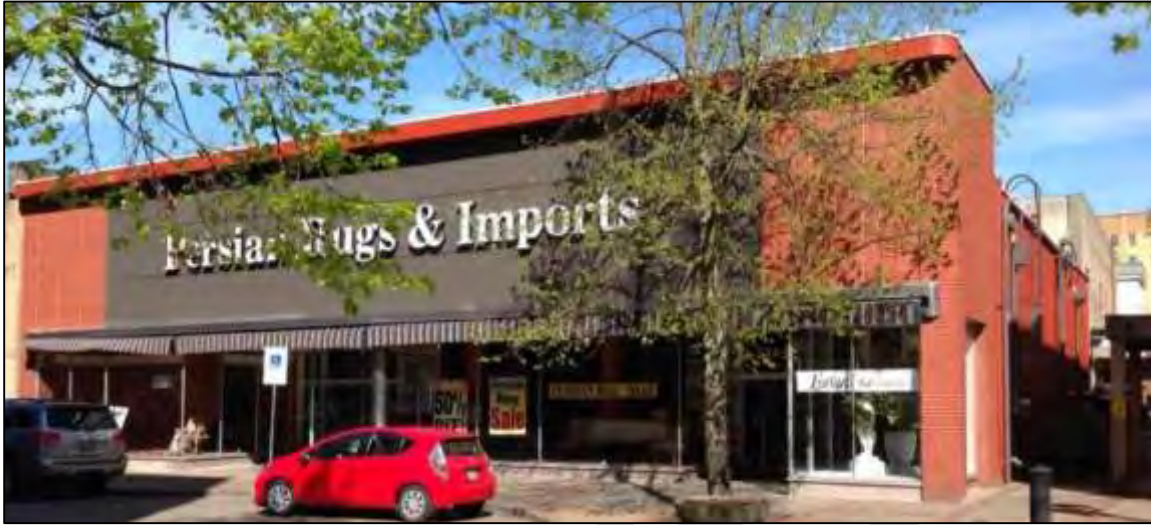
Property: 82	Name: Persian Rugs and Imports	Determination of Blight:	Yes
Taxlot(s): 1703311404800	1703311405300	Depreciation Ratio:	1.40
	1703311405400		
Property Notes:	Property appears in good condition. The building has a few areas with exterior damage such as damage to Windows with scratched graffiti. Blight determination based on ORS 457.010 (1)(g) and (h).
