**Summary of Council Discussions/Actions
on Downtown Improvements**

Map to Accompany Downtown Urban Renewal Slums and Blight Report 2016

Downtown Urban Renewal District – Determination of Slums and Blight - Detailed Property Survey

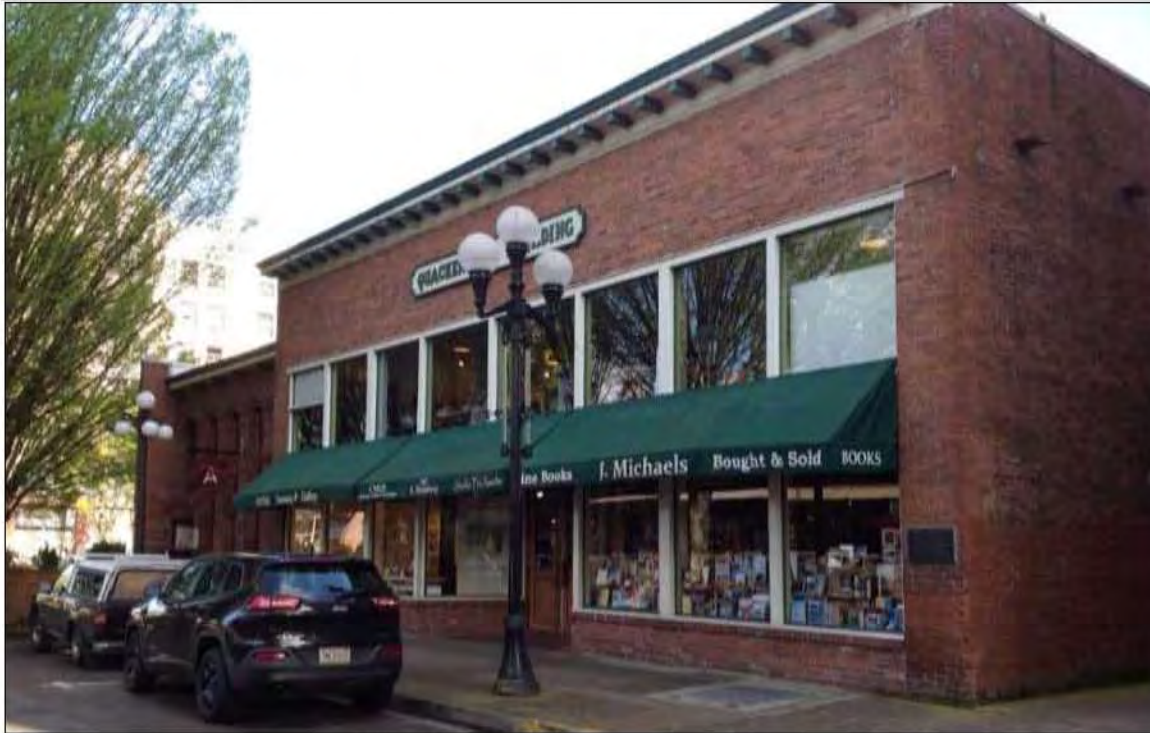
Photo: Top: front of building on East Broadway; bottom left: example of boarded up window along alley; bottom right: view of rear section of building with old cinderblock looking construction.

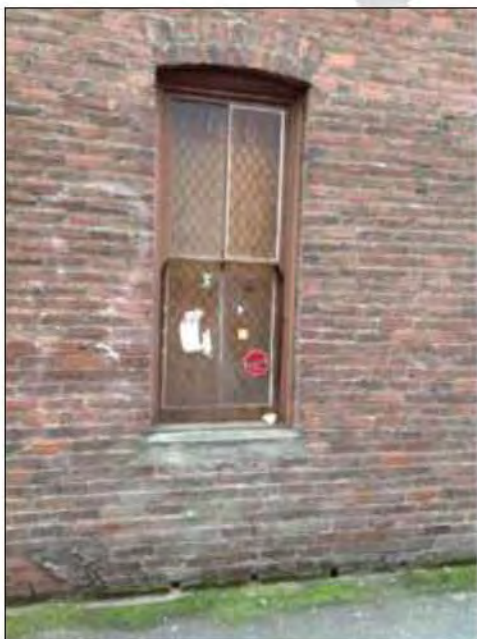
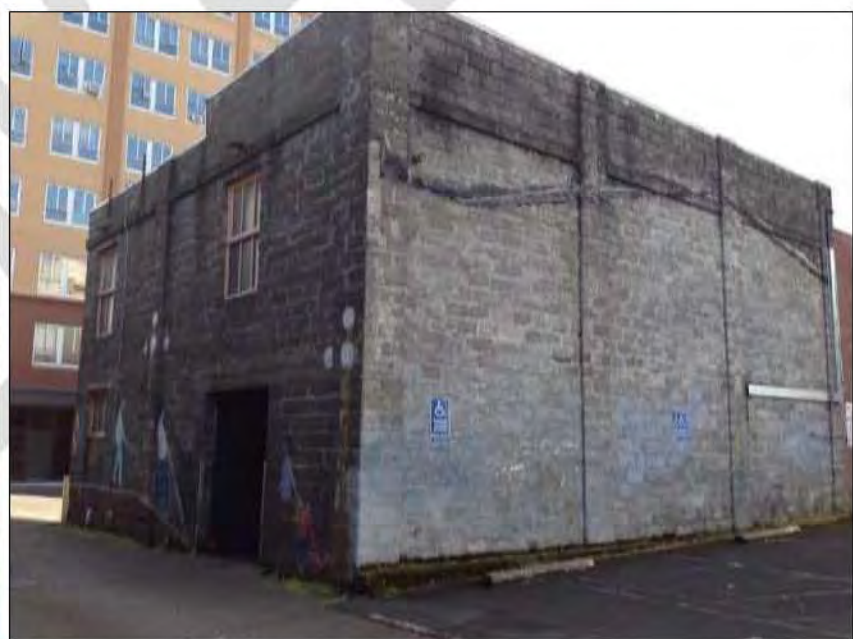
Property: 86	Name: Quakenbush Building	Determination of Blight: No
Taxlot(s): 1703311407500		Depreciation Ratio: 5.95
Property Notes:	Building appears in good condition even though very old. Questionable section in rear of building with old and visibly patched cinder block construction. Old windows are boarded up alongside of building.

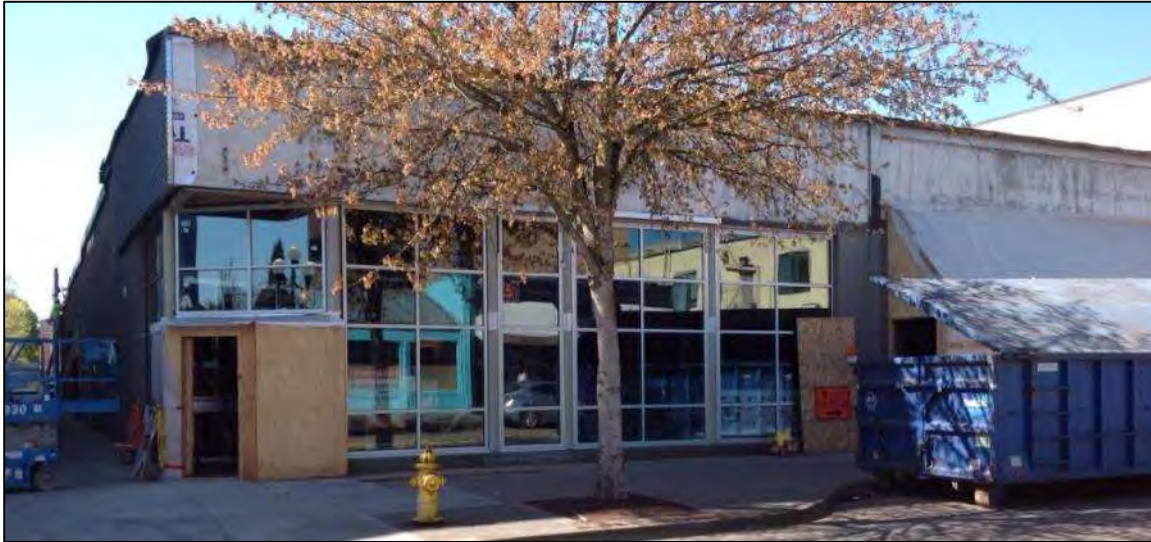
Property: 87	Name: RAIN	Determination of Blight:	Yes
Taxlot(s): 1703311305000		Depreciation Ratio:	1.08
Property Notes:	The building is under renovation and is owned by the University of Oregon. Blight determination by ORS 457.010 (1)(g) and (h).

Photo: View of property from Olive Street.

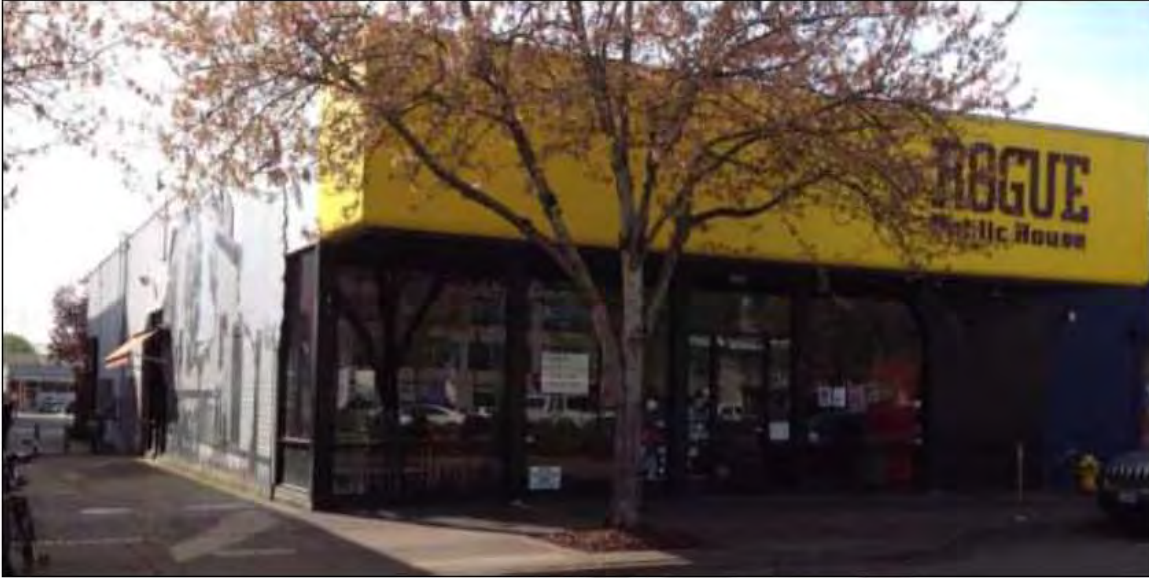
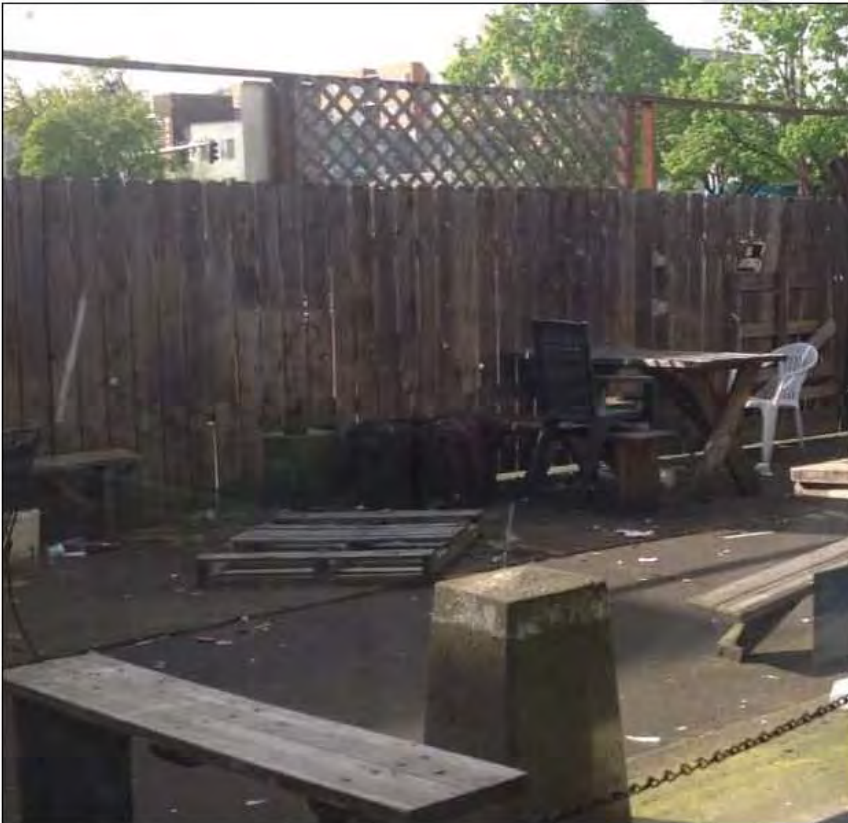
Property: 88	Name: Rogue	Determination of Blight:	Yes
Taxlot(s): 1703311304400		Depreciation Ratio:	3.38
Property Notes:	Building appears in relatively good condition. Outside seating area in back looks vandalized and in poor shape. Building shows evidence of graffiti. Property is vacant, underutilized, and with extended vacancy creates safety concerns, especially with damage on patio. Blight determination by ORS 457.010 (1)(b),(g), and (h).

Photo: Top: view of property from Olive Street; bottom: view of back patio damage.

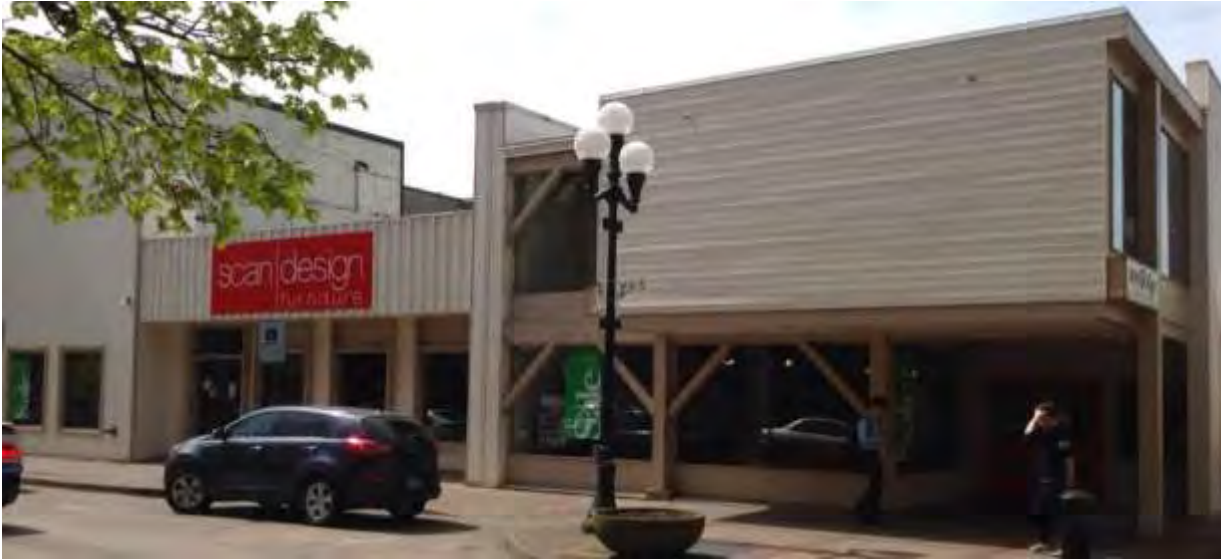
Property: 89	Name: Scan Design	Determination of Blight: Yes
Taxlot(s): 1703311300900	1703311301000	Depreciation Ratio: 3.18
Property Notes:	Building appears in good shape. Blight determination by ORS 457.010 (1)(g).

Photo: View of property from Willamette Street.

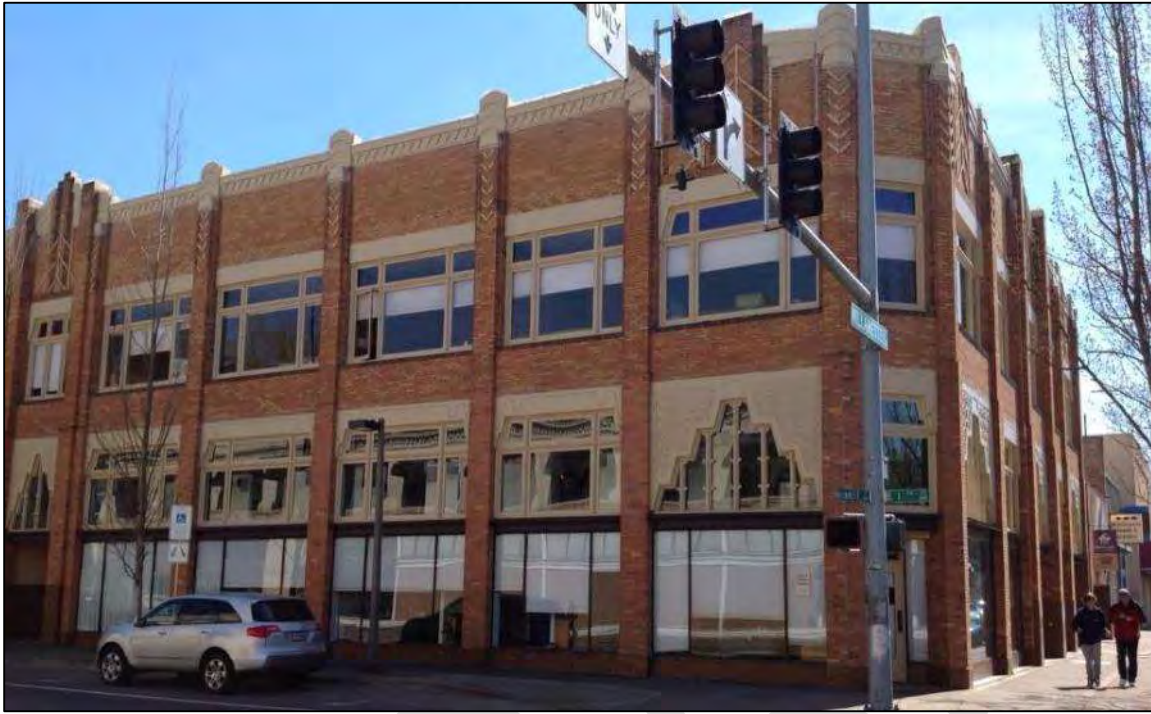
Photo: Top: view of property from East 10th Avenue and Willamette Street; bottom: image shows damage at base of building.

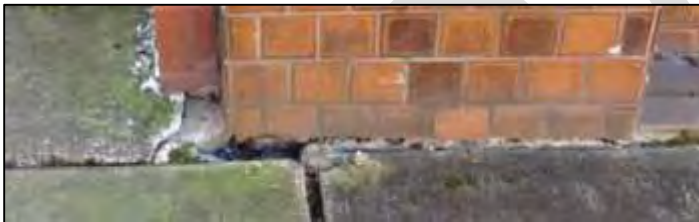
Property: 90	Name: Schaefer building	Determination of Blight:	No
Taxlot(s): 1703311412500		Depreciation Ratio:	7.19
Property Notes:	Property appears in good shape. There is a section with damage on NE corner.

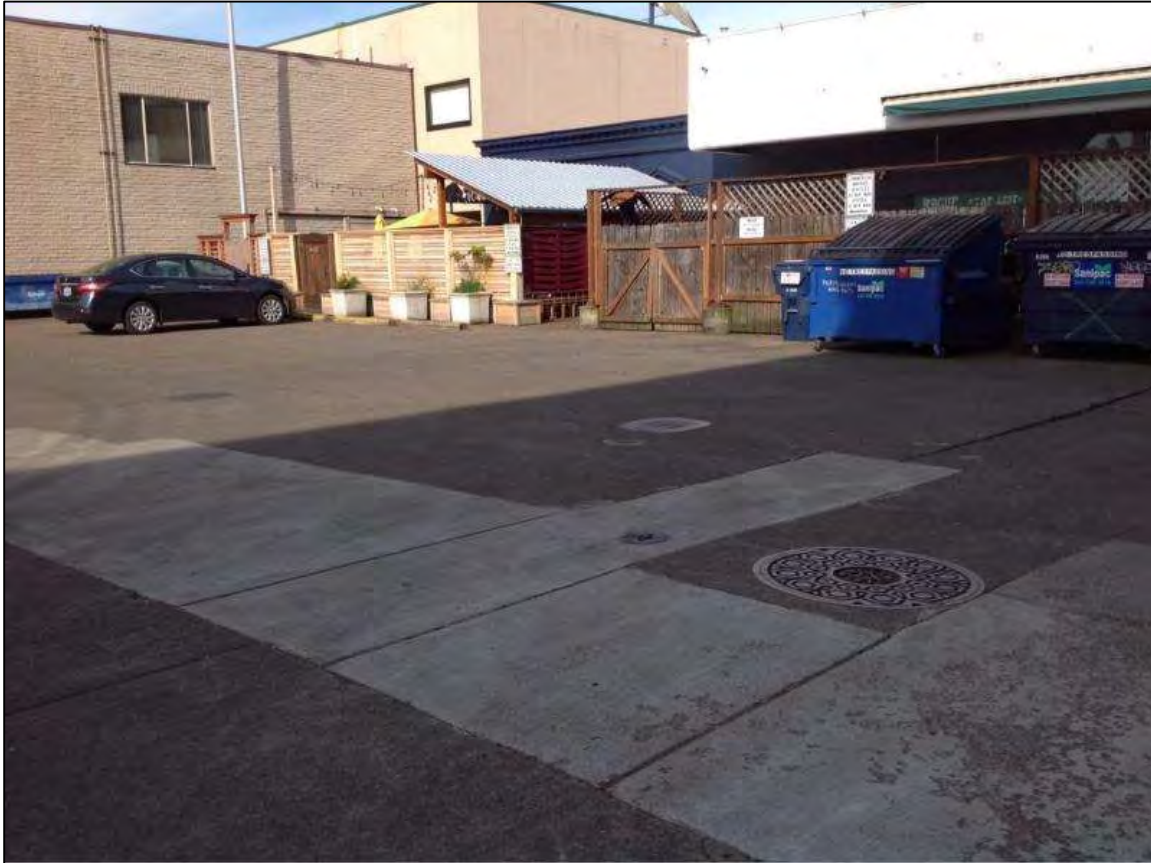
Property: 91	Name: Service court	Determination of Blight: Yes
Taxlot(s): 1703311304200		Depreciation Ratio: 0.12
Property Notes:	Property appears in good condition. Blight determination by ORS 457.010(1)(g) and (h).

Photo: View of property from Olive alley.

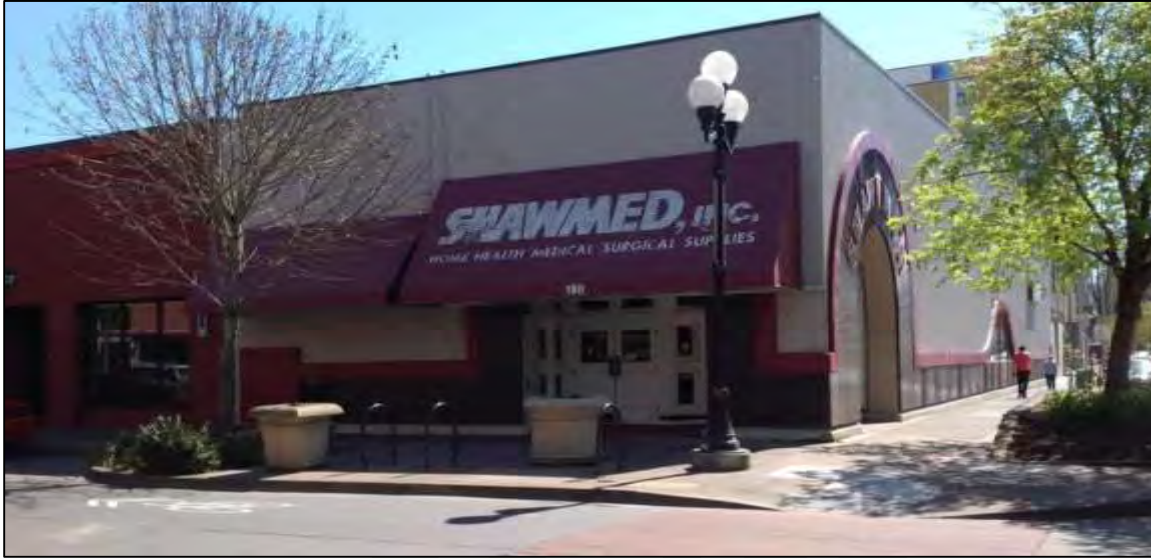
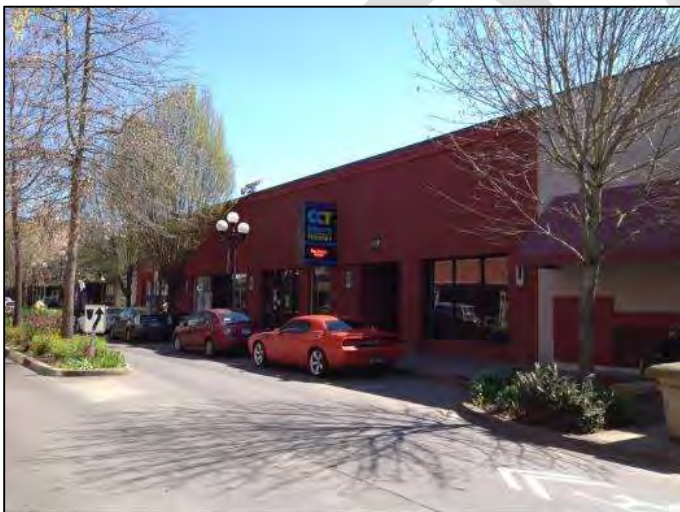
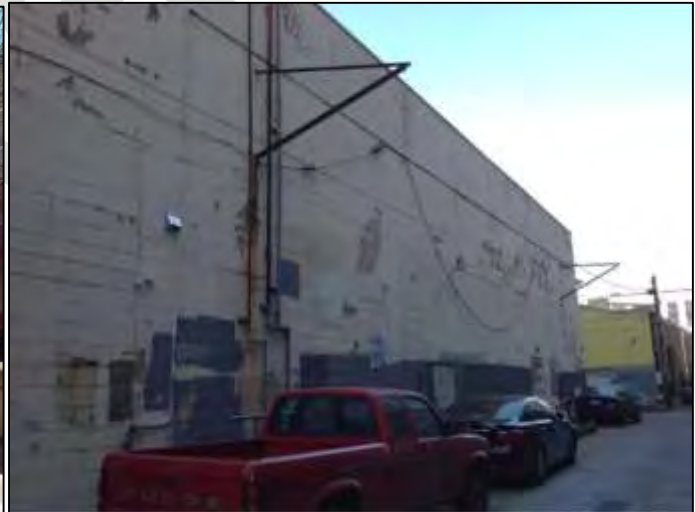
Property: 92	Name: Shawmed	Determination of Blight:	Yes
Taxlot(s): 1703311306700		Depreciation Ratio:	1.74
Property Notes:	Property appears in good condition. There are several businesses in one building that is a ¼ block n size. The Shawmed section has few windows. This is a single level building, connected to Oregon Contemporary Theater (OCT). The OCT property is painted in good condition in front but back of OCT in less than good condition with graffiti, peeling paint, but no structural damage. Blight determination by ORS 457.010(1)(g) and (h).

Photo: Top: View of Shawmed section of building from Broadway; bottom left: view of Oregon Contemporary Theater section from Broadway; bottom right: back section of OCT portion of building.

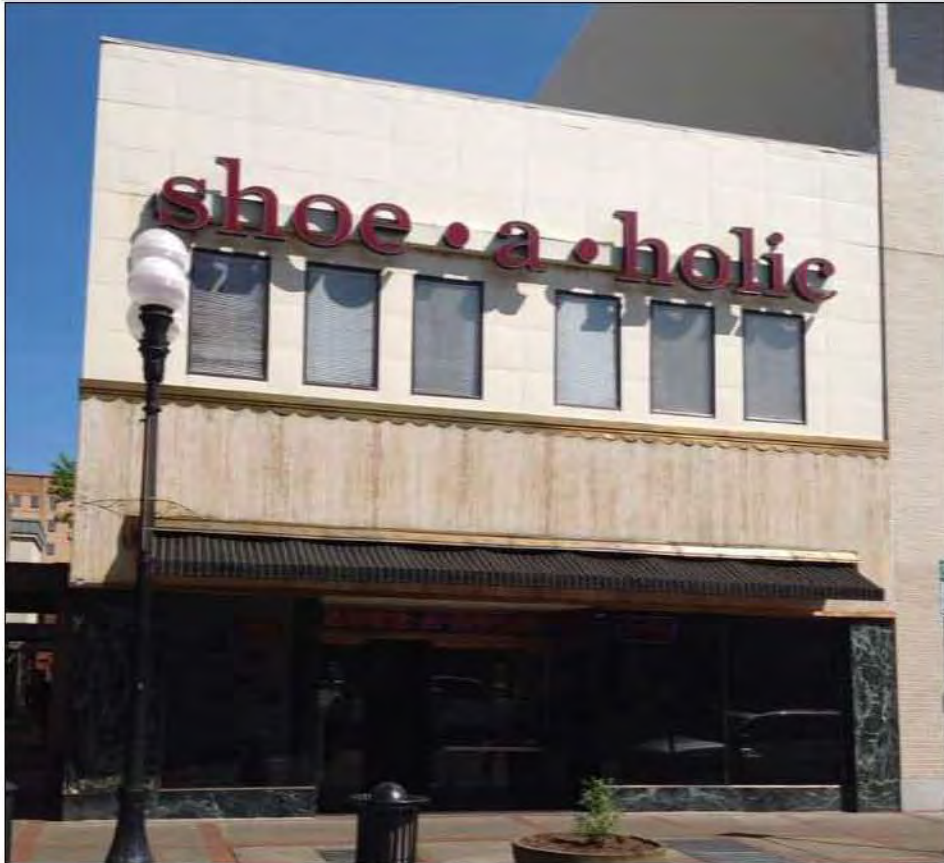
Photo: Top left: view of property from Willamette Street; top right: damage by rear door; bottom left: damage to front façade; bottom right: worn brick area.

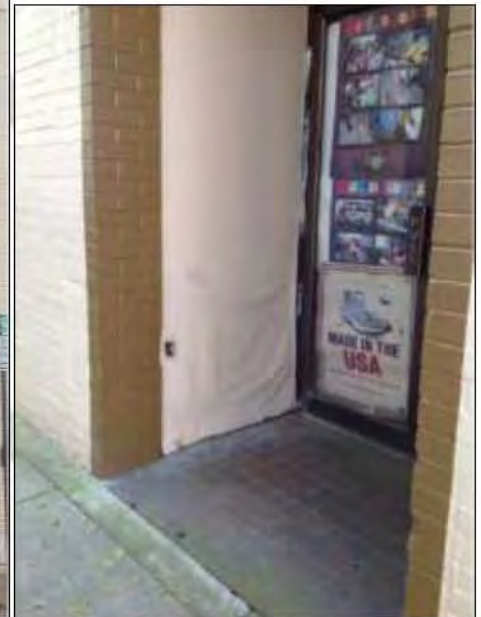
Property: 93	Name: Shoe-a-Holic	Determination of Blight:	Yes
Taxlot(s): 1703311405500		Depreciation Ratio:	1.62
Property Notes:	Building appears in good condition. This is an older building and there are a few areas with damage and wear, these include the brick on the side of the building, the façade on the front, and the rear door. Blight determination by ORS 457.010(1)(g).

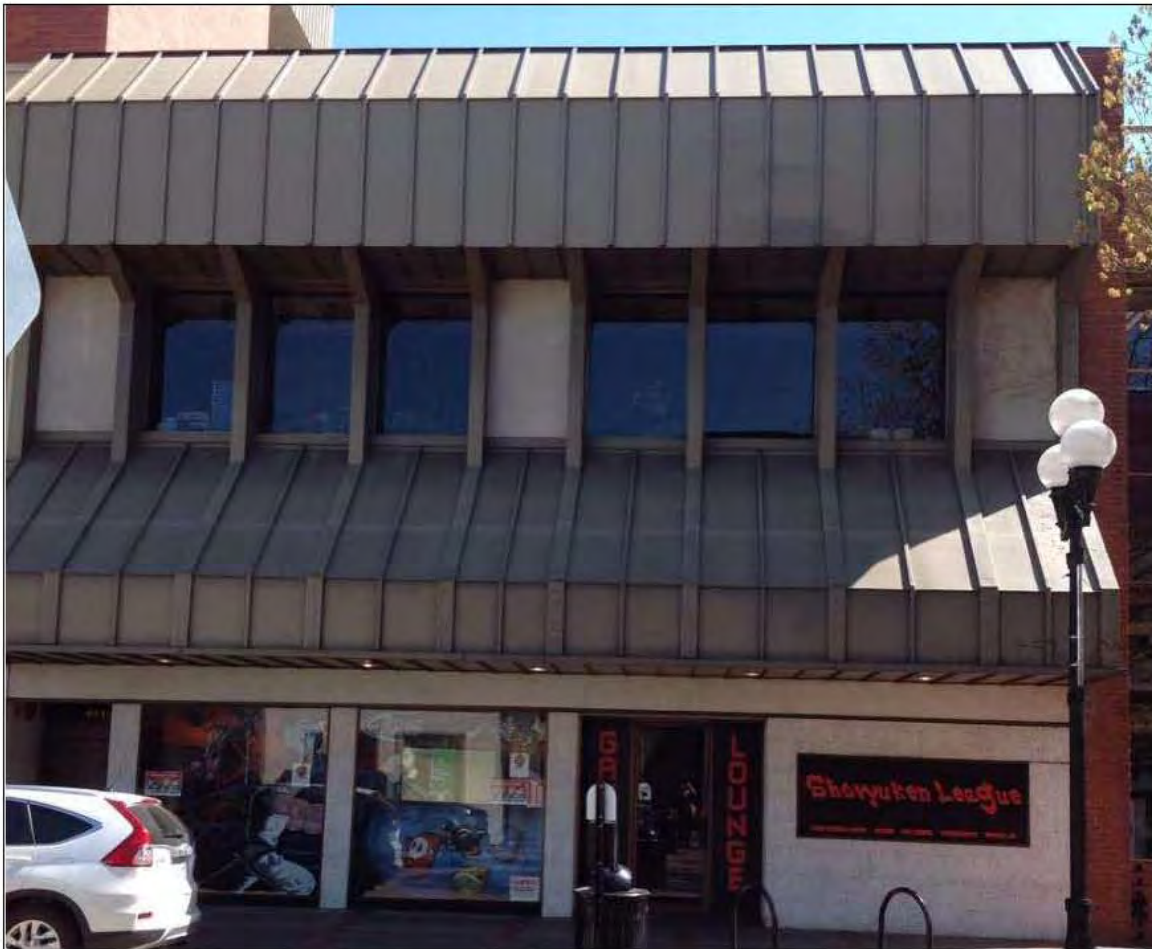
Photo: Top: View of property from Willamette Street; bottom: Damage and deterioration on front of building.

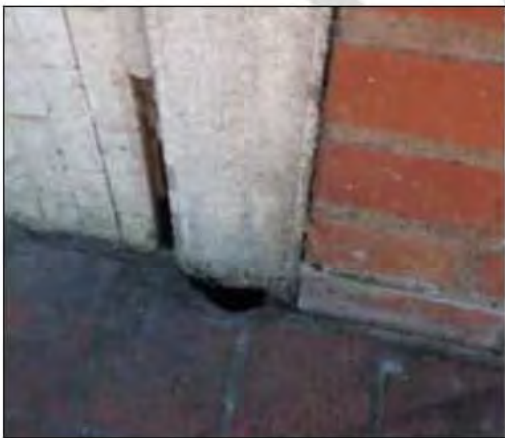
Property: 94	Name: Shoryuken Lounge and law office	Determination of Blight: Yes
Taxlot(s): 1703311404000		Depreciation Ratio: 3.10
Property Notes:	Property appears in good condition. East side and second floor appear to be law offices and west 1st floor is a bar and game lounge. The west side of the building has marble looking tiles, a few are gone, and the bottom of building edge has hole. Blight determination by ORS 457.010(1)(g).

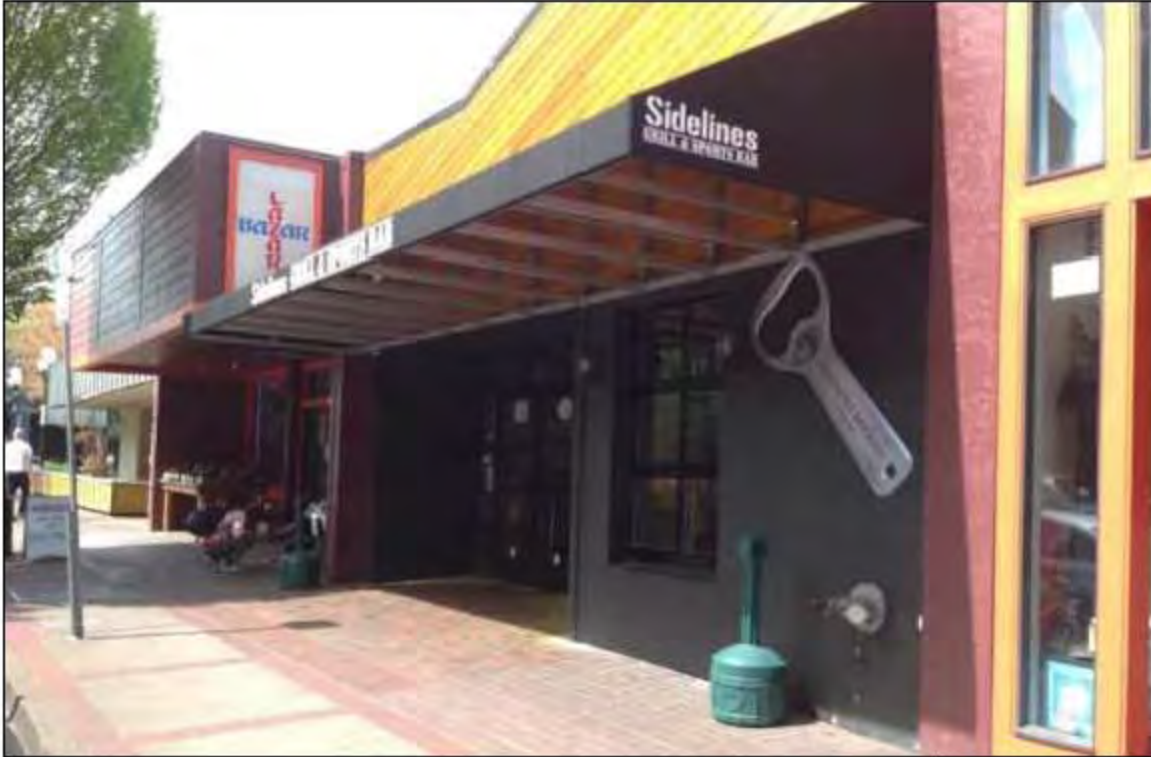
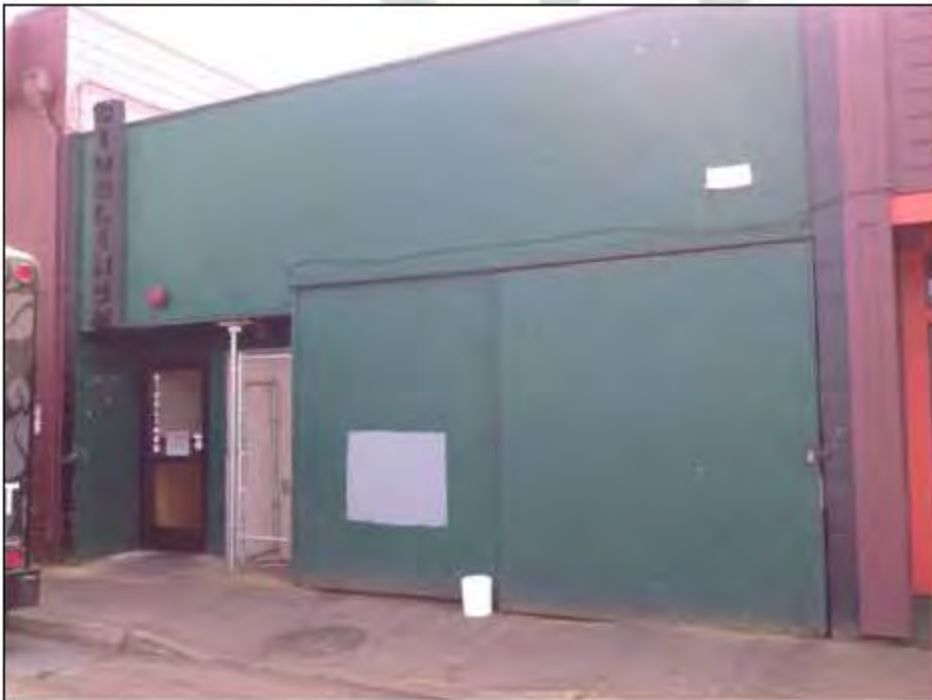
Property: 95	Name: Sidelines Bar	Determination of Blight:	Yes
Taxlot(s): 1703311303200		Depreciation Ratio:	1.52
Property Notes:	Property appears in good condition. Lot shape is long and very thin. Blight determination by ORS 457.010(1)(c),(g), and (h).

Photo: Top: front of property facing Broadway; bottom: rear of building.

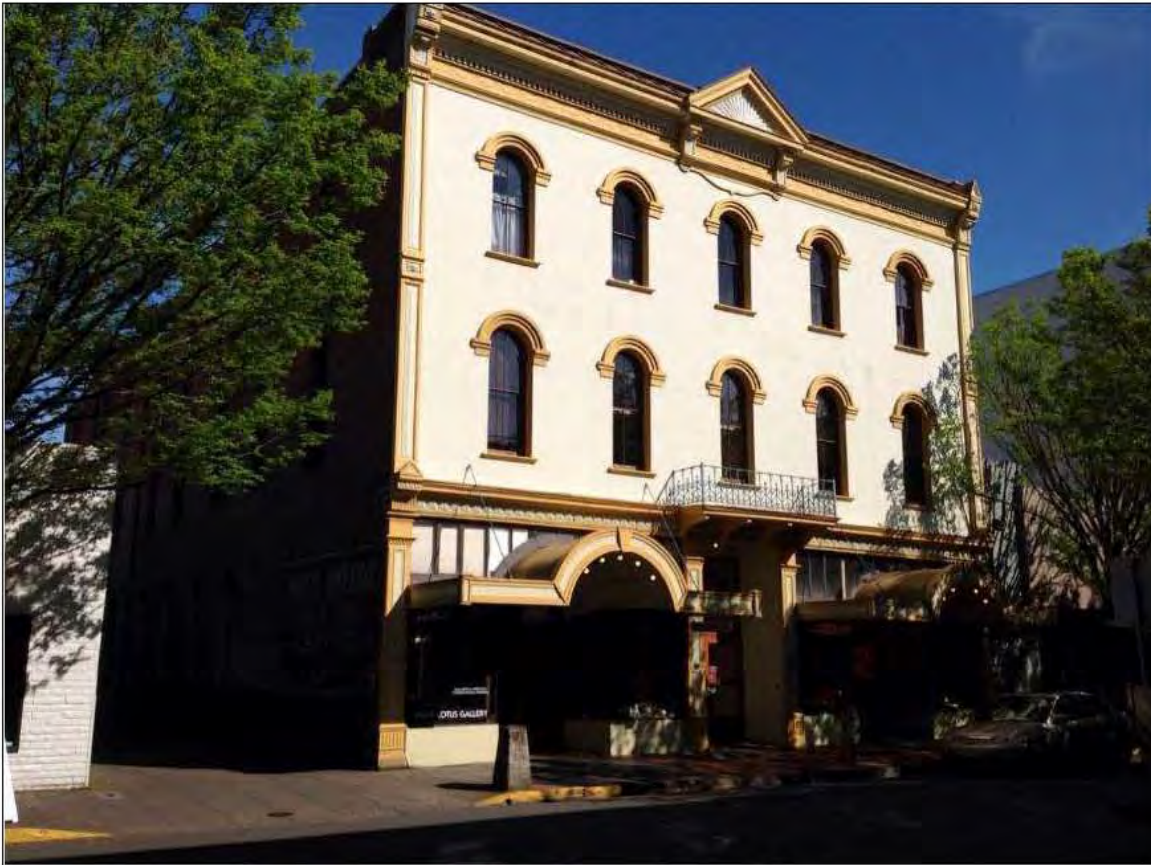
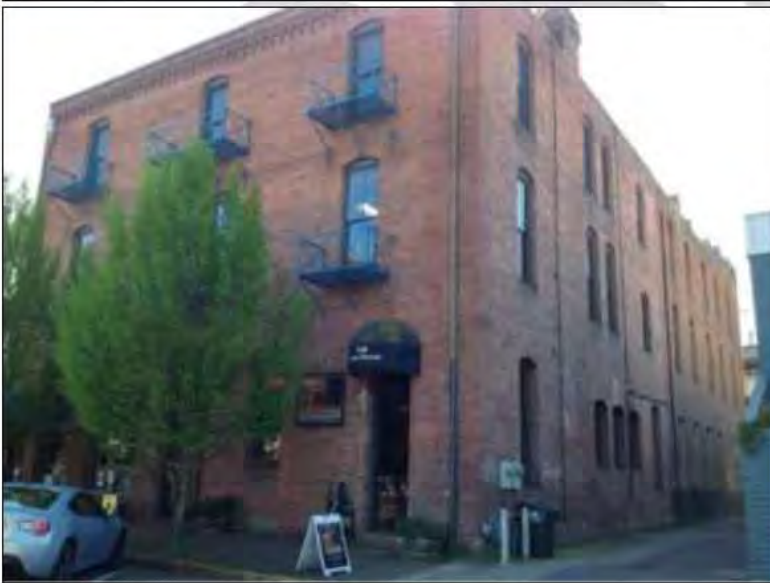
Property: 96	Name: Smeed Hotel	Determination of Blight:	No
Taxlot(s): 1703311109200		Depreciation Ratio:	4.81
Property Notes:	This is an historic building and property appears in good shape.

Photo: Top: View of property from Willamette Street, bottom: back of property on West Park Street.

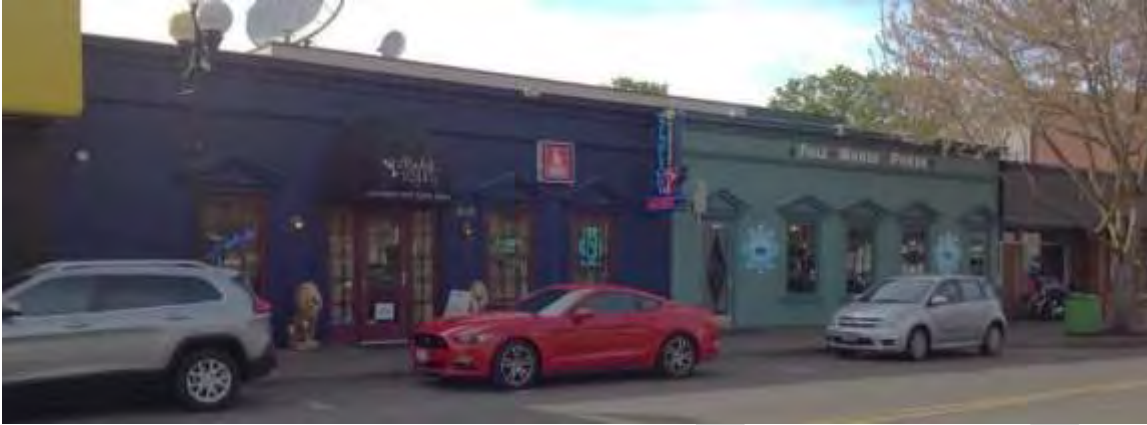
Property: 97	Name: Starlight Lounge, Full House Poker	Determination of Blight:	Yes
Taxlot(s): 1703311304300		Depreciation Ratio:	3.22
Property Notes:	Property appears in good condition. Building contains two businesses. Blight determination based on ORS 457.010(1)(g) and (h).

Photo: View of property on Olive Street.

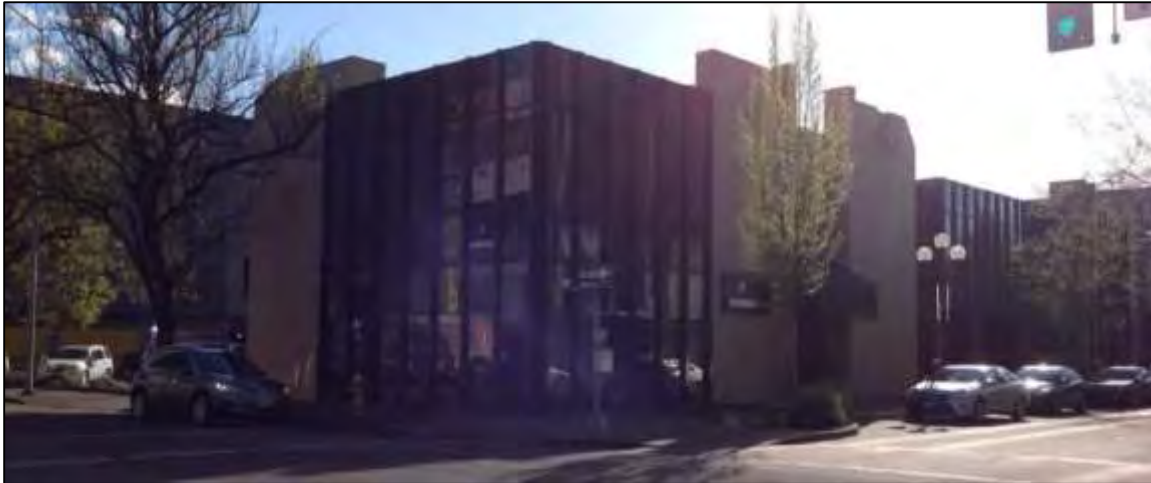
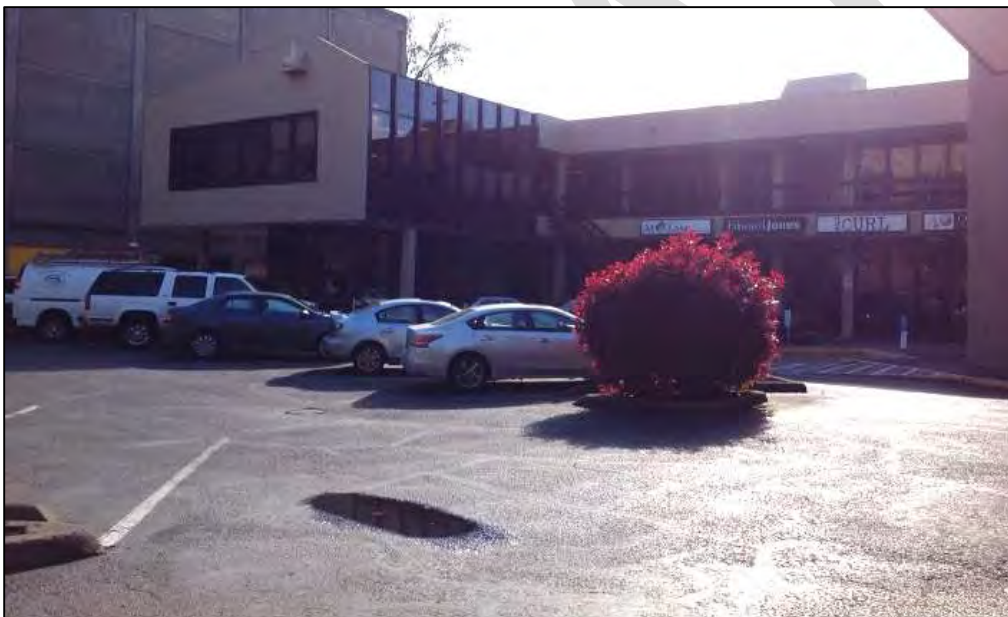
Property: 98	Name: Summit Bank and shopping	Determination of Blight:	Yes
Taxlot(s): 1703311406200		Depreciation Ratio:	2.02
Property Notes:	Property appears in good condition. The property is a ½ block with a bank and assorted businesses. There are multiple buildings on the property and about ¼ is parking and another ¼ open space. Building is in good condition but utilization of space is low. Blight determination based on ORS 457.010(1)(g) and (h).

Photo: Top: view of building from Oak Street and Broadway; bottom: View of property from Oak Street

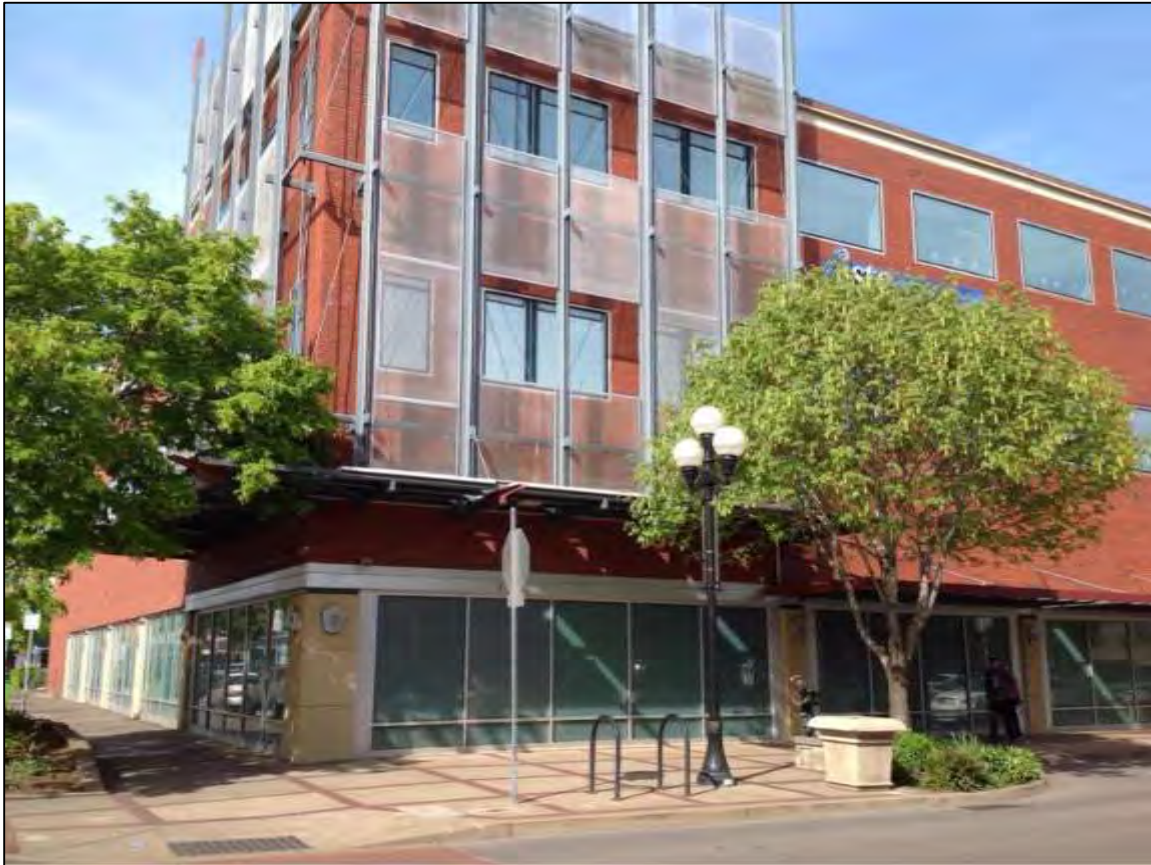
Property: 99	Name: Sykes	Determination of Blight:	No
Taxlot(s): 1703311306800		Depreciation Ratio:	8.53
Property Notes:	Property is in good condition. Blight determination based on ORS 457.010(1)(g).

Photo: View of property from Broadway and Charnelton Street.

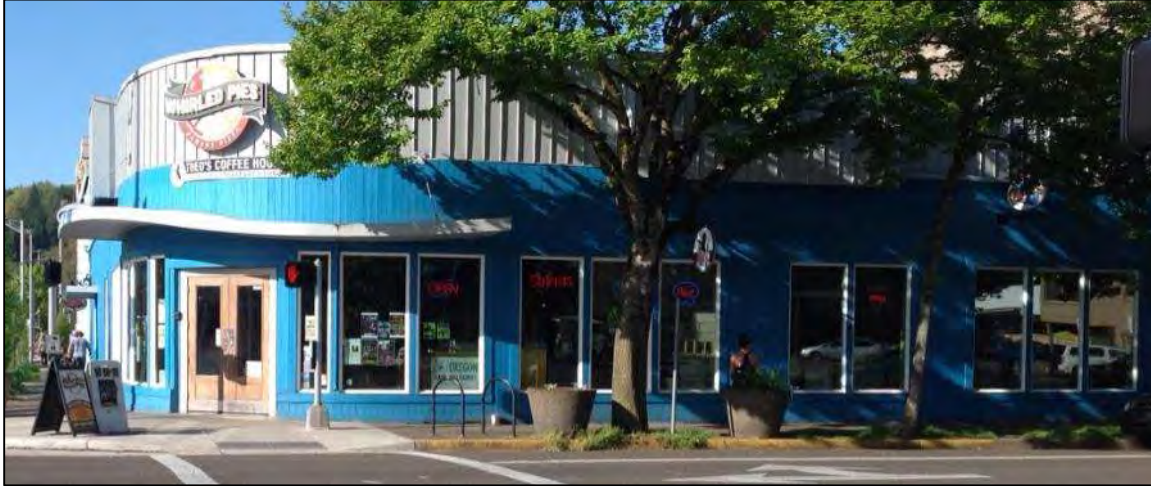
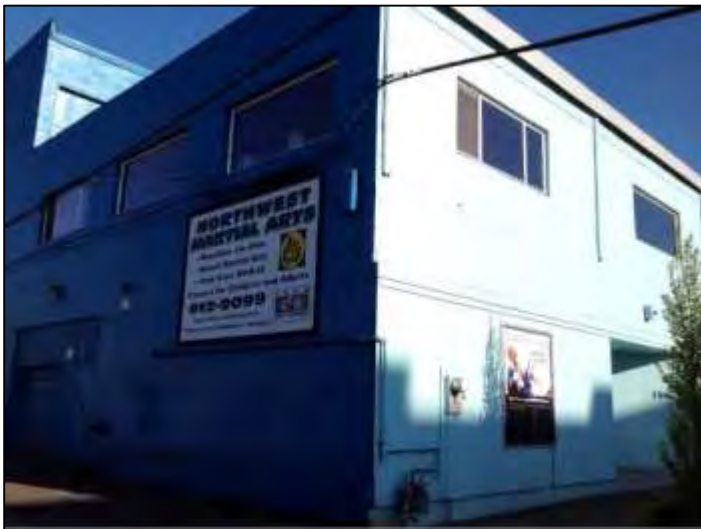
Property: 100	Name: Theos, Whirled Pies	Determination of Blight:	Yes
Taxlot(s): 1703311306800		Depreciation Ratio:	3.32
Property Notes:	Building appears in fairly good condition. A few locations show wood deterioration on exterior. Blight determination based on ORS 457.010 (1)(g).

Photo: Top: view of property from West 8th Avenue and Charnelton Street; bottom left: north side of building, bottom right: example of damage on exterior

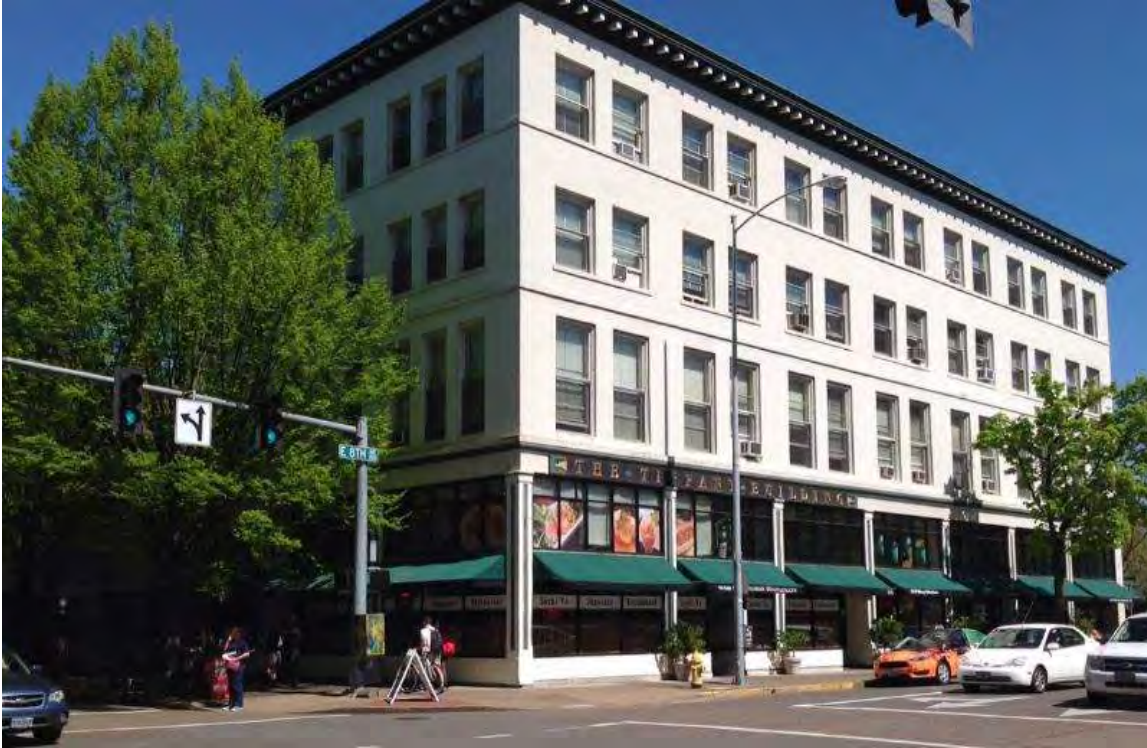
Property: 101	Name: Tiffany building	Determination of Blight:	No
Taxlot(s): 1703311109400		Depreciation Ratio:	6.79
Property Notes:	Housing over commercial. Building is old, but was renovated a while ago. Property in appears in good condition. Edge where sidewalk meeting building has some damage.

Photo: View of property from Willamette Street and East 8th Avenue.

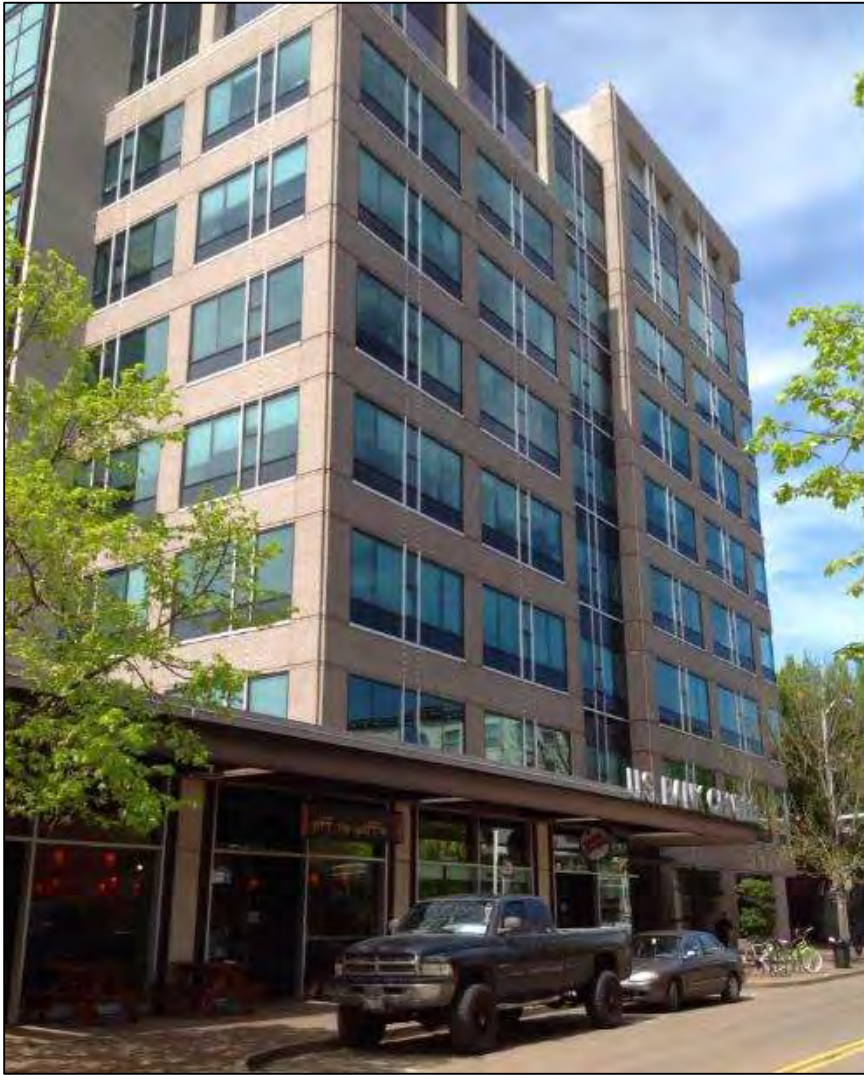
Property: 102	Name: US Bank	Determination of Blight:	No
Taxlot(s): 1703311300700		Depreciation Ratio:	13.04
Property Notes:	Building appears in good shape

Photo: View of property from Willamette Street.

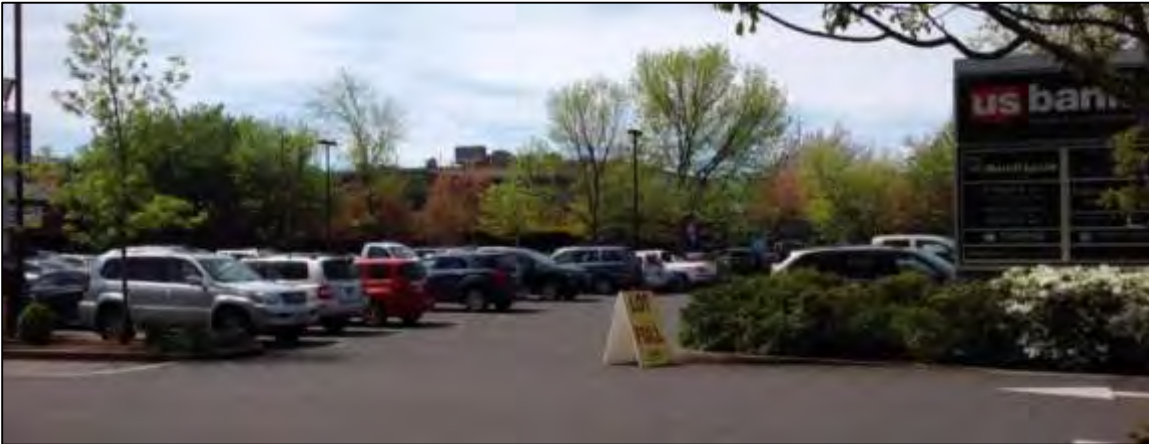
Property: 103	Name: US Bank Parking Lot	Determination of Blight:	Yes
Taxlot(s): 1703311303500	1703311303600	Depreciation Ratio:	0.04
	1703311303700		
Property Notes:	Property in good condition. The property is surface parking lot which consists of multiple narrow and thin lots. Blight determination based on ORS 457.010 (1)(c), (g), and (h).

Photo: View of property from mid-block West 8th Avenue.

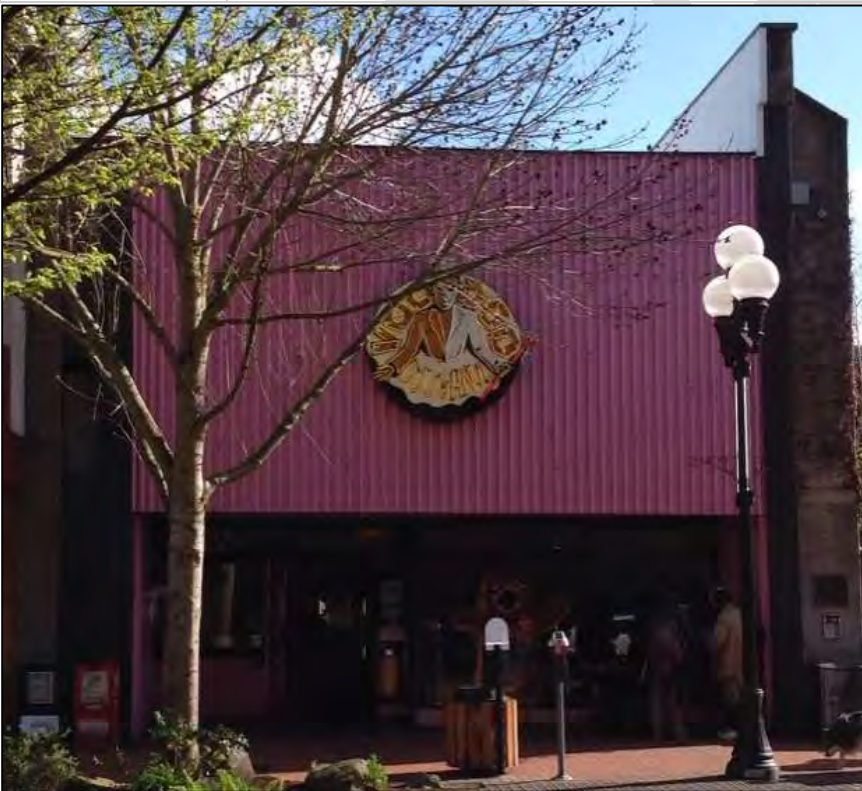
Property: 104	Name: VooDoo Doughnuts	Determination of Blight:	Yes
Taxlot(s): 1703311404900		Depreciation Ratio:	3.30
Property Notes:	Building appears in good condition. Blight determination based on ORS 457.010 (1)(c),(g), and (h).

Photo: View of building front from Broadway.

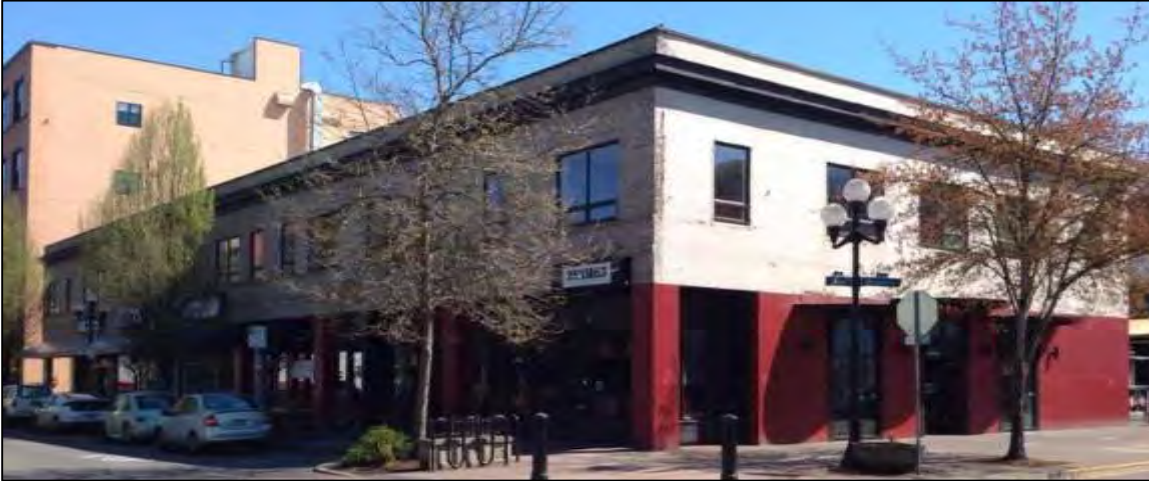
Property: 105	Name: Washburne Building	Determination of Blight:	Yes
Taxlot(s): 1703311302900		Depreciation Ratio:	3.96
Property Notes:	Building in fair condition. There are upper level offices and bottom floor commercial. The building has some peeling paint. Blight determination based on ORS 457.010 (1)(g).

Photo: View of property from Broadway and Olive Street.
