**Summary of Council Discussions/Actions
on Downtown Improvements**

Map to Accompany Downtown Urban Renewal Slums and Blight Report 2016

Downtown Urban Renewal District – Determination of Slums and Blight - Detailed Property Survey

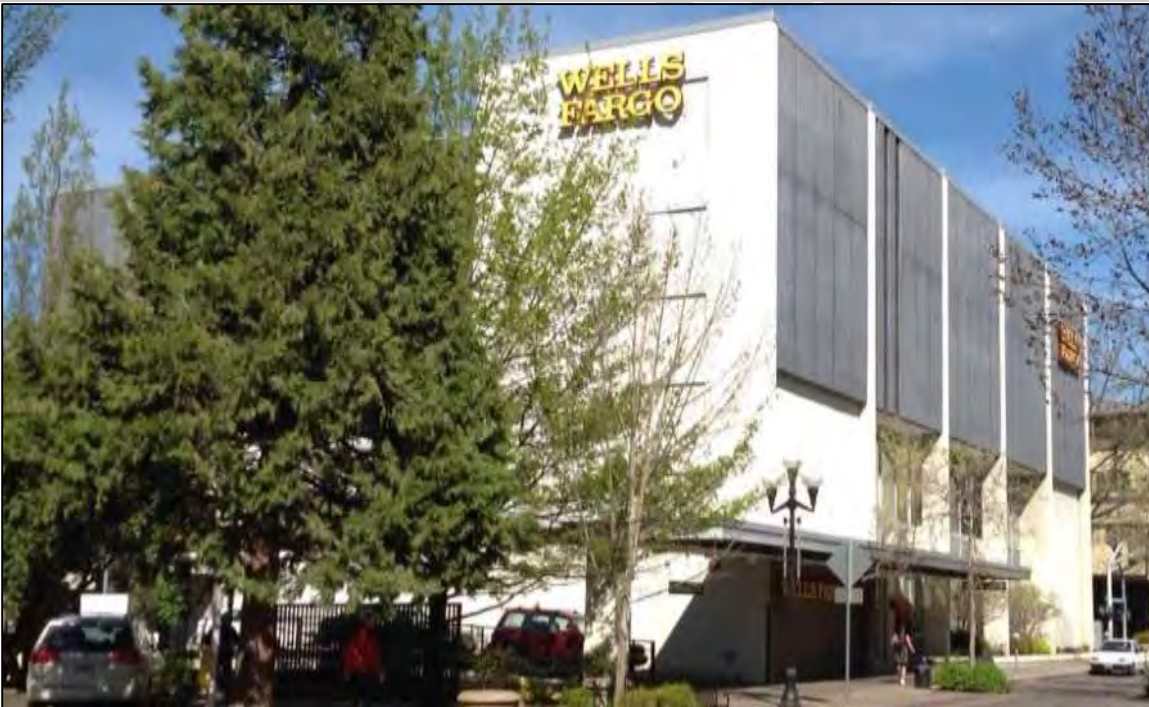
Property: 106	Name: Wells Fargo	Determination of Blight:	No
Taxlot(s): 1703311403300		Depreciation Ratio:	7.08
Property Notes:	Property is in good condition.

Photo: View of property from Broadway.

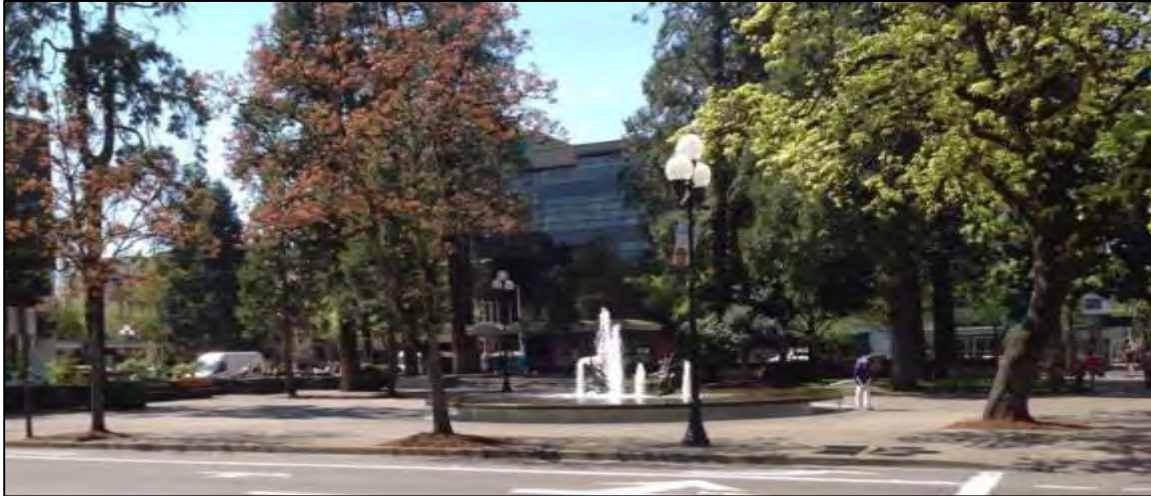
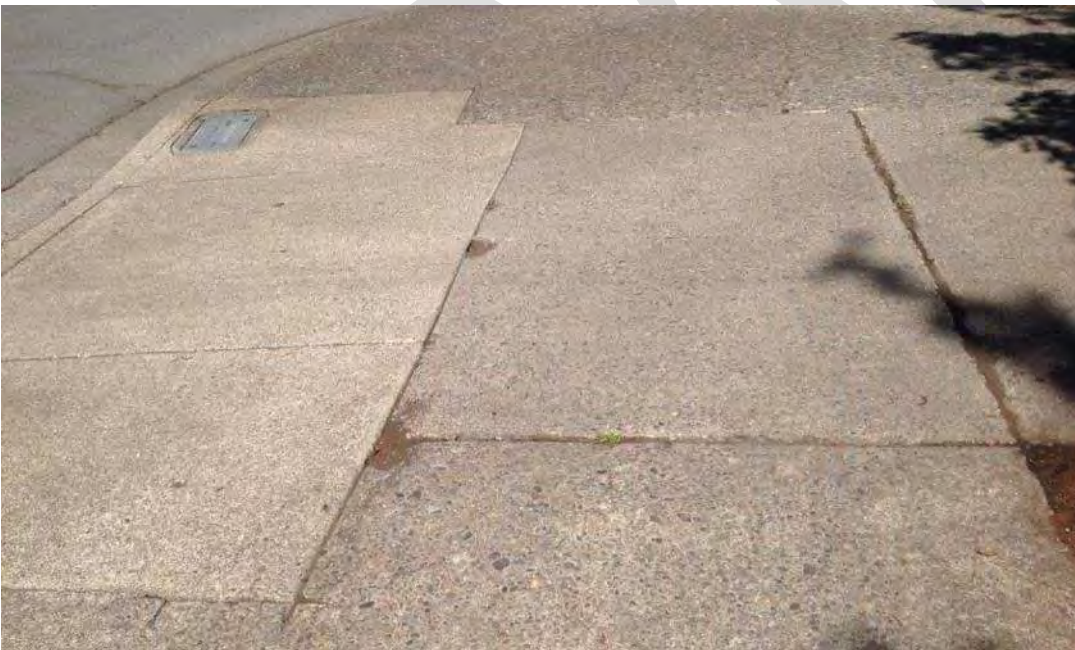
Property: 107	Name: West Park Block	Determination of Blight:	Yes
Taxlot(s): 1703311404700		Depreciation Ratio:	0.05
Property Notes:	Property is in poor conditions. Damage includes broken sidewalks that uneven and have holes, benches are rusty with peeling paint and some are crooked; and there is a broken utility box with wires exposed. Property does not look maintained with garbage lying around and portable restrooms with graffiti add to perceptions of blight. Accessibility is questionable, the ramp is not flush with the sidewalk and it has holes. Determination of blight based on ORS 457.010 (1) (b), (e),(g),(h), and (i).

Photo: Top: view of property from Oak Street; bottom: image shows holes and cracks in pavement leading up to ramp

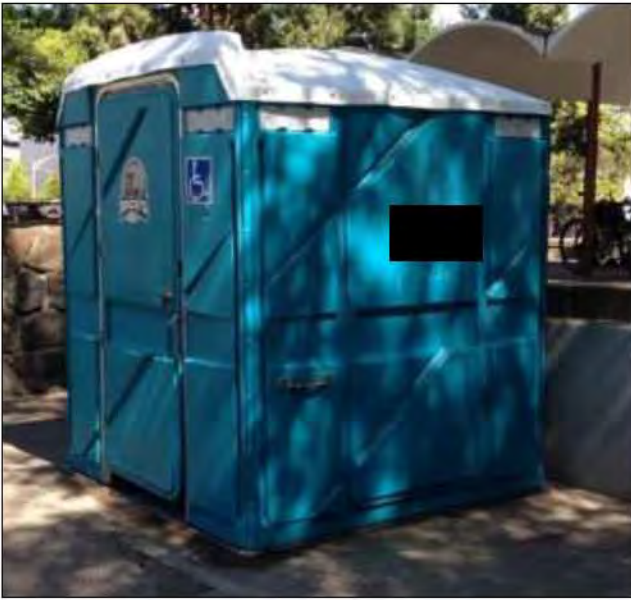
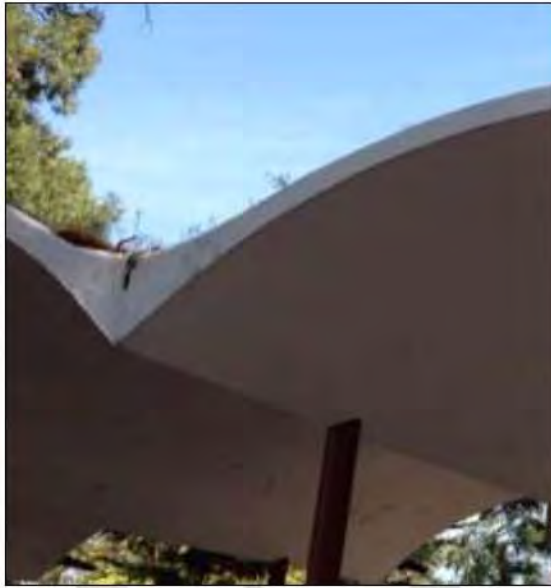
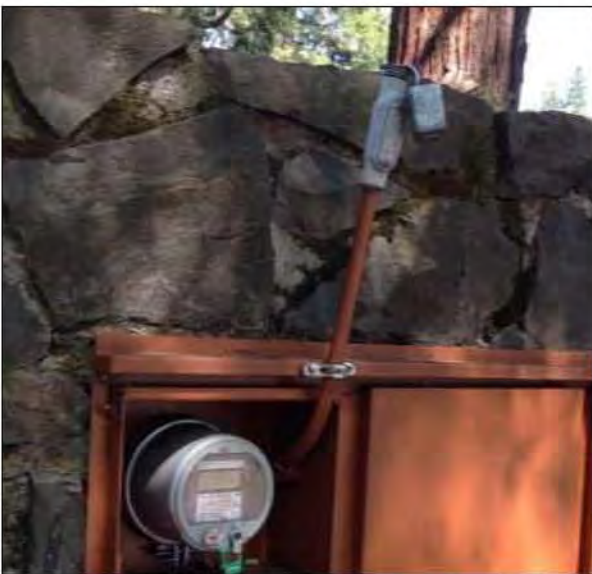
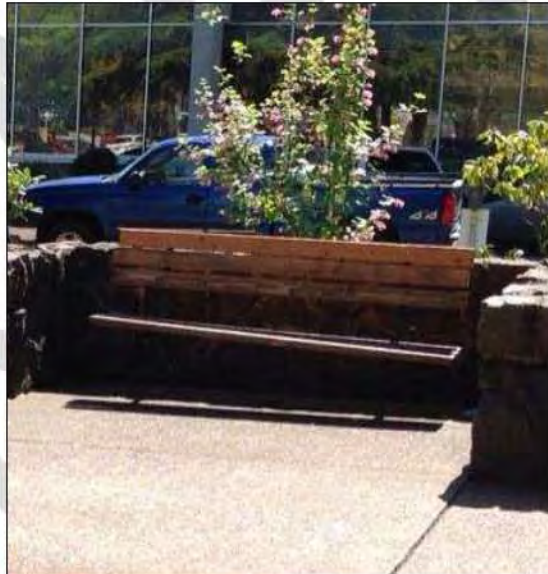
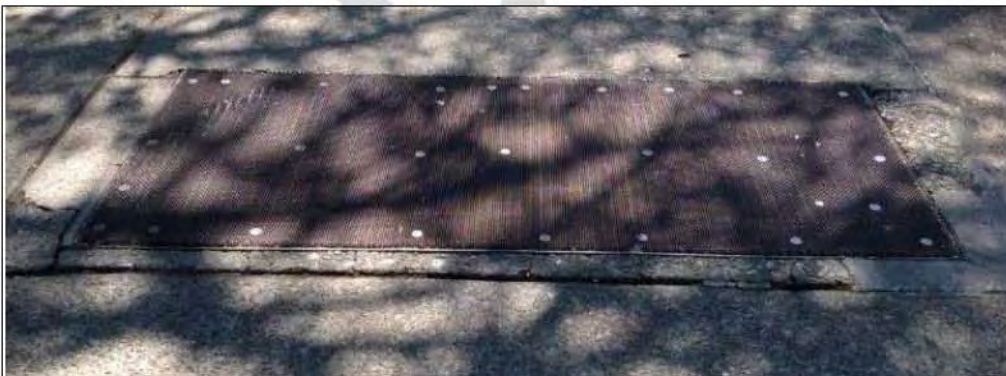
Property #107 images continued on next page.

Photo: Top left: portable restroom on property, graffiti is covered by black box; top right: image shows plants growing on shelter; middle left: broken utility box; middle right: example of crooked bench; bottom: metal grate in damaged sidewalk

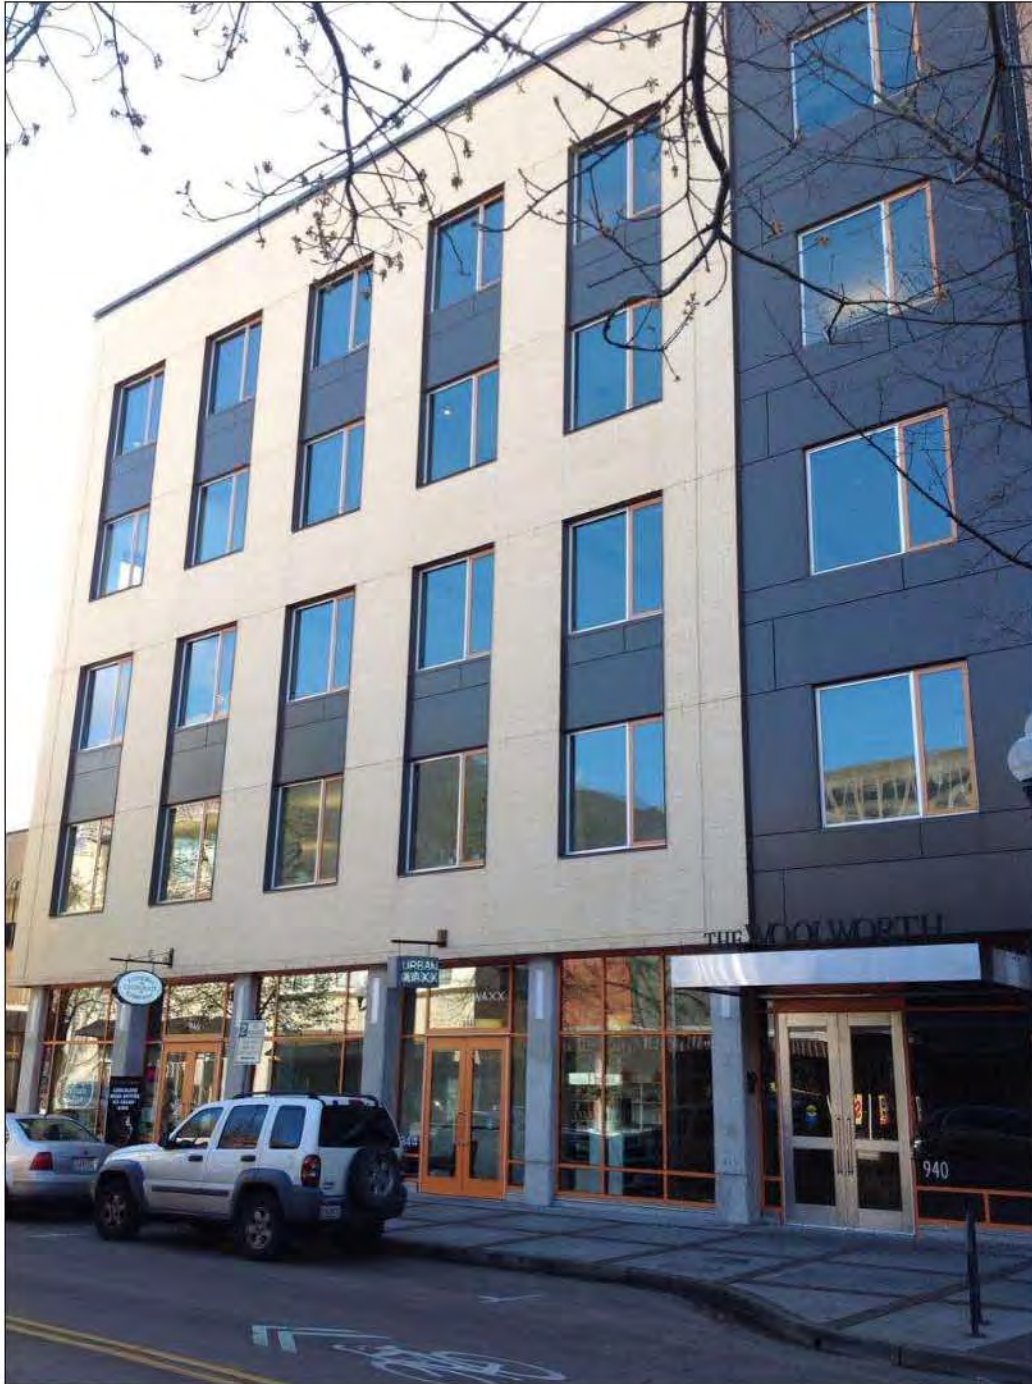
Property: 108	Name: Woolworth's Building	Determination of Blight:	No
Taxlot(s): 1703311301400	1703311301500	Depreciation Ratio:	19.80
Property Notes:	Building is in good condition. Property is a newer five story office building with bottom floor retail facing Willamette Street.

Photo: View of property facing Willamette street.

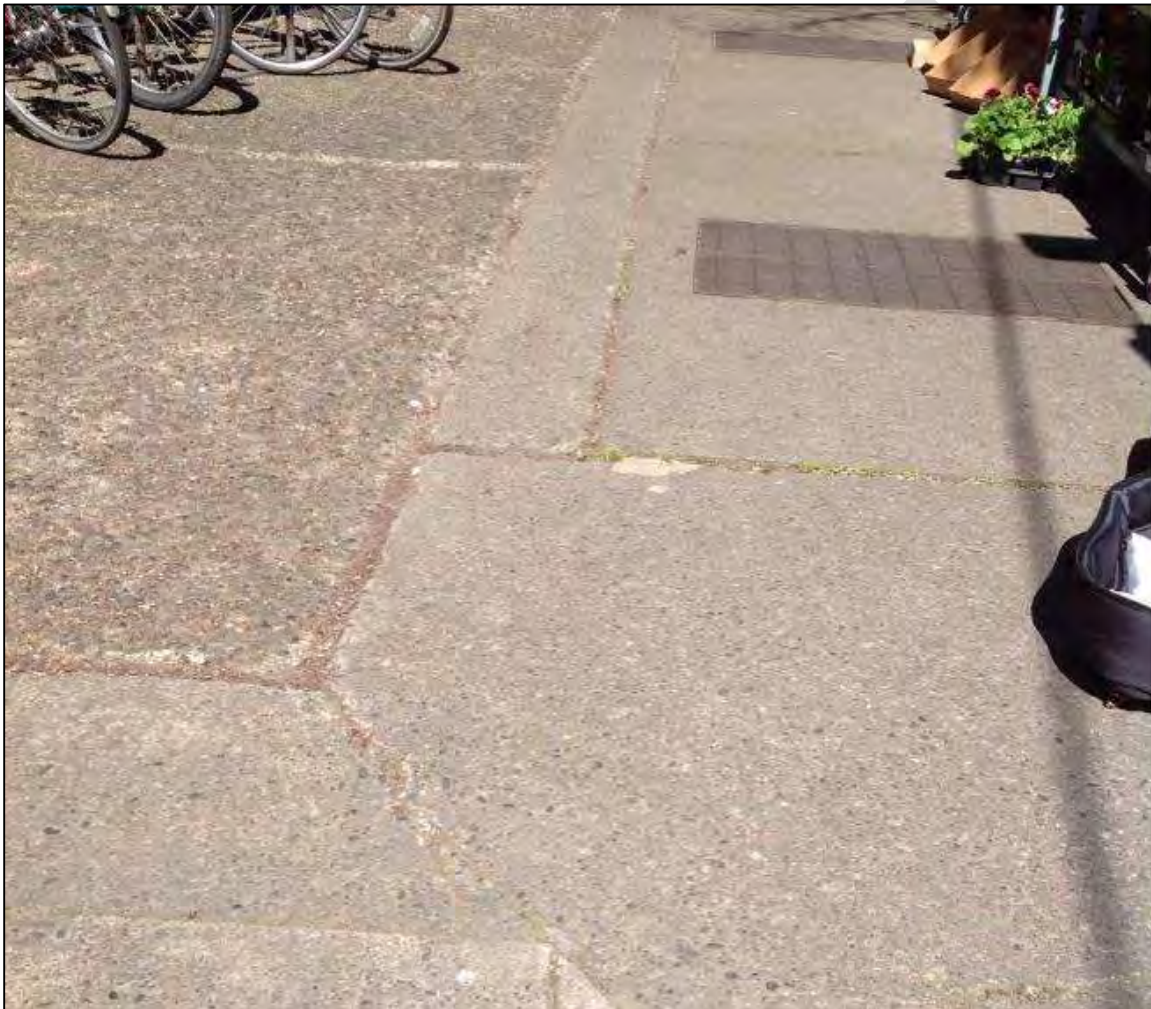
Area:	109	Name:	Sidewalk	Determination of Blight:	Yes
Notes:	Sidewalk is uneven and broken increasing concerns for accessibility. Determination of blight based on ORS 457.010 (1)(e).

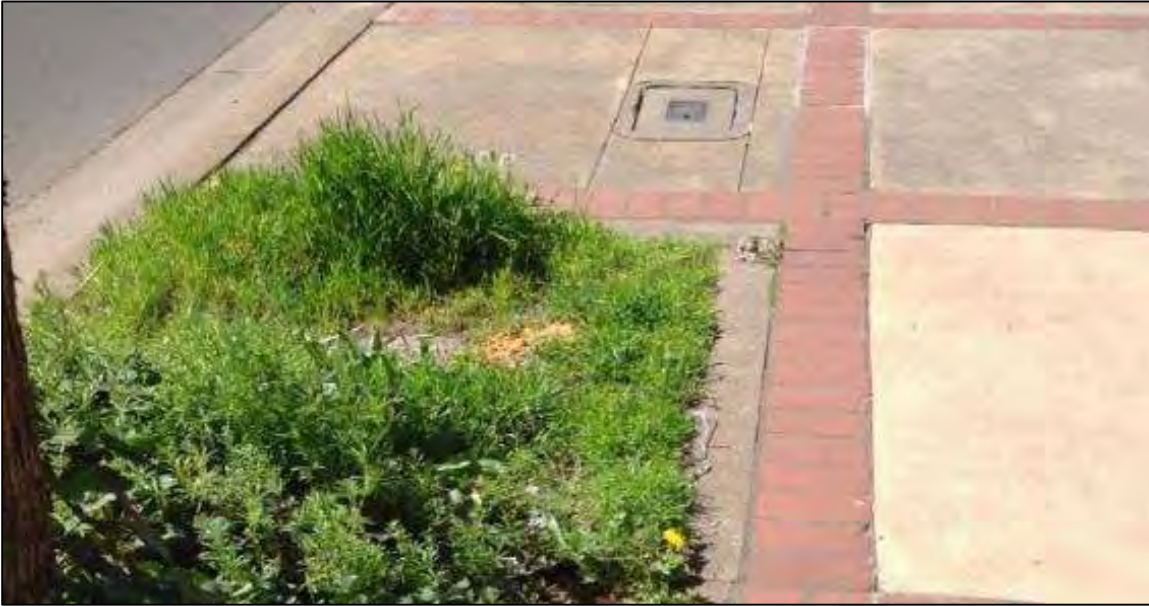
Area:	110	Name:	Sidewalk	Determination of Blight:	Yes
Notes:	Sidewalk has a large hole in pavement and vegetation is not maintained. Determination of blight based on ORS 457.010 (1)(e).

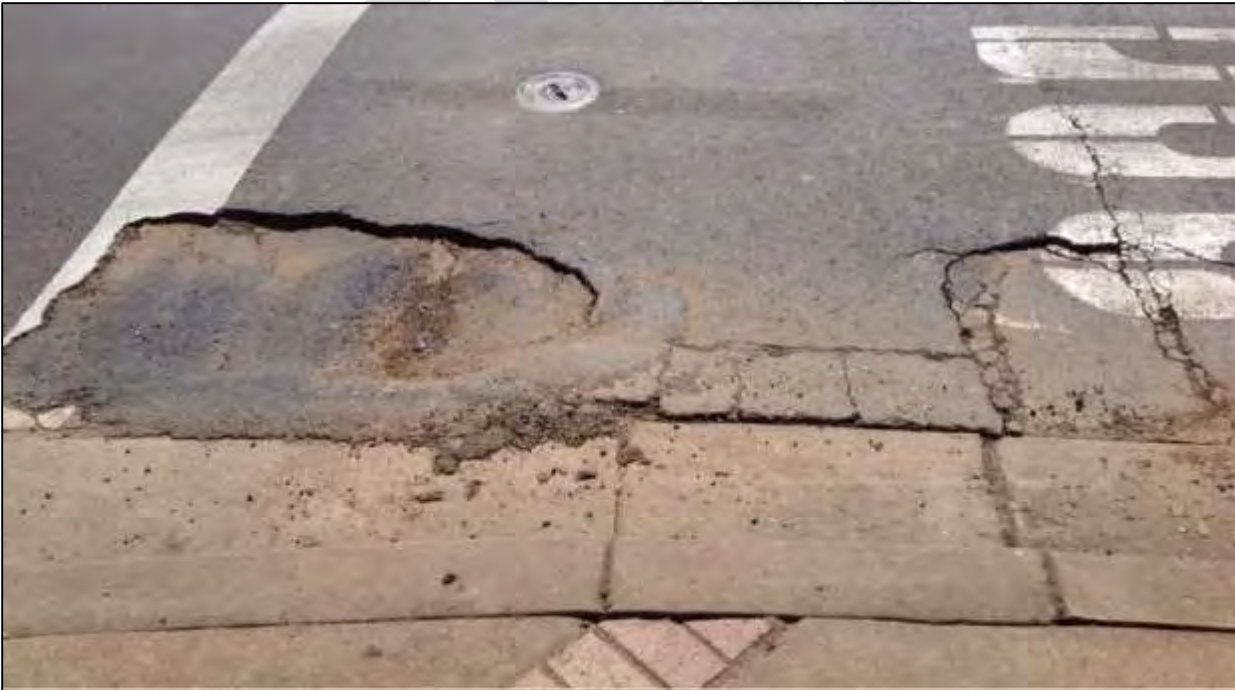
Area:	111	Name:	Road	Determination of Blight:	Yes
Notes:	Road with large potholes and liquid in one. Determination of blight based on ORS 457.010 (1)(e).

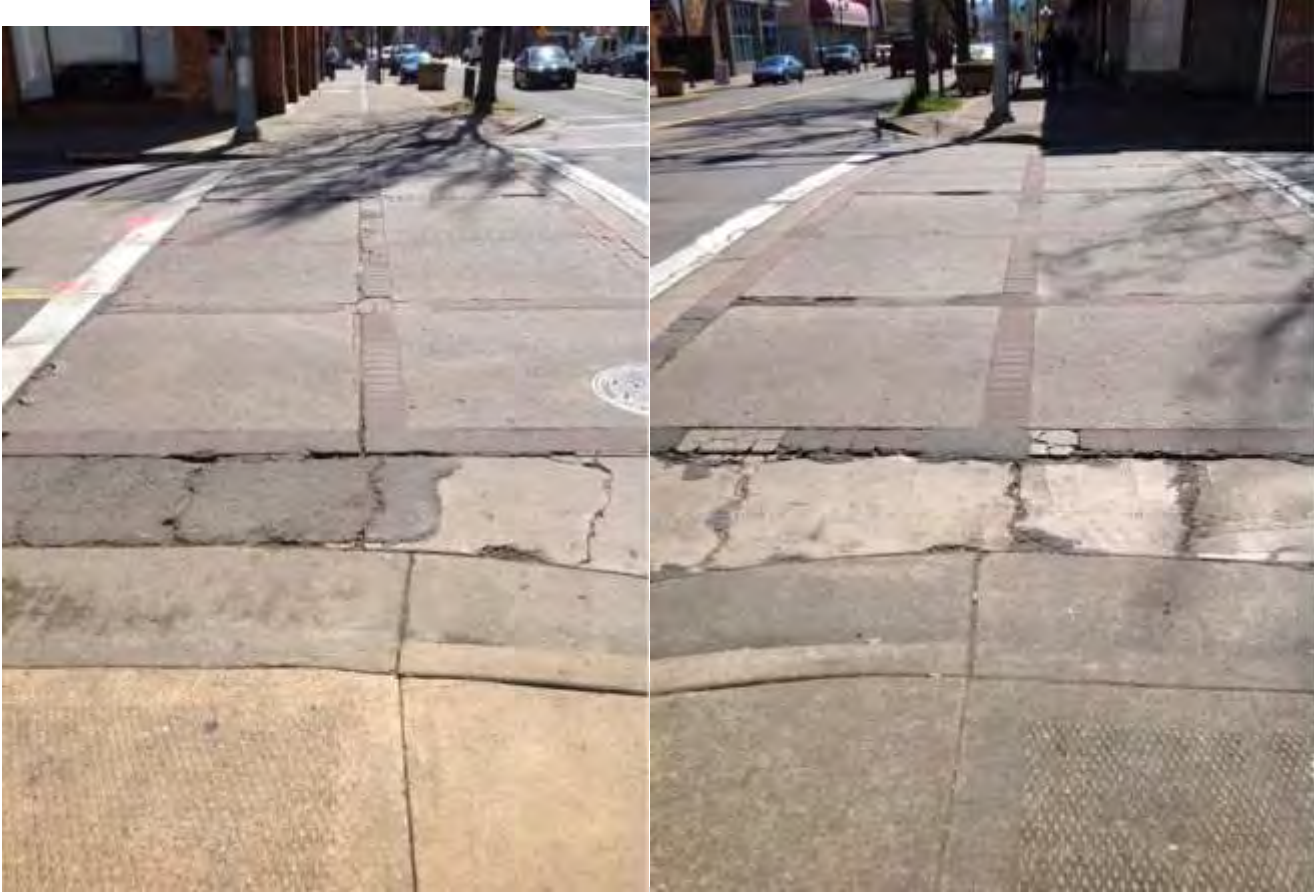
Area:	112	Name:	Sidewalk	Determination of Blight:	Yes
Notes:	Pedestrian crossing at 10th and Willamette. The crossings most notably on 10 th Avenue are broken, pitted, and have large holes increasing concerns for accessibility. Determination of blight based on ORS 457.010 (1)(e).

Photo: left: east crossing on 10th, right: west crossing on 10th

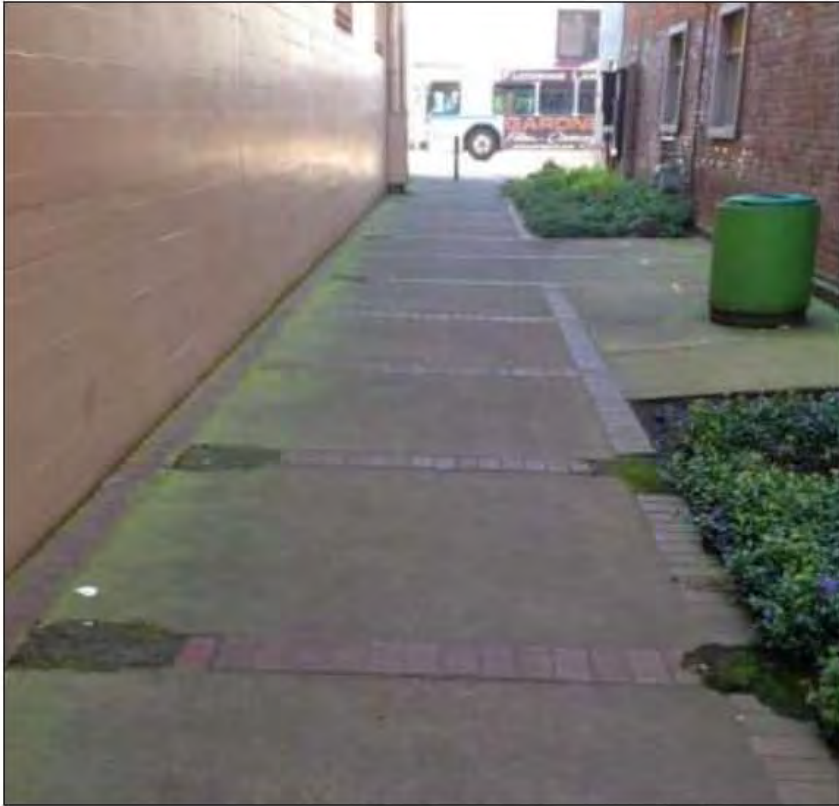
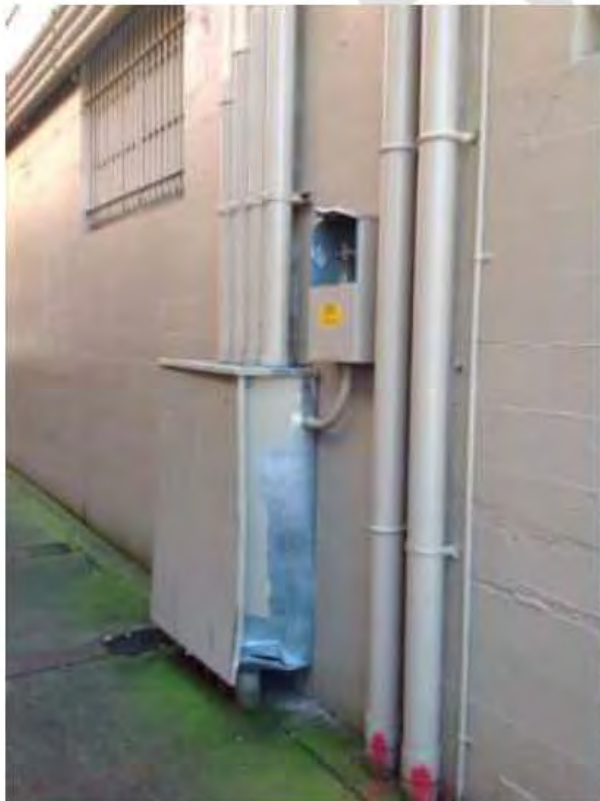
Area:	113	Name:	Sidewalk	Determination of Blight:	Yes
Notes:	Pedestrian walkway has damaged and patched sections and there are damaged utility boxes along walkway. Determination of blight based on ORS 457.010 (1)(e).

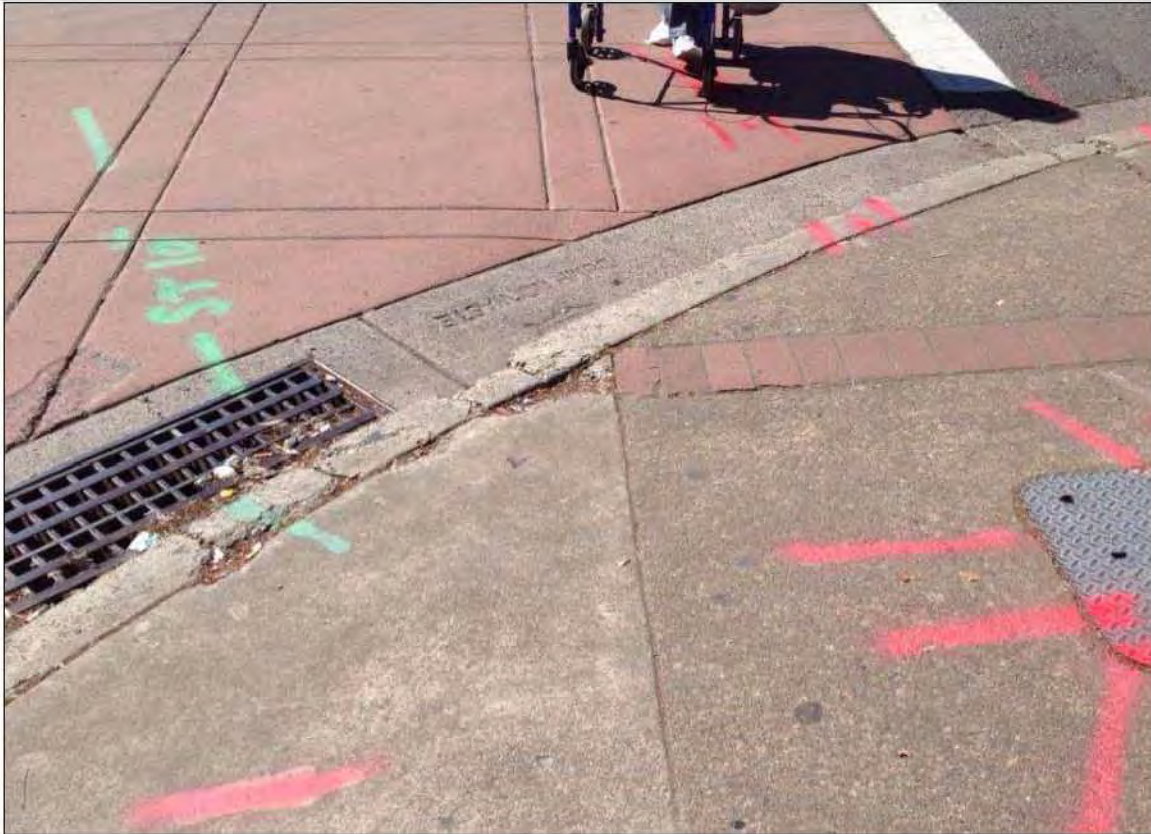
Area:	114	Name:	Sidewalk	Determination of Blight:	Yes
Notes:	The sidewalk and ramp are uneven with holes. The ramp not very accessible due to pavement, ramp and grate. Determination of blight based on ORS 457.010 (1)(e).

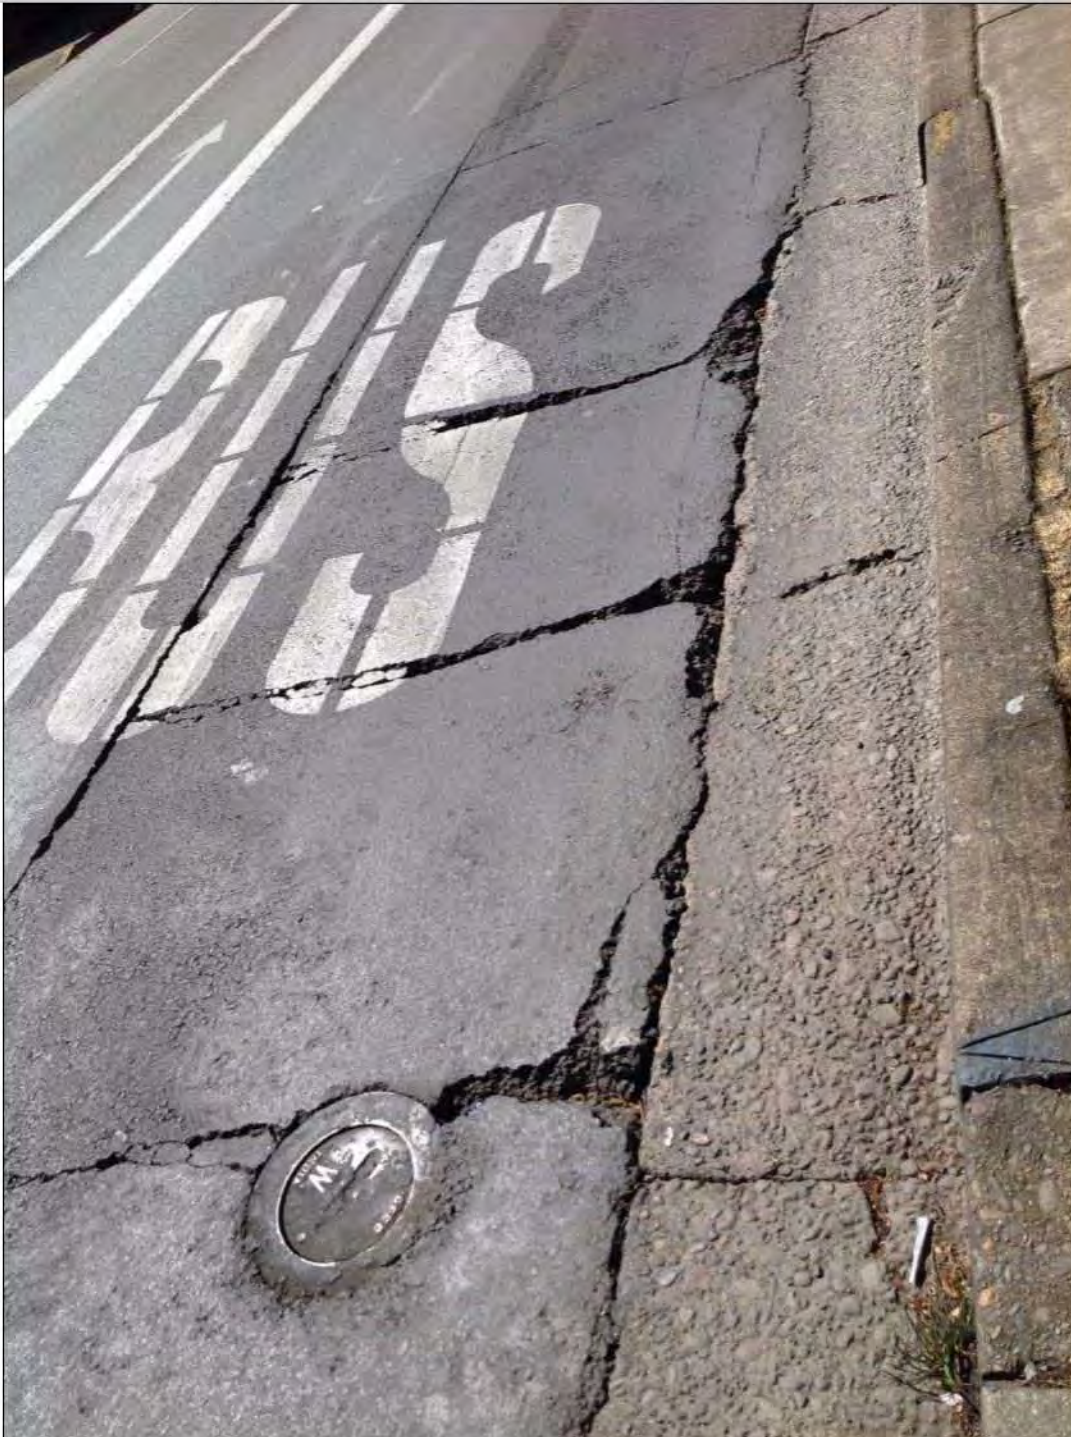
Area:	115	Name:	Road	Determination of Blight:	Yes
Notes:	There are several large holes in street. Determination of blight based on ORS 457.010 (1)(e).

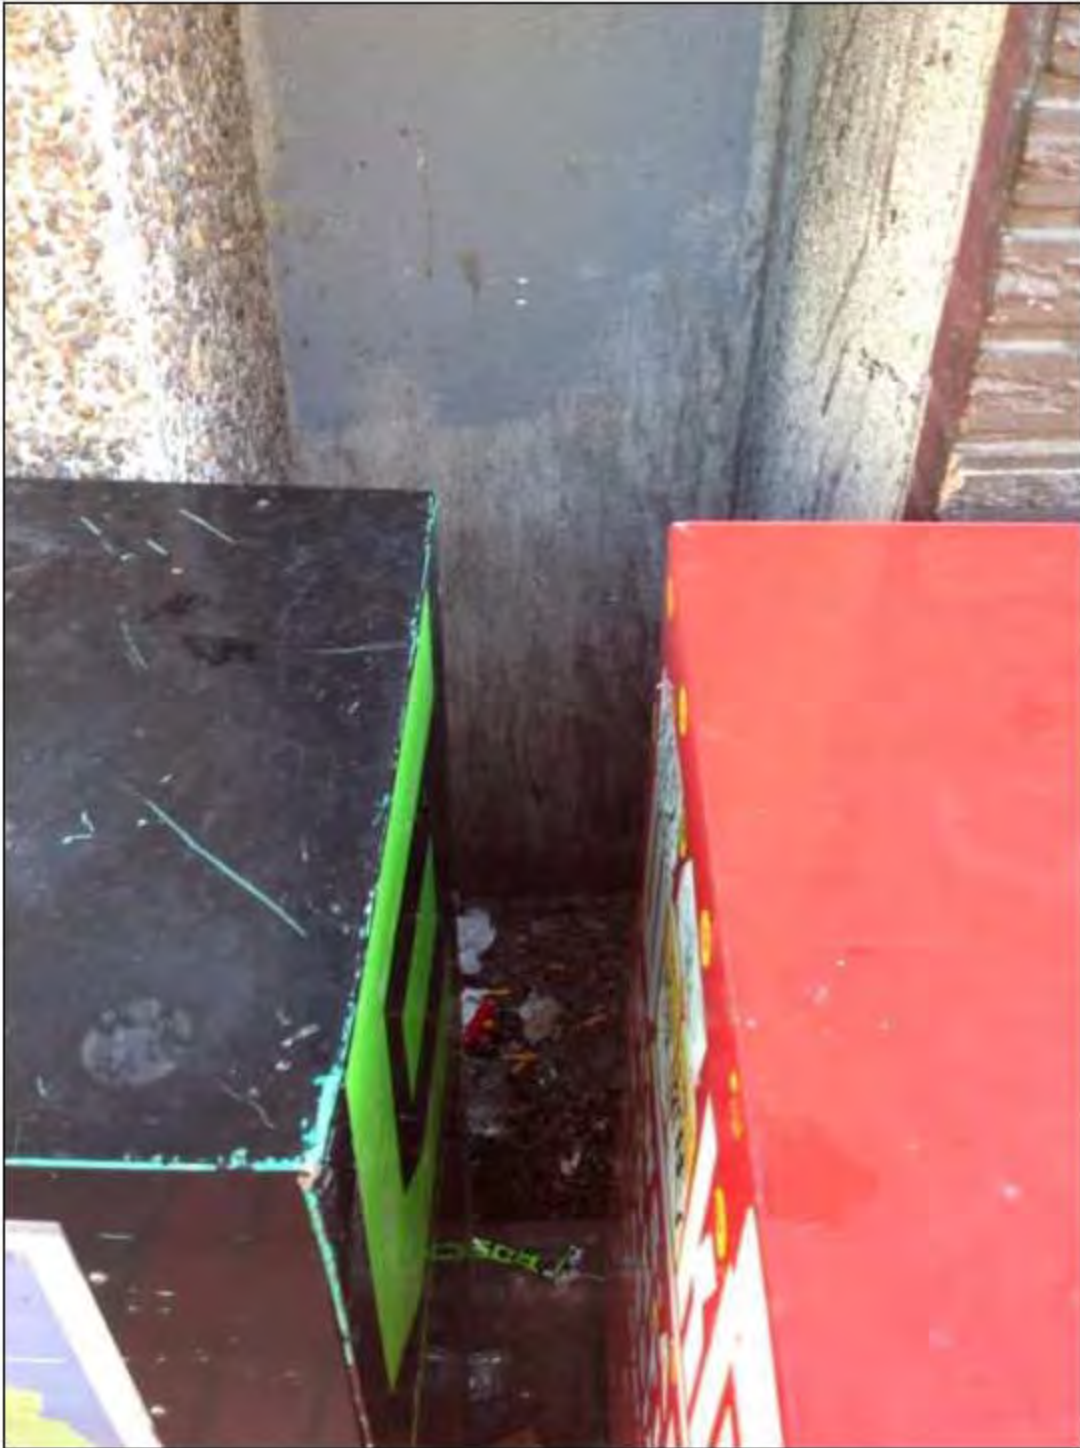
Area:	116	Name:	Sidewalk	Determination of Blight:	Yes
Notes:	This location is a divider between building #8 and #104. Location does not look maintained and is used for garbage. Determination of blight based on ORS 457.010 (1)(e).

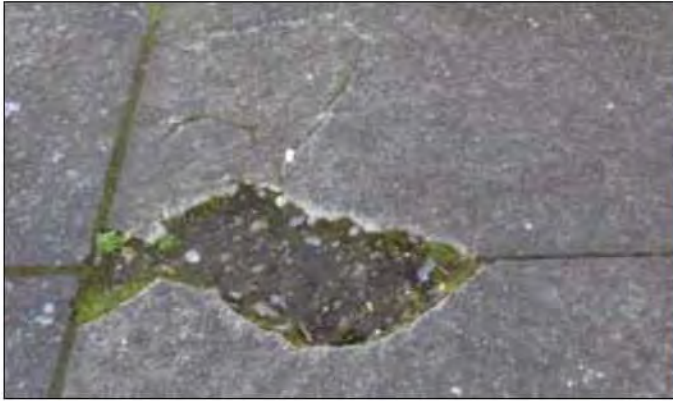
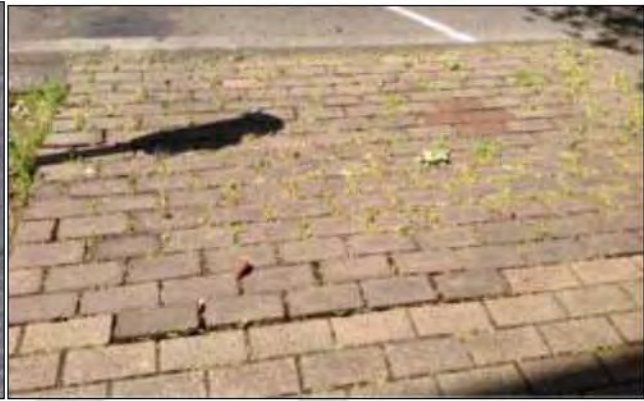
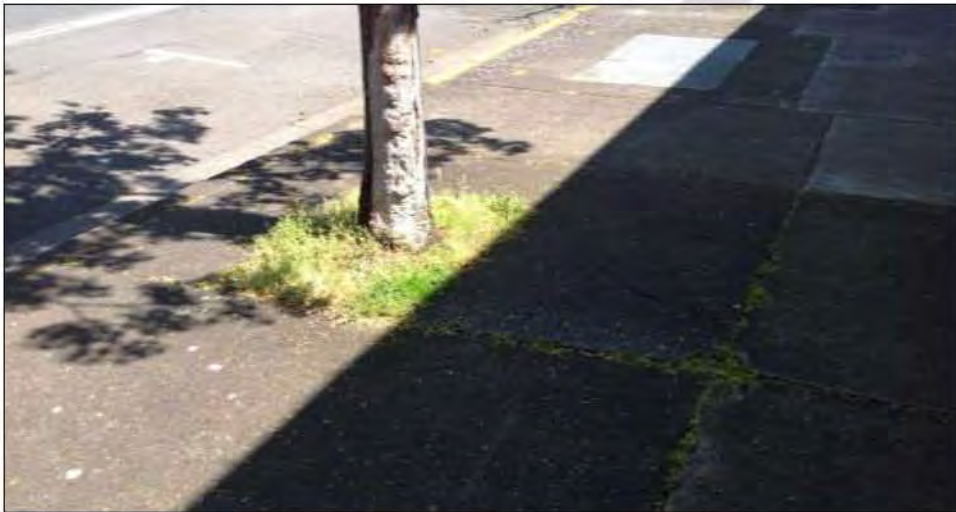
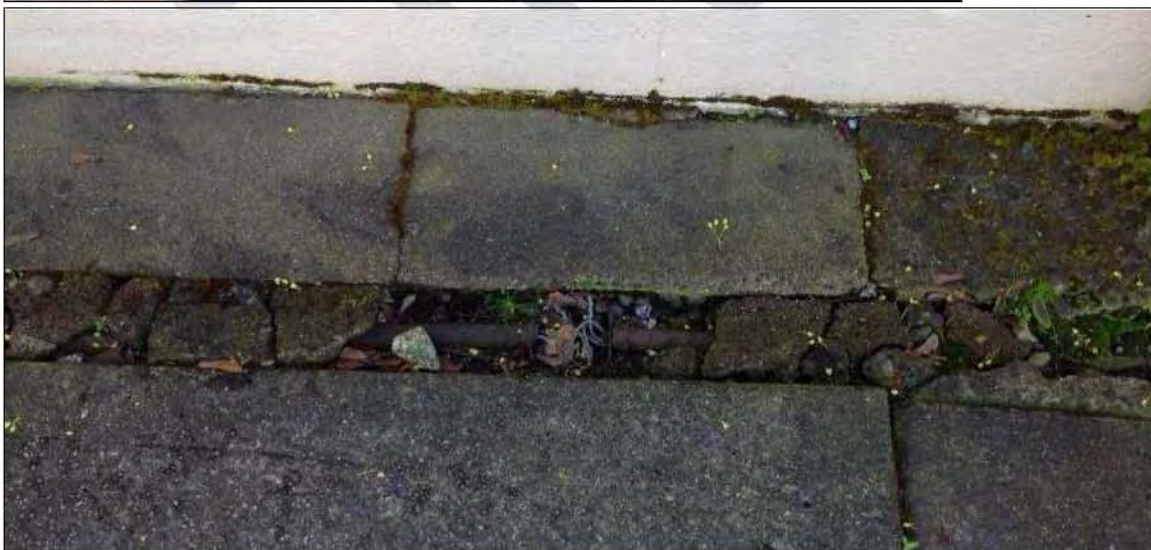
Area:	117	Name:	Sidewalk	Determination of Blight:	Yes
Notes:	Sidewalk around ¼ block damaged, is uneven with holes, has visible wiring, and loose bricks. Determination of blight based on ORS 457.010 (1)(e).

Photo: bottom image shows wiring in an exposed underground pipe.

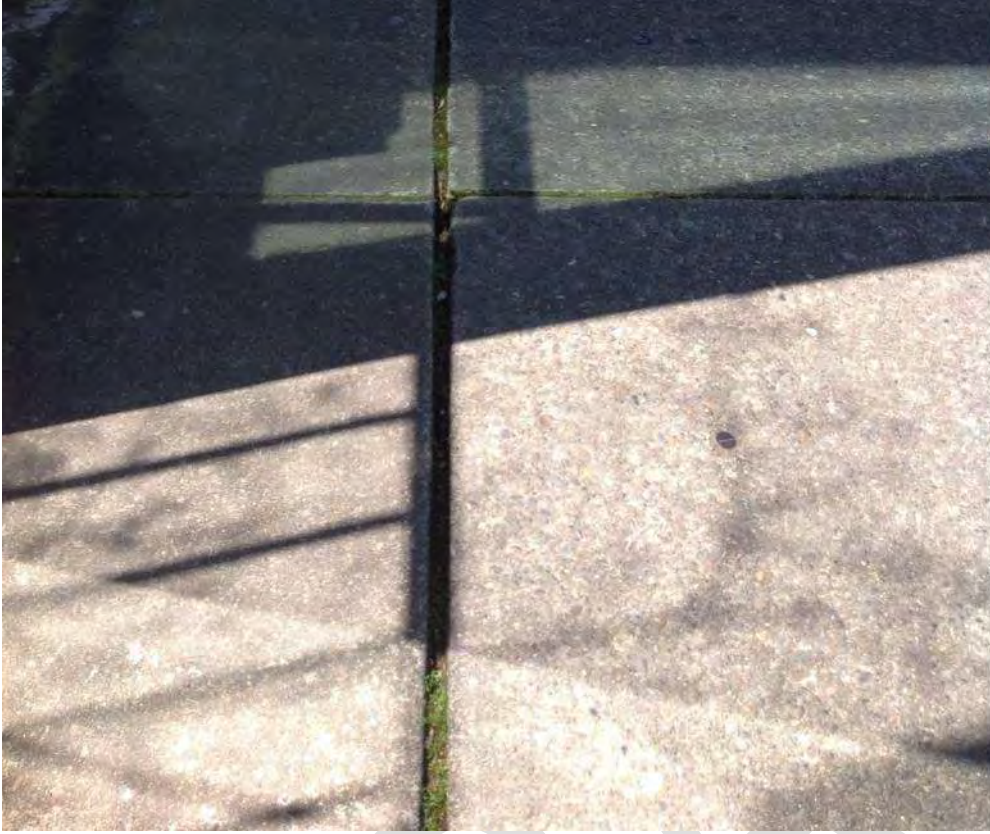
Area:	118	Name:	Sidewalk	Determination of Blight:	Yes
Notes:	Sidewalk has large gap. Determination of blight based on ORS 457.010 (1)(e).

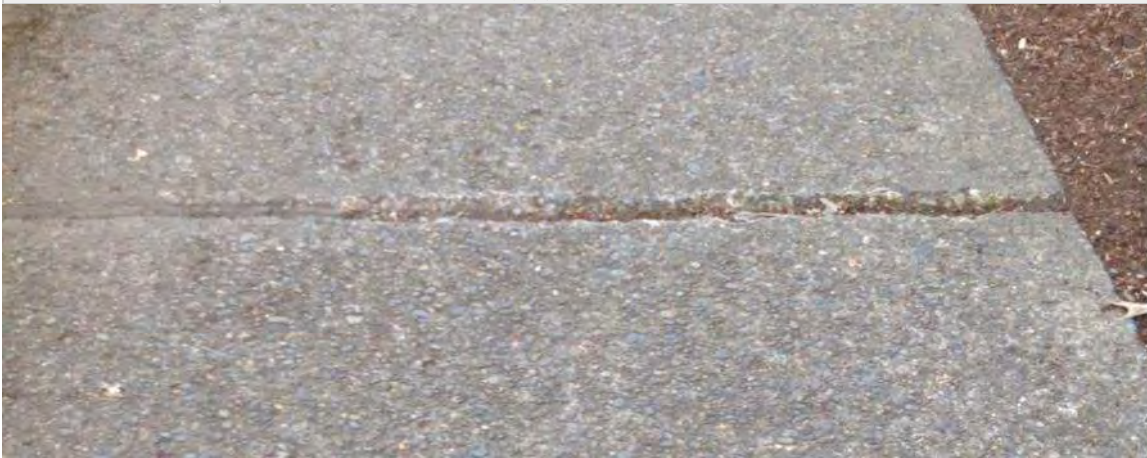
Area:	119	Name:	Sidewalk	Determination of Blight:	Yes
Notes:	The sidewalk is uneven and has a large space between tiles. Determination of blight based on ORS 457.010 (1)(e).

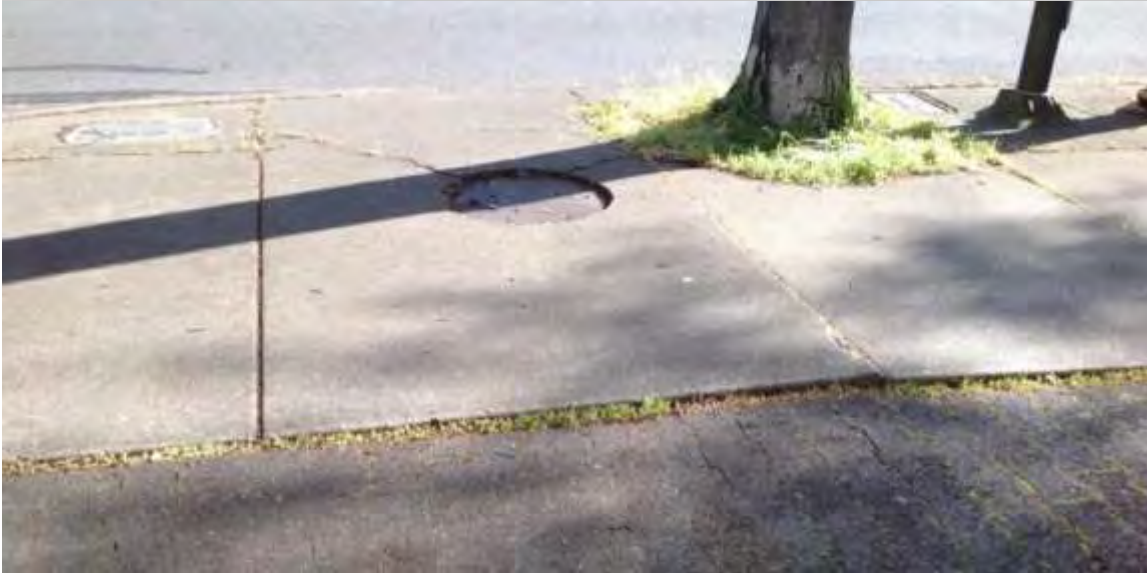
Area:	120	Name:	Sidewalk	Determination of Blight:	Yes
Notes:	The sidewalk is uneven and broken, raising concerns for accessibility. Determination of blight based on ORS 457.010 (1)(e).

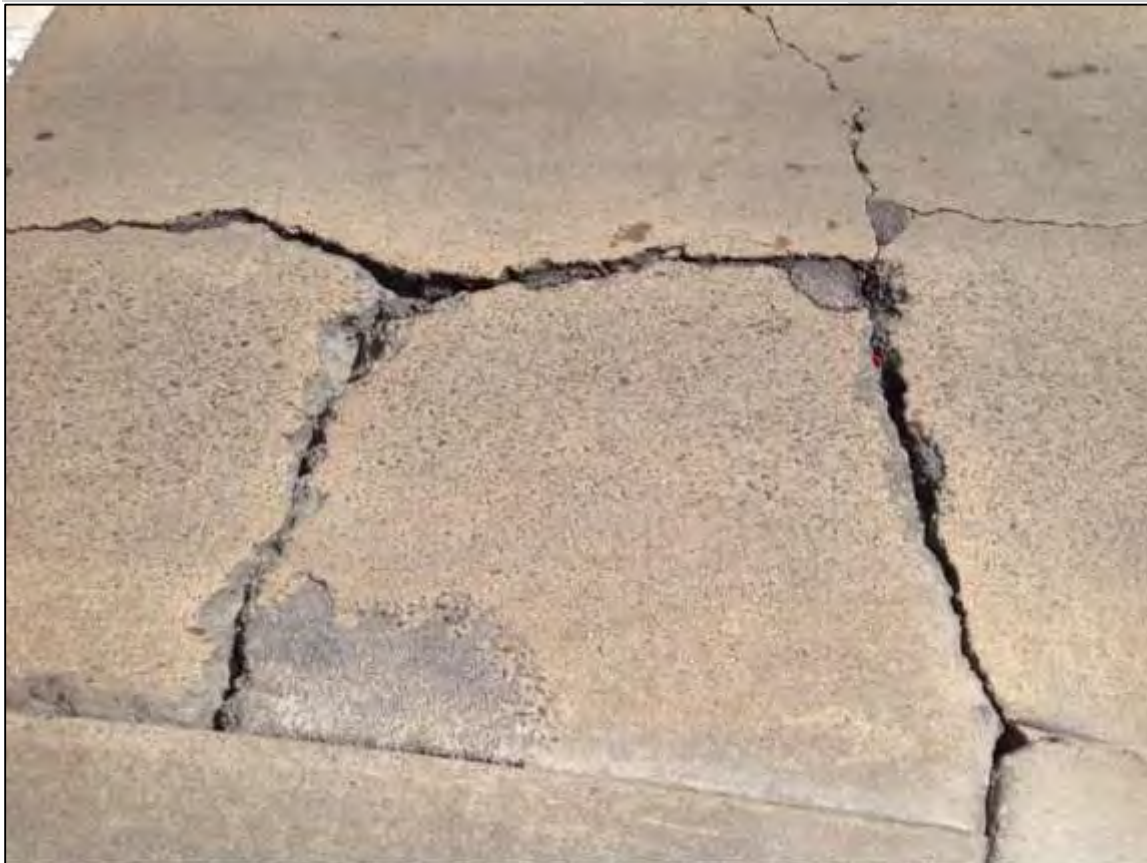
Area:	121	Name:	Road	Determination of Blight:	Yes
Notes:	Road shows several deep cracks. Determination of blight based on ORS 457.010 (1)(e).

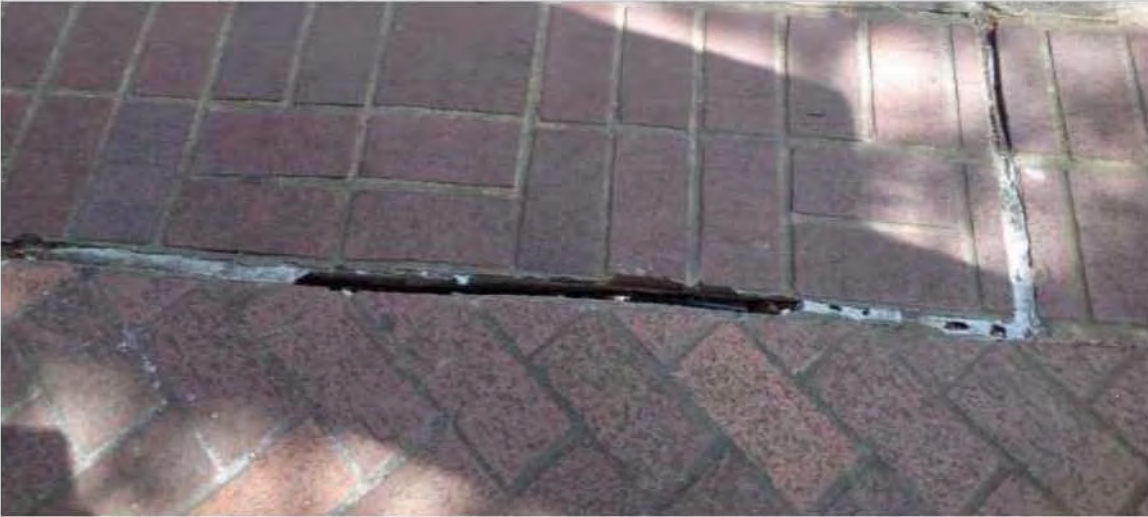
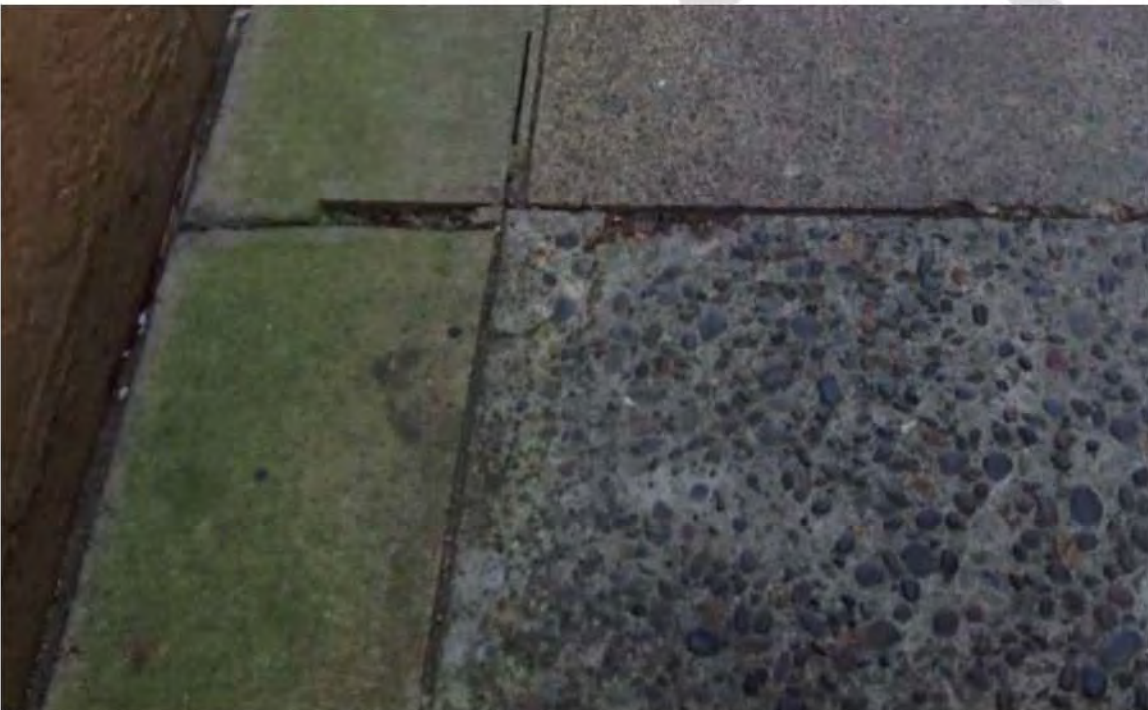
Area:	122	Name:	Pedestrian Walkway	Determination of Blight:	Yes
Notes:	Walkway has holes. Determination of blight based on ORS 457.010 (1)(e).

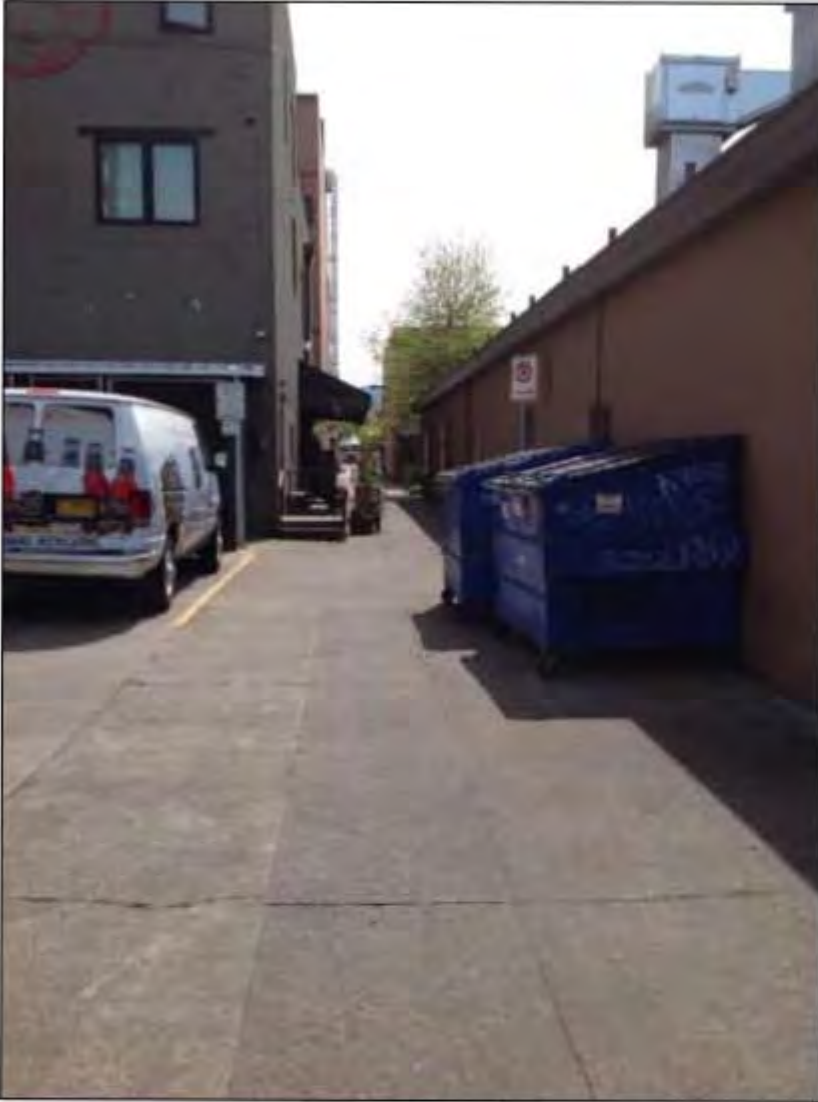
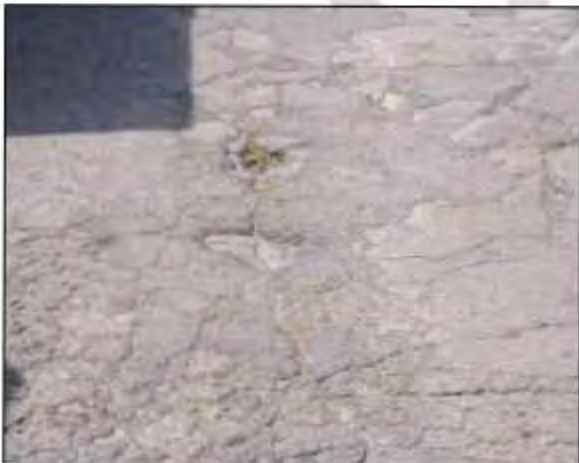
Area:	123	Name:	Alley and service court	Determination of Blight:	Yes
Notes:	In walkway and service court, the pavement is uneven with large holes. The pedestrian walkway leads people to service court with garbage containers. Determination of blight based on ORS 457.010 (1)(e).
