**Summary of Council Discussions/Actions
on Downtown Improvements**

Map to Accompany Downtown Urban Renewal Slums and Blight Report 2016

Downtown Urban Renewal District – Determination of Slums and Blight - Detailed Property Survey

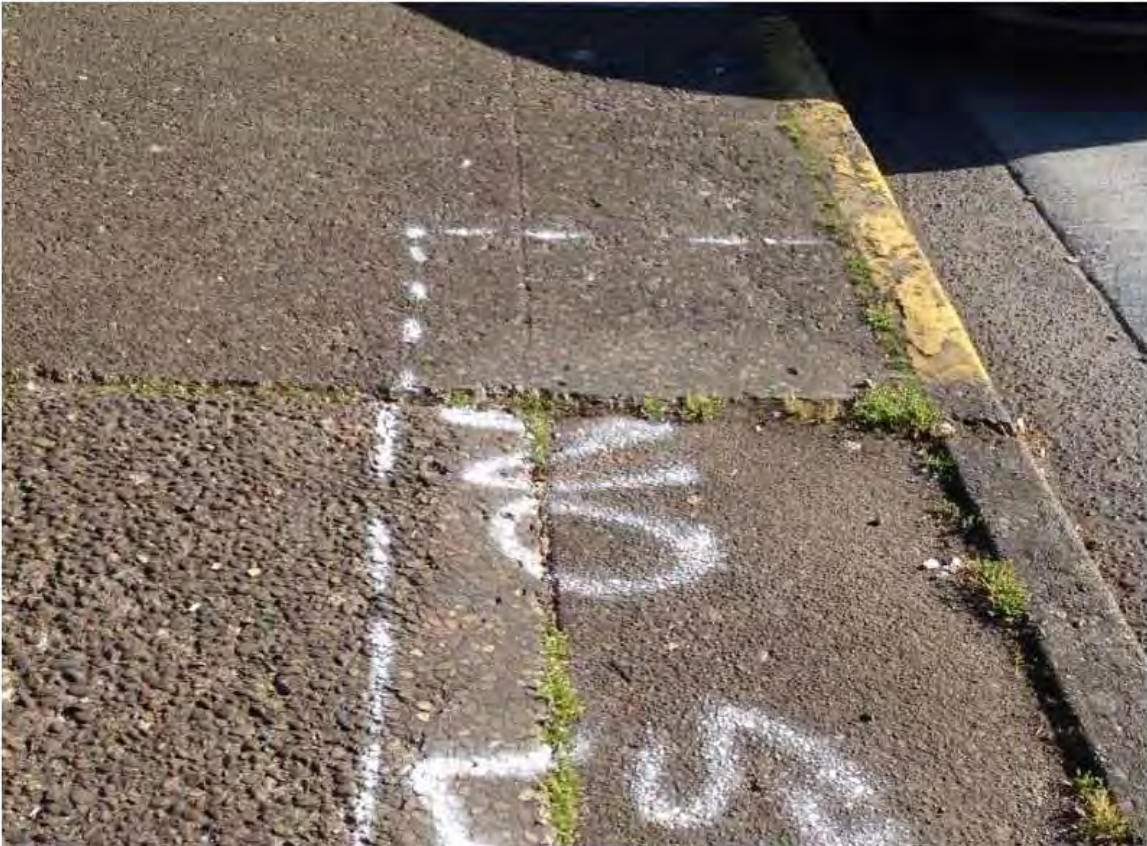
Area:	124	Name:	Sidewalk	Determination of Blight:	Yes
Notes:	Sidewalk is uneven with holes. Determination of blight based on ORS 457.010 (1)(e).

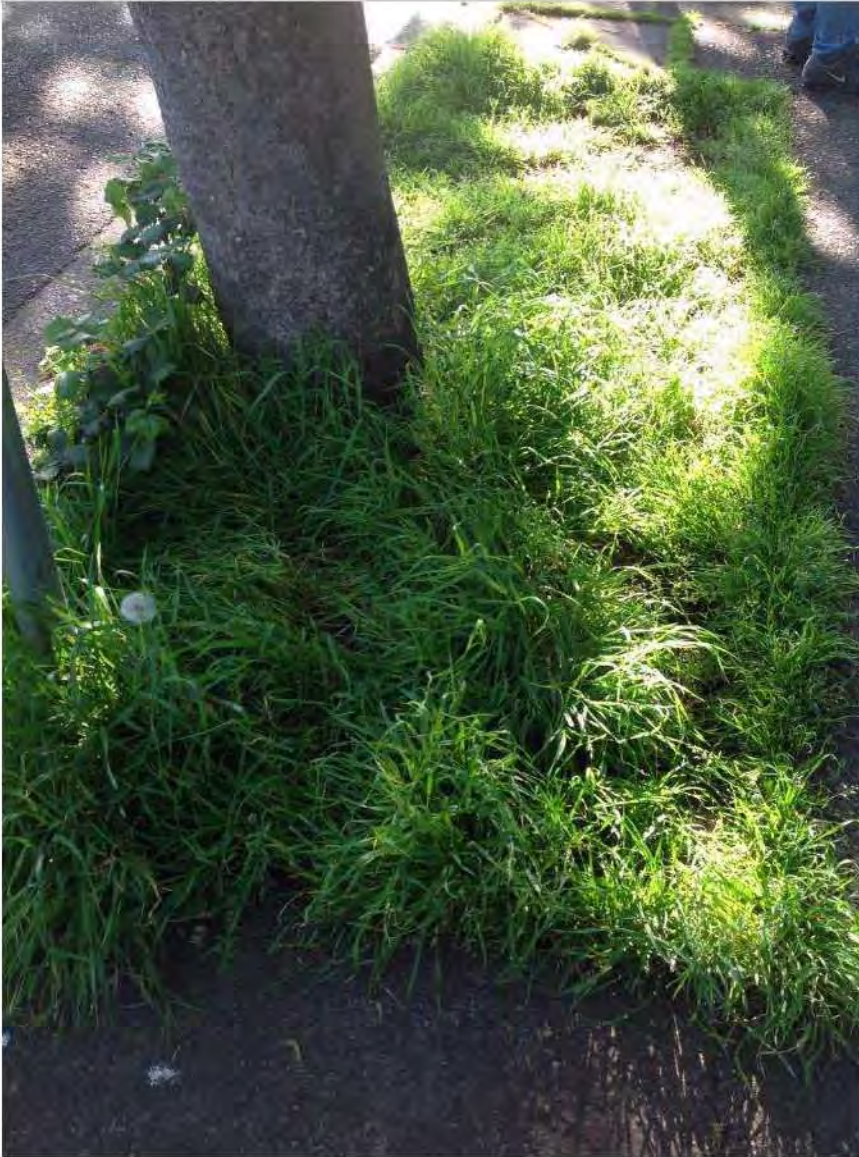
Area:	125	Name:	Sidewalk	Determination of Blight:	Yes
Notes:	Sidewalk is uneven and broken with overgrown vegetation. Determination of blight based on ORS 457.010 (1)(e).

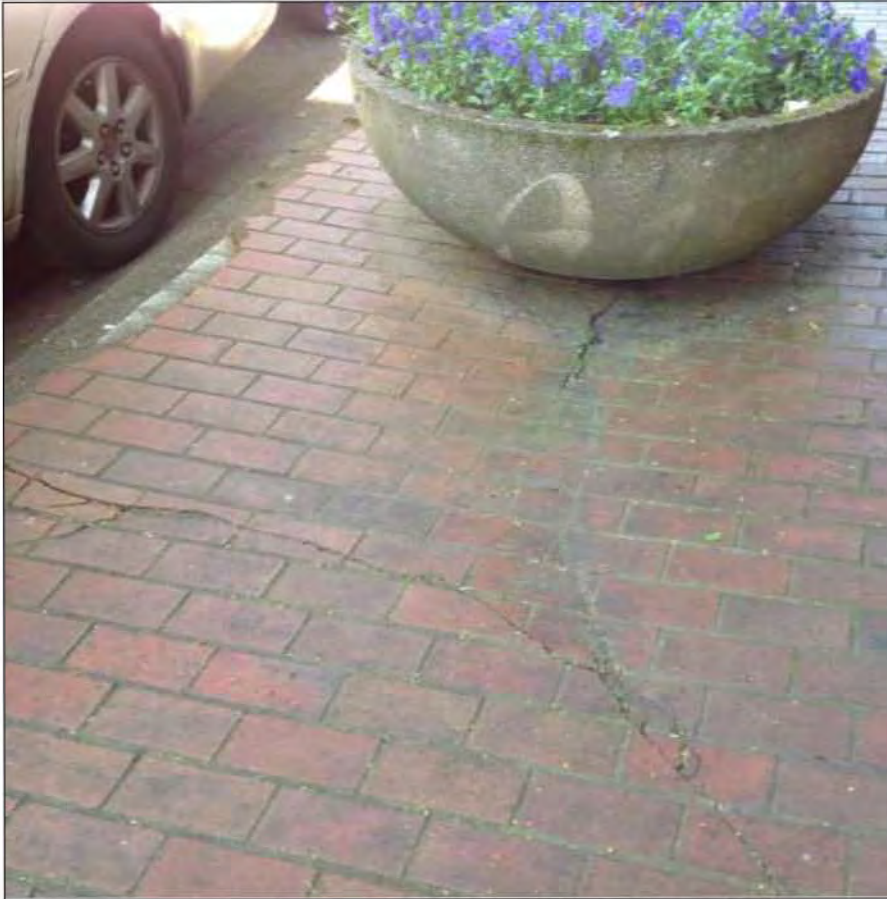
Area:	126	Name:	Sidewalk	Determination of Blight:	Yes
Notes:	Sidewalk is damaged and uneven. Determination of blight based on ORS 457.010 (1)(e).

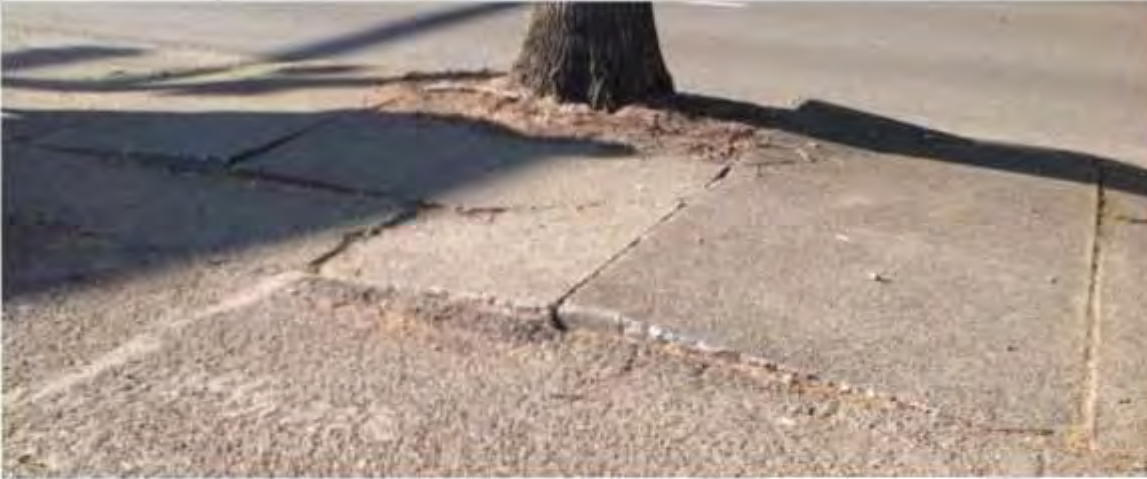
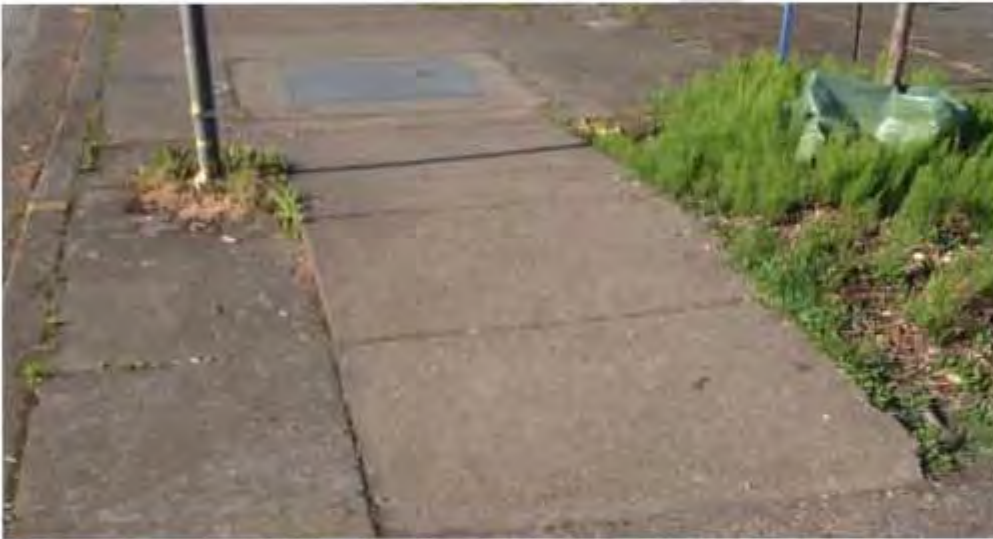
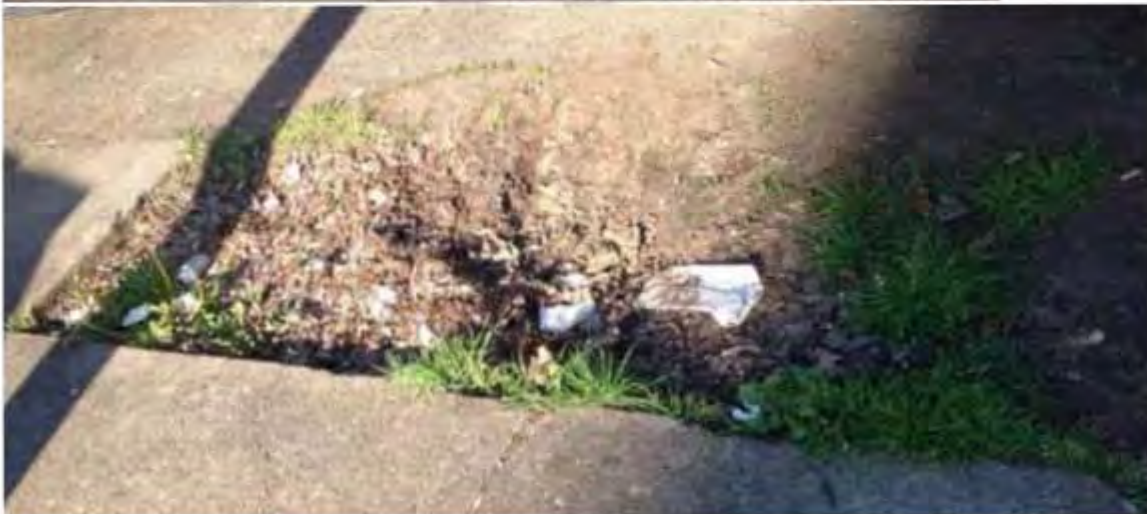
Area:	127	Name:	Sidewalk	Determination of Blight:	Yes
Notes:	Sidewalk has large holes, it is uneven, broken, and accessibility is questioned. Determination of blight based on ORS 457.010 (1)(e).
